5 Build Reports and Analysis

5.1 Overview of the DBDOC build reports

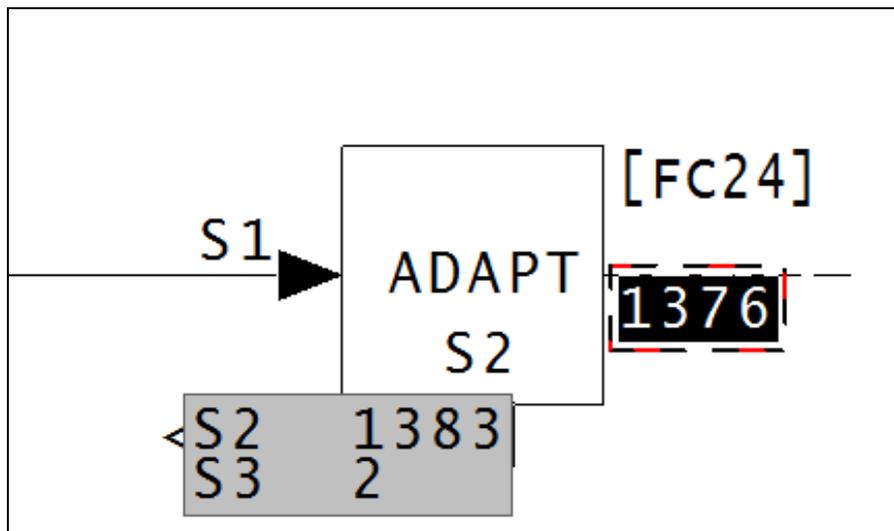
In the above image, the adapt block has an S2 value of 1383, however there is no block 1383 on the same module. This means that no adaptation is available. In the below image, spec 2 is a 0, so there is no block for this adapt block to adapt. Therefore this block is doing nothing.

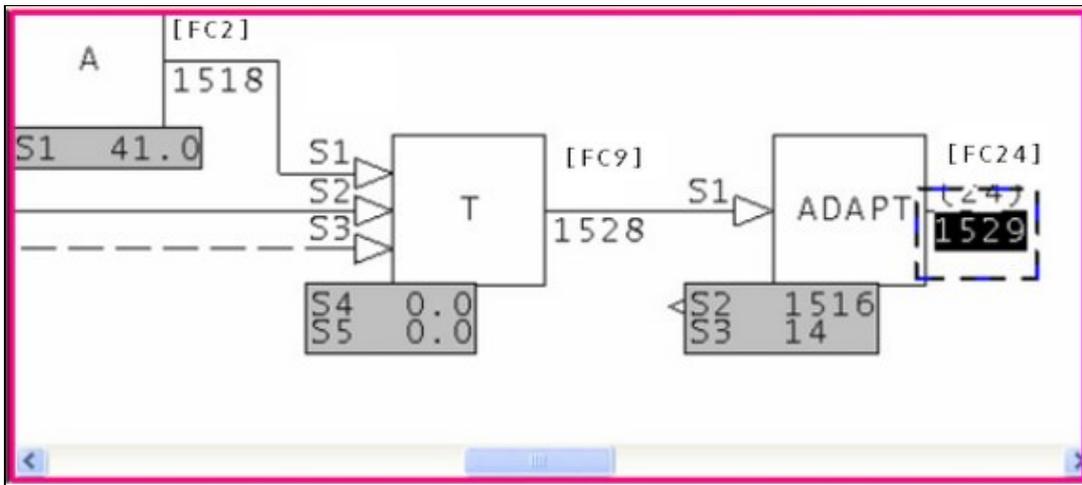
```
Adapt block Module 4,50,02 Block 1529 on drawing 45002P3:  
Spec 14 on block 1516 out of range, (function code 40).
```

Click on the link in the error browser to bring up the CLD/CAD sheet where we have an adapt block issue.

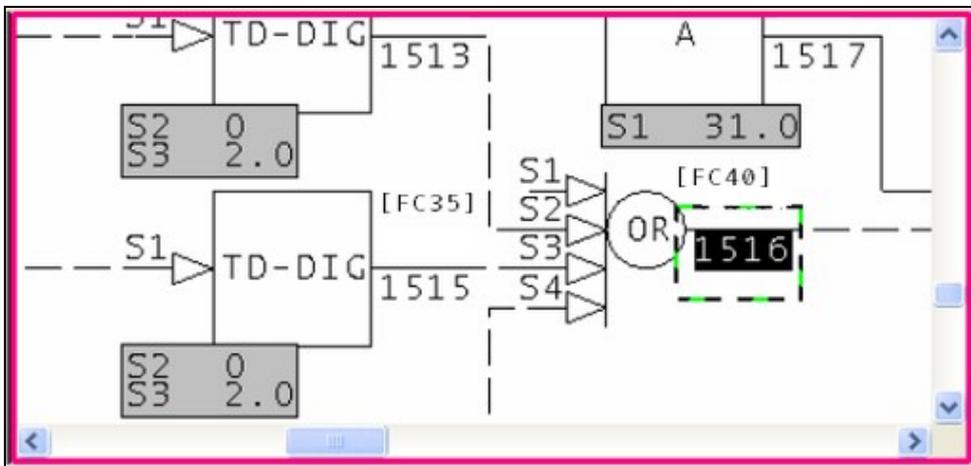
Double click on the hot spot hiding under Spec 2.

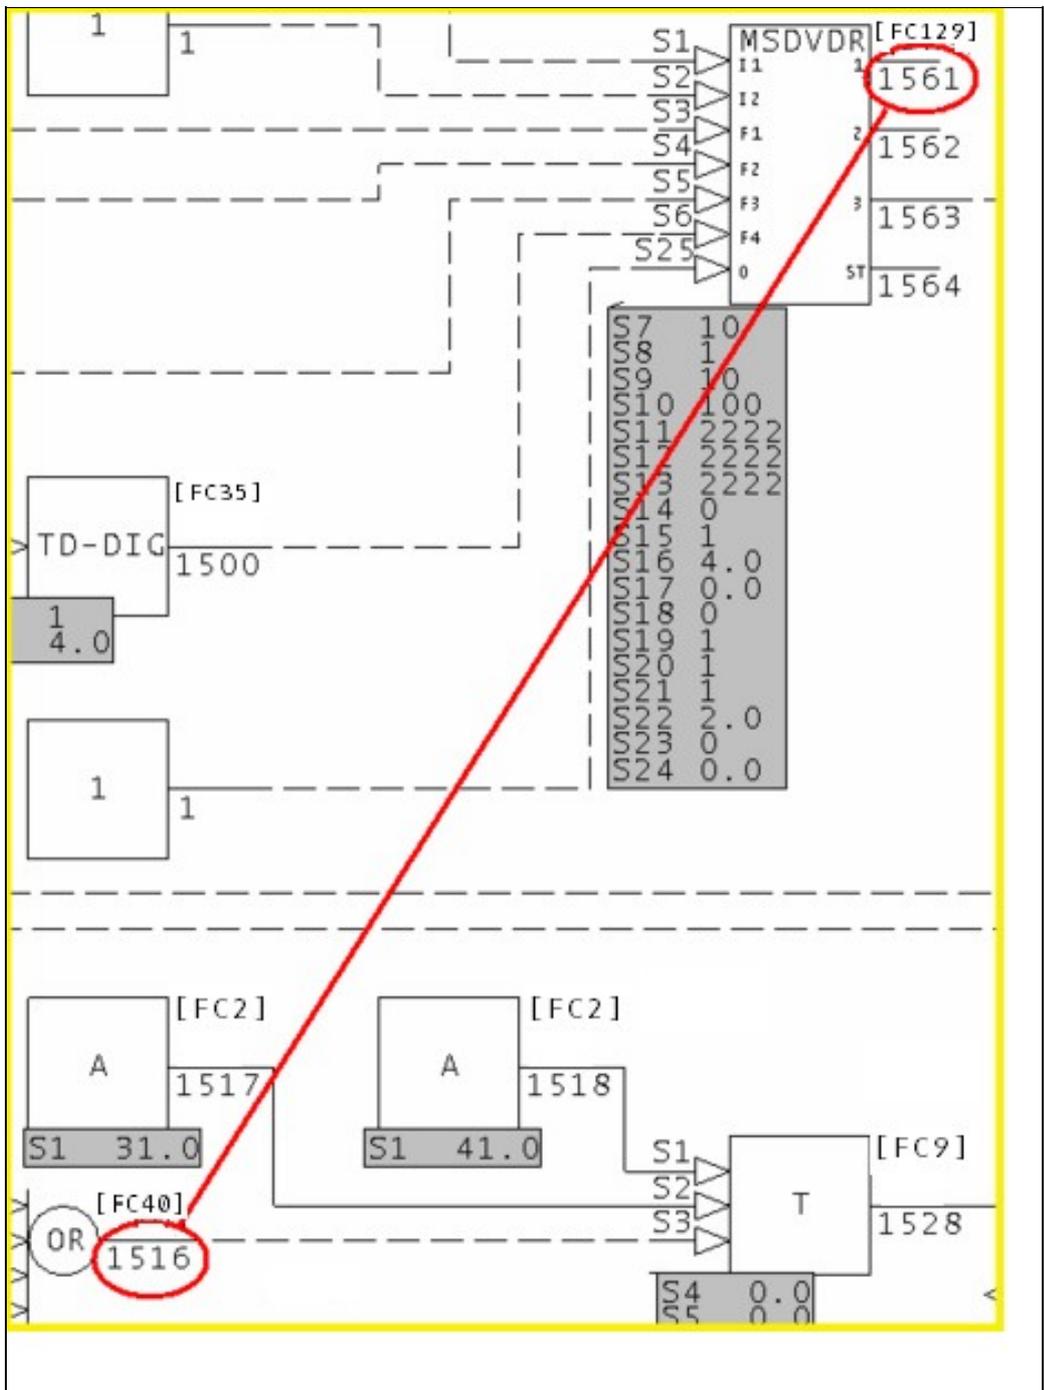
Zoom out and see the MSDVDR block - it is Block 1561.

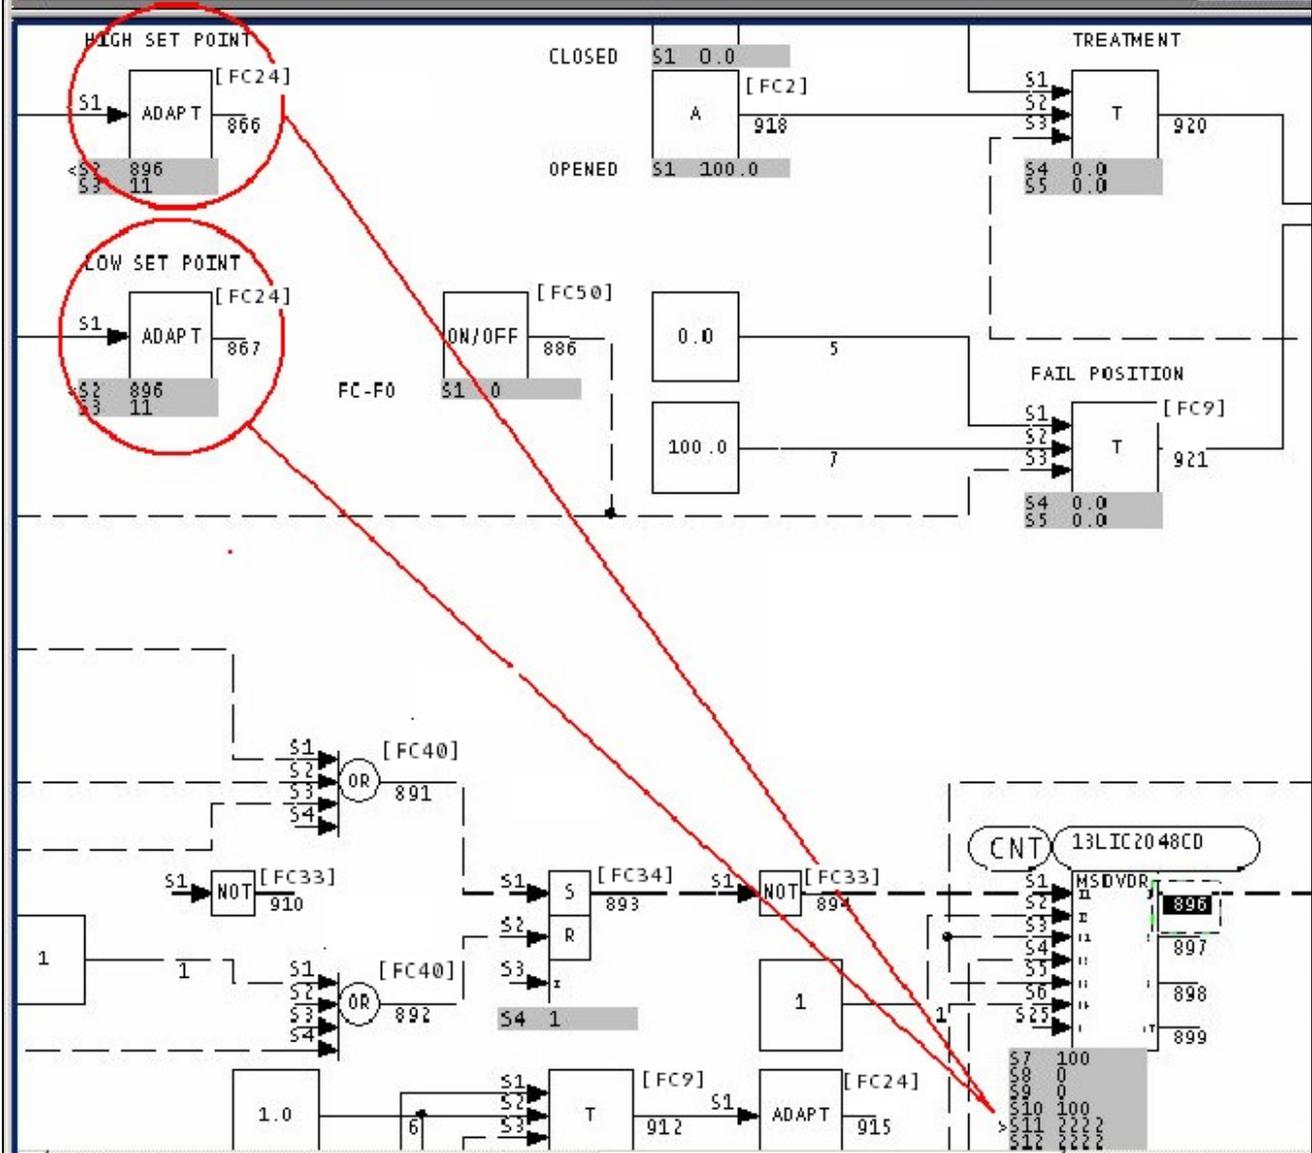
This drawing shows more than one, except that it is likely this is actually abandoned logic. Sheet Z9, as the last sheet, is often a boneyard sheet. Here, legal blocks have probably been used badly.

- 2. 28002Z9C.CAD S11 adapted by block 866
- 3. 28002Z9C.CAD Source (FC 129 MULTI-STATE DEVICE DRIVER)
- 4. 28002Z9C.CAD S14 adapted by block 932

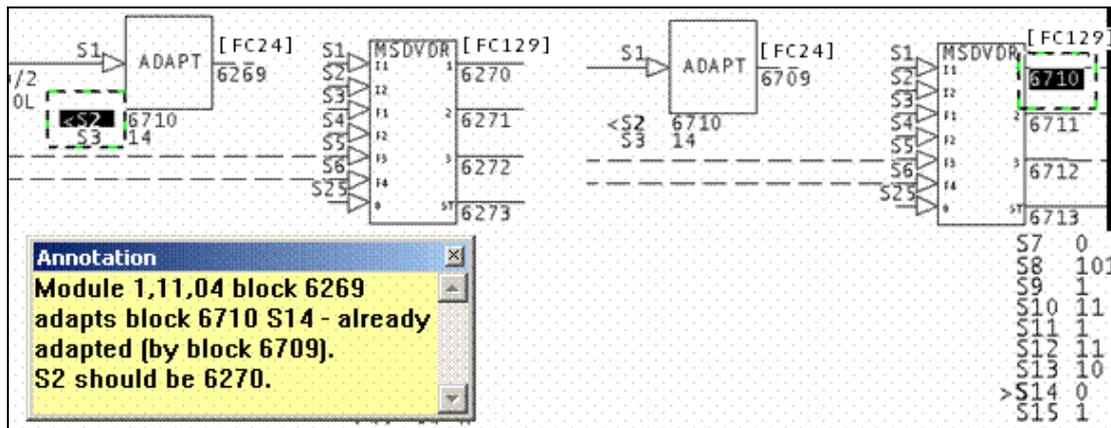
Module 1,11,04 block 6269 adapts block 6710 S14 - already adapted (by block 6709).

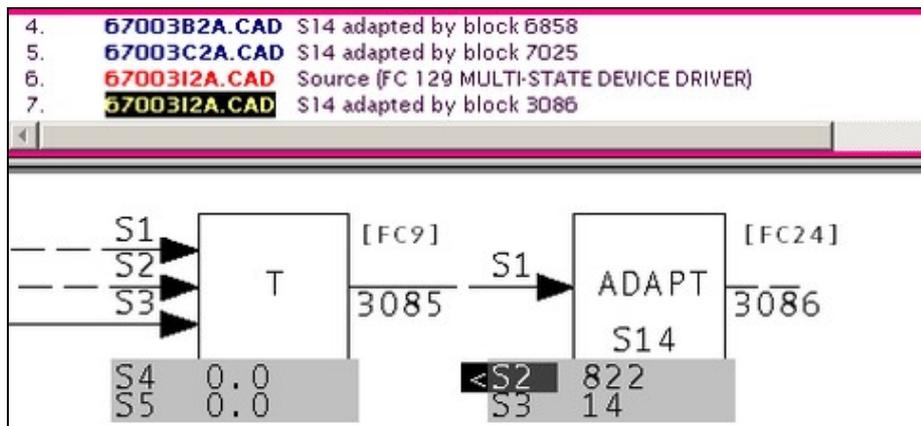
The normal scenario for this error is that S2 of a cloned adapt block has not been changed to match a target, even though the output block number has.

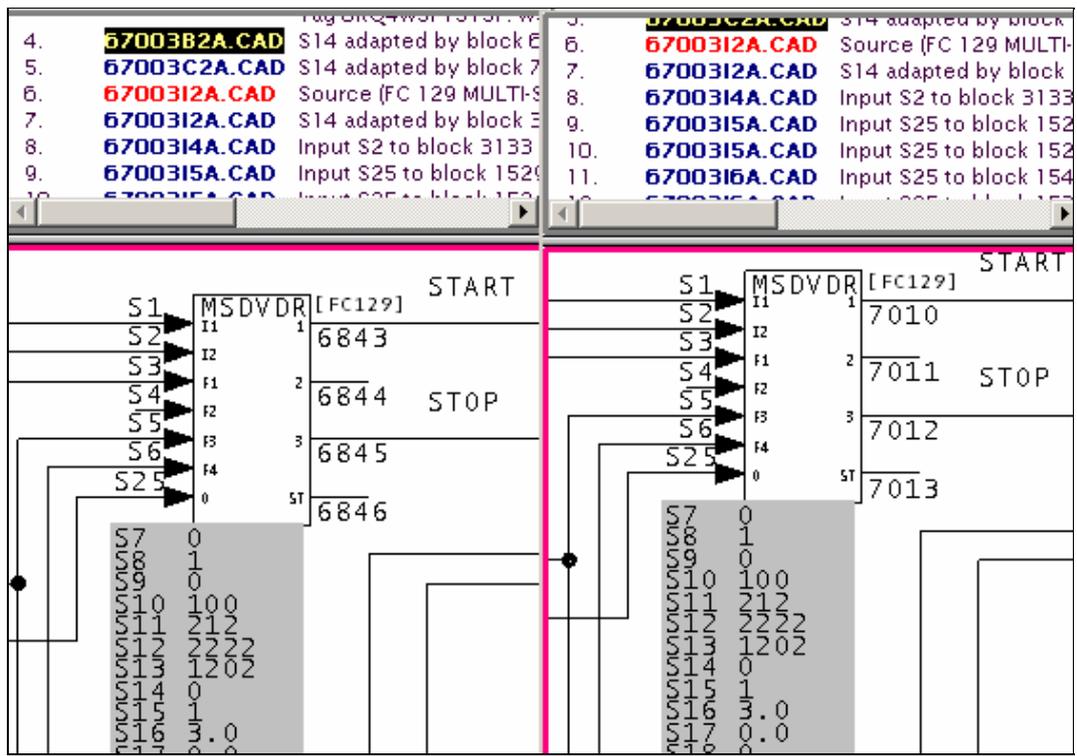
On sheets 67003B2A.CAD and 67003C2A.CAD, we will guess that there are MSDD blocks that do not have S14 adapted by an adapt block on that page. They have been orphaned.

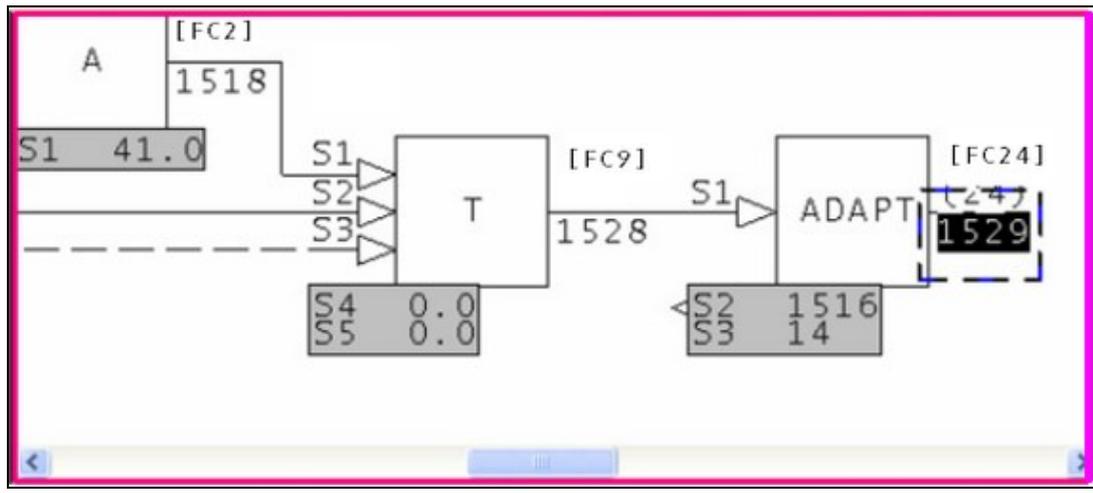
Adapt block Module 4,50,02 Block 1529 on drawing 45002P3:
Spec 14 on block 1516 out of range, (function code 40).

Click on the link in the error browser to bring up the CLD/CAD sheet where we have an adapt block issue.

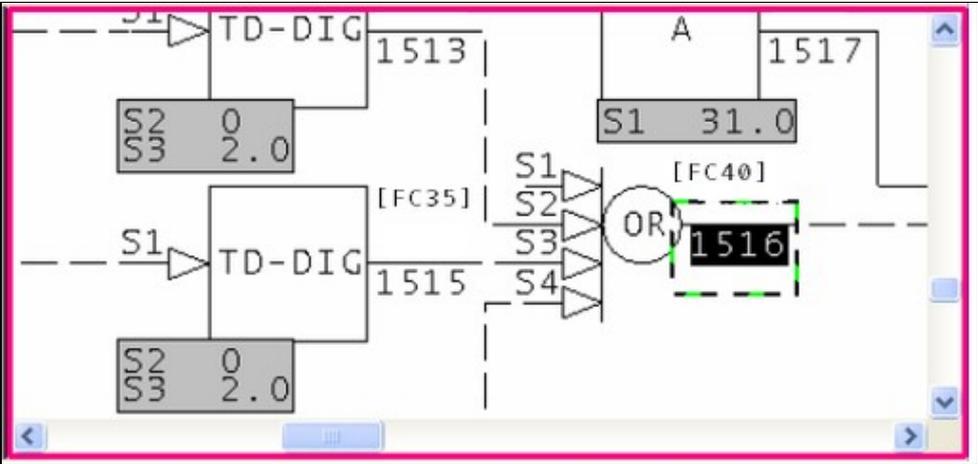
Double click on the hotspot hiding under Spec 2.

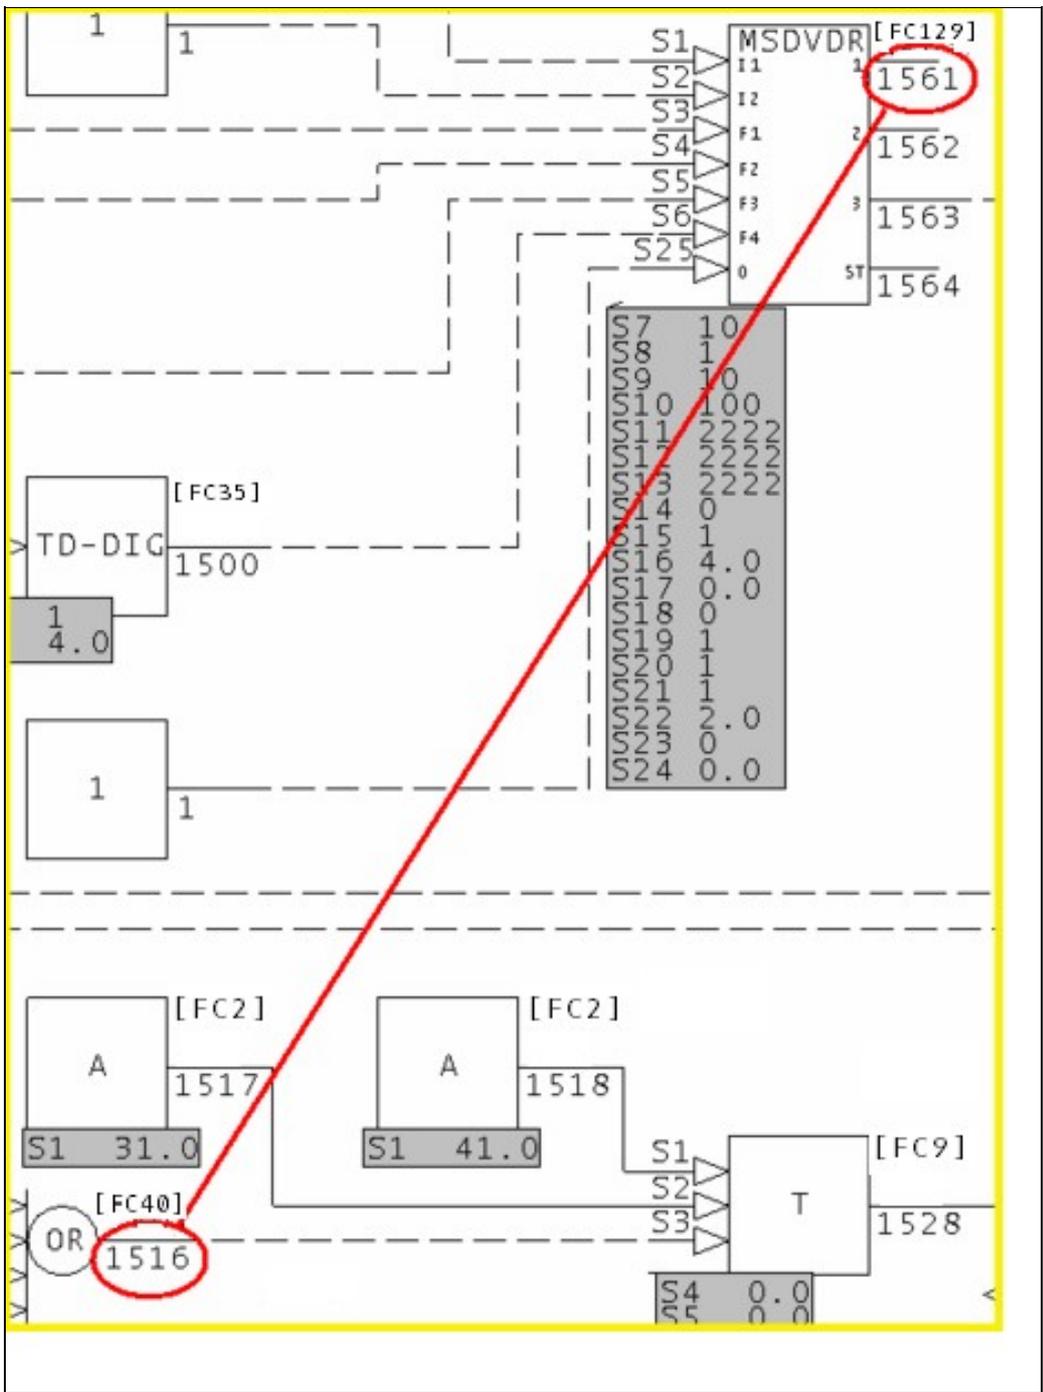
Zoom out and see the MSDVDR block - it is Block 1561.

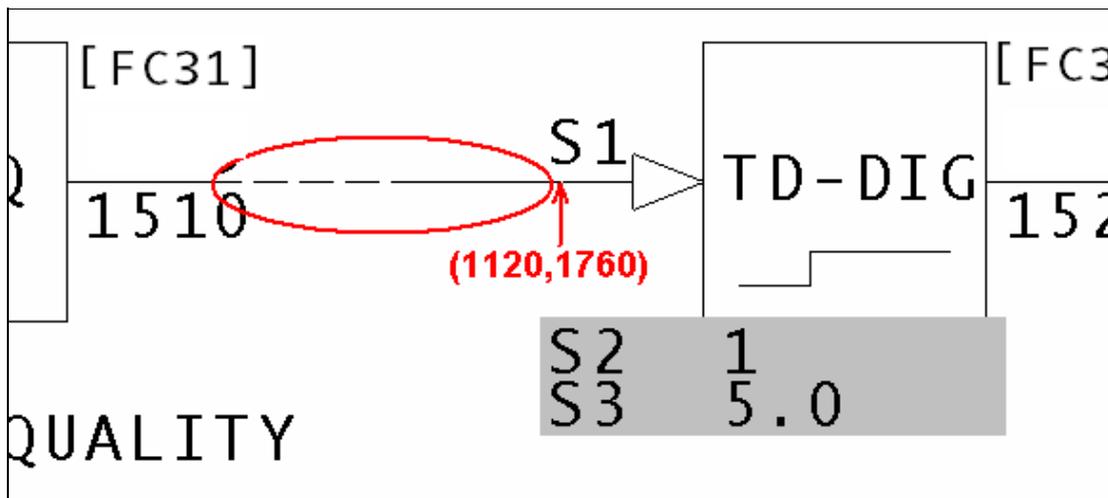
This message appears when DBDOC could not figure out the wiring and did not connect blocks to inputs where they are used. In the case below, we can guess that the line circled is really two separate line segments (quite possibly both digital dashed ones) and we could not figure out what to do, though it may be obvious to someone when he actually looks at it, of course.

```
Ambiguous wiring at 1120,1760: multiple wires at sink  
Ambiguous wiring at 4400,5140: multiple wires at sink Module 1,15,03 Block 23776 FC 38 S3  
Ambiguous wiring at 6110,4430: multiple wires at sink Module 7,101,04 Block 25785 FC 38 input 2 (old
```

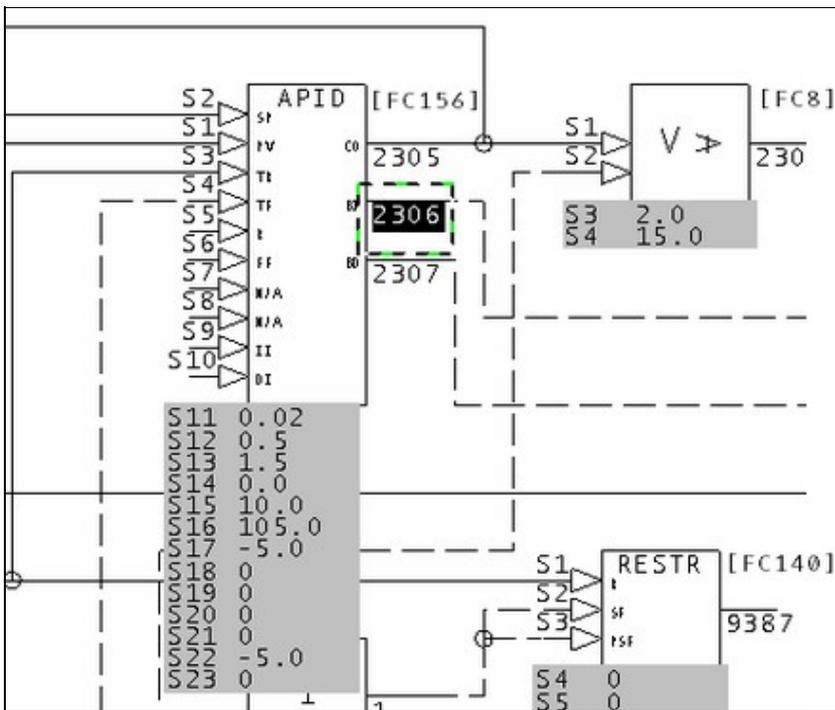
The documentation for APID: Advanced PID Controller [FC156] says: "Note: Do not use the output block increase (or decrease) flag if using the quick saturation recovery option (S19 equals zero)."

In this example, the Block Increase/Decrease Flag Outputs are in use. The documentation indicates that you should not use the output block increase or decrease flag if the quick saturation recovery option (S19 = 0) is being used.

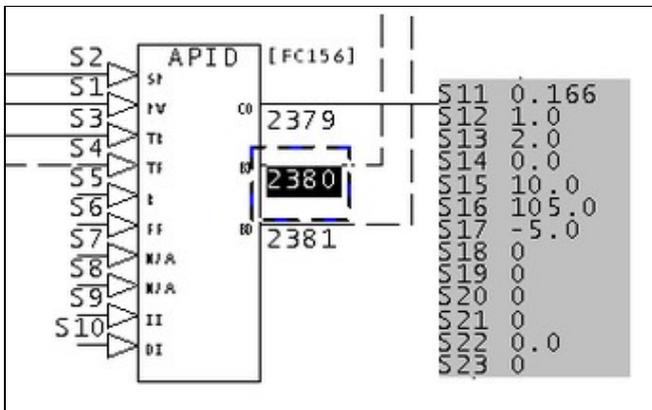
Advanced PID Module 4,50,02 Block 2380 using block increase flag with S19=0.

Both Block Increase BI and Block decrease BD outputs are in use, which is contrary to the documentation. S19 = 0, indicating the quick recovery form of the algorithm is being used.

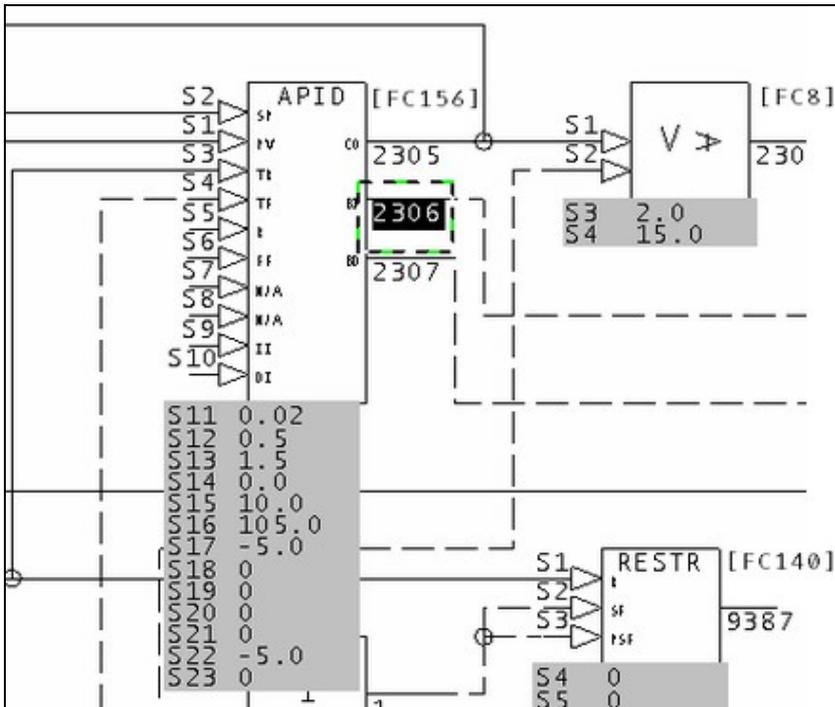
The documentation for APID: Advanced PID Controller [FC156] says: "Note: Do not use the output block increase (or decrease) flag if using the quick saturation recovery option (S19 equals zero)."

In this example, the Block Increase/Decrease Flag Outputs are in use. The documentation indicates that you should not use the output block increase or decrease flag if the quick saturation recovery option (S19 = 0) is being used.

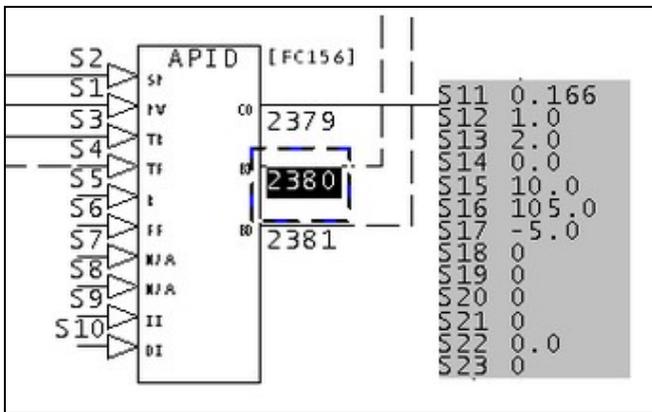
Advanced PID Module 4,50,02 Block 2380 using block increase flag with S19=0.

Both Block Increase BI and Block decrease BD outputs are in use, which is contrary to the documentation. S19 = 0, indicating the quick recovery form of the algorithm is being used.

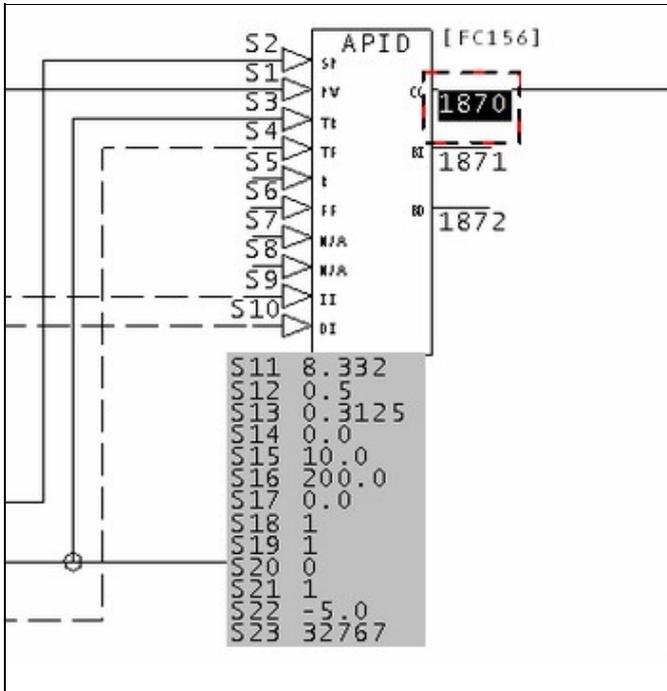
Advanced PID Module 1,11,03 Block 1870 using old algorithm with inhibit inputs.

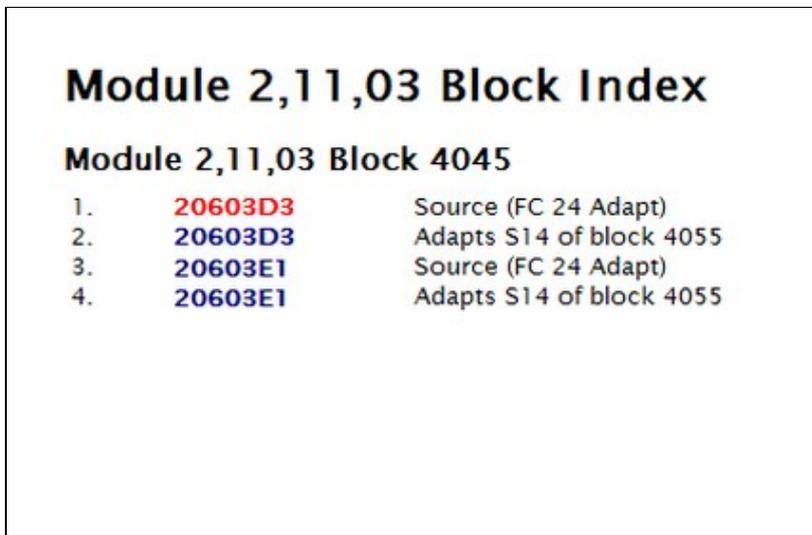
Adapt block problems reported here include places where two adapt blocks adapt the same specification, and other adapt block issues. Whenever a specification is adapted by more than one block, you should verify that is the intent.

On-site testing has confirmed that an adapt block continues to adapt its target block / spec, even if it has no input. Since block types cannot be changed, the unintentionally adapted spec is legal, but not likely correct.

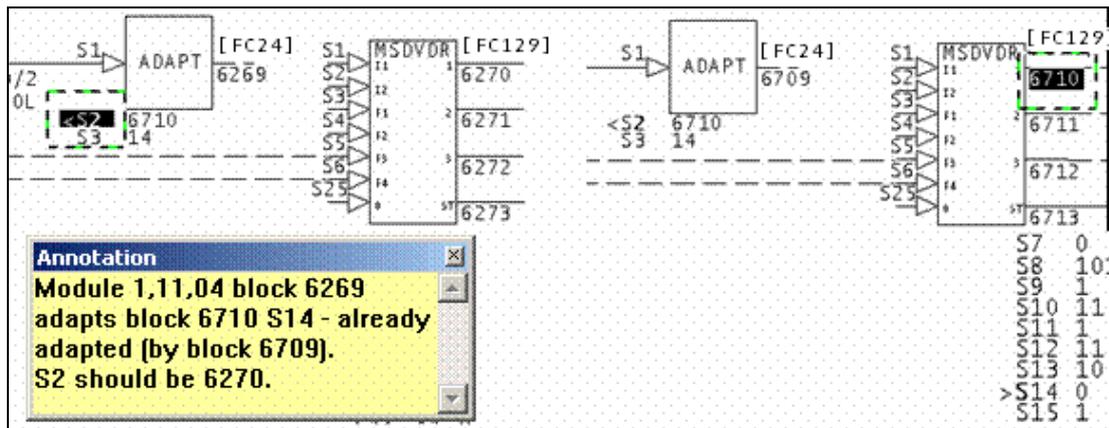
Module 1,11,04 block 6269 adapts block 6710 S14 - already adapted (by block 6709).

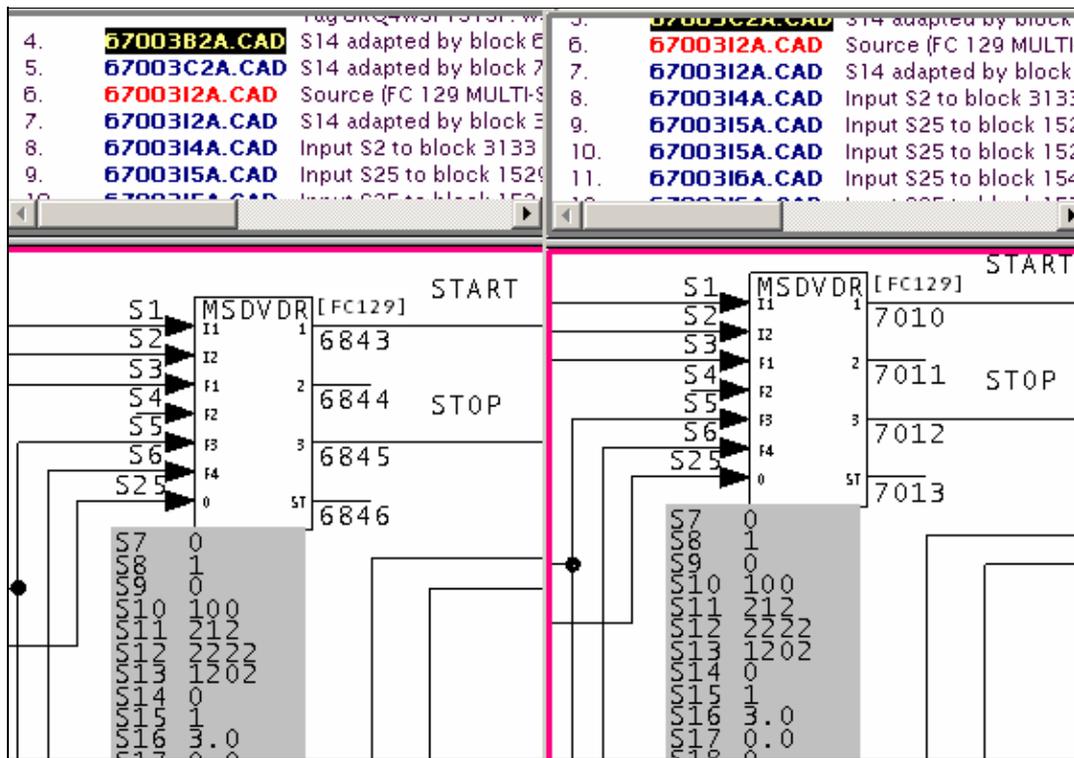
On sheets 67003B2A.CAD and 67003C2A.CAD, we will guess that there are MSDD blocks that do not have S14 adapted by an adapt block on that page. They have been orphaned.

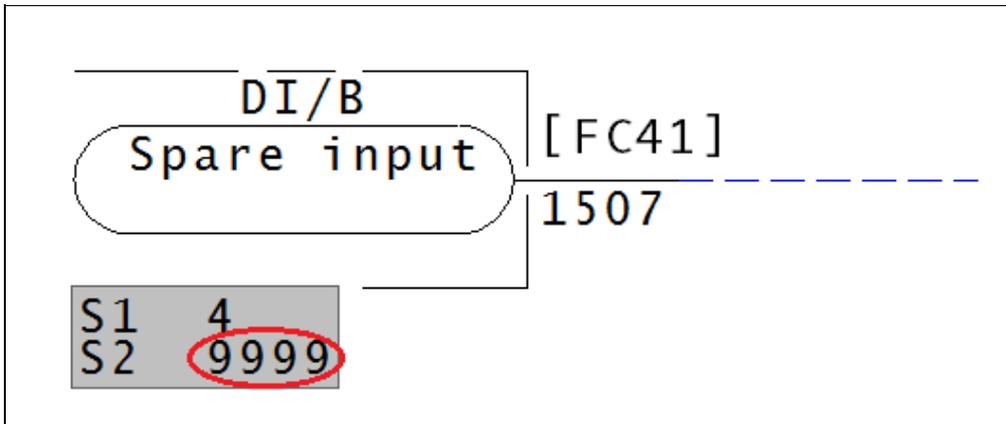
This message means that the value of a block is smaller or larger than the allowed value range.

Block must be between 0-9998.

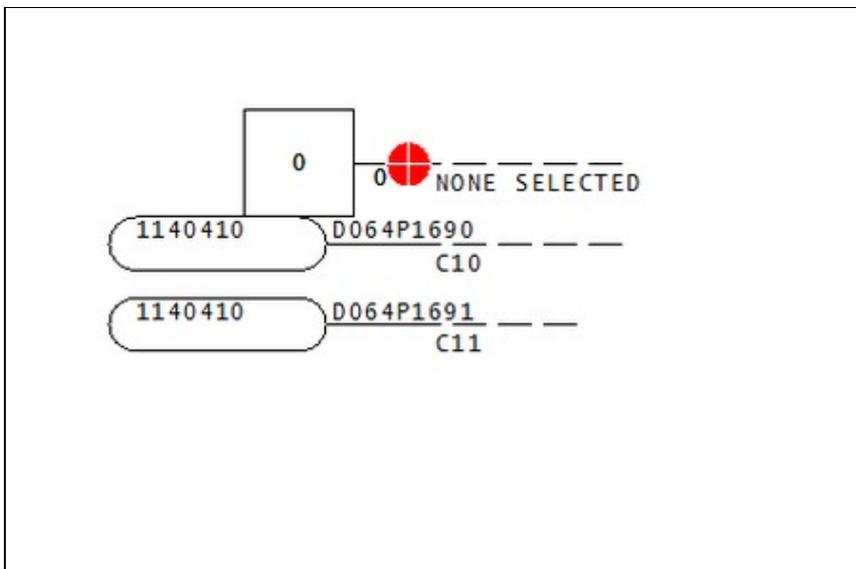
This messages tells you that a block or reference has been placed on top of another.

There are several blocks of the same value overlapping. If one is deleted and Hyperview was refreshed, then there would be another directly underneath.

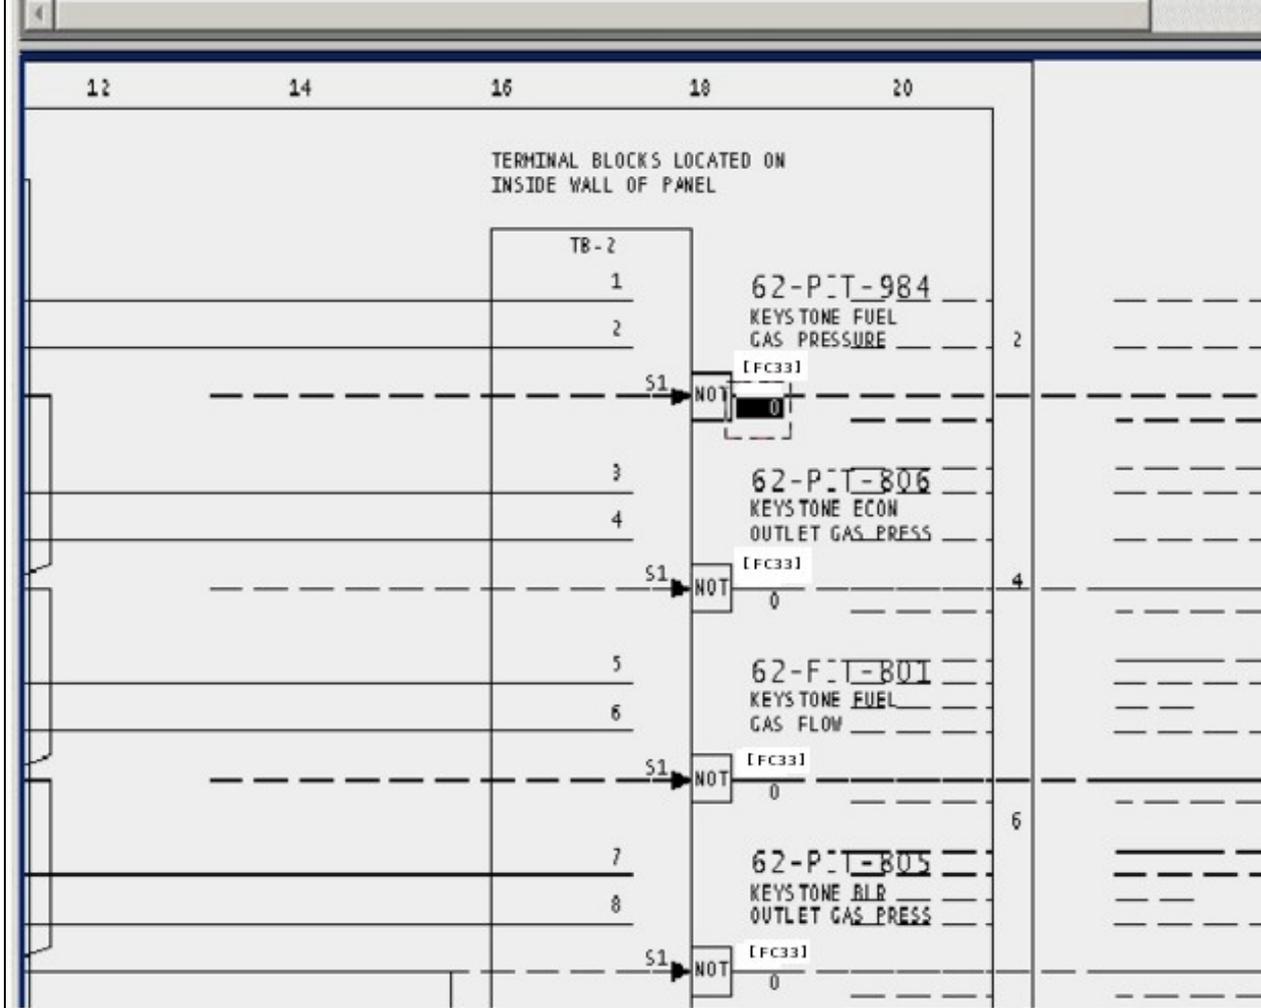
This can be caused by using function code blocks in diagrams. For example, dropping NOT blocks on a picture looked good in one system, but caused many useless messages.

```
--Generating index: Module 2,01,02 Block Index  
Bogus source for block zero on 199030A.CAD
```

- 2. 1990301A.CAD Source (FC 33 NOT)
- 3. 1990301A.CAD Source (FC 33 NOT)
- 4. 1990301A.CAD Source (FC 33 NOT)
- 5. 1990301A.CAD Source (FC 33 NOT)

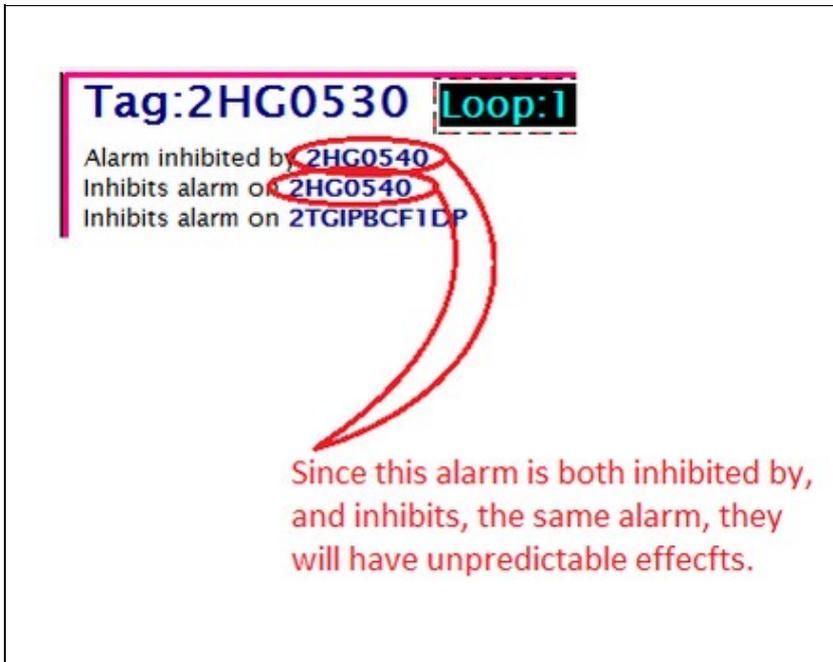
In the database for a graphics system, two tags inhibit each other. That is, if one goes into alarm, it is supposed to inhibit alarms on the other. The actual effect is not necessarily predictable and probably cannot be counted on. Unreliable operation of alarm inhibits is not desirable for the operators.

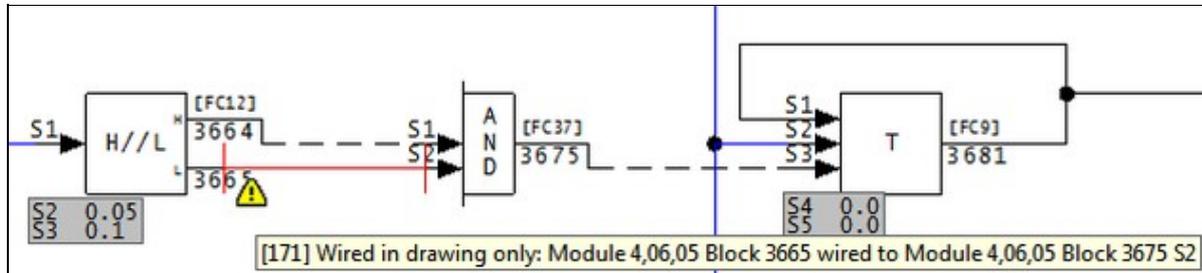
We have found a situation in the Composer wiring tables we cannot reconcile.

Note that DBDOC has drawn the missing connection in red. Examples we have found so far involve lines that have a connector on the end of an input arrow, or that have an output directly connected to an input with no line connecting them.

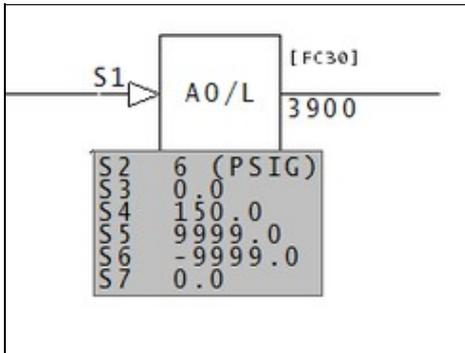
```
--Scanning drawing A050292: AS-SHIPPED  
Continuous exception reports generated by Module 10,05,02 Block 3900 (FC 30): Significant change val
```

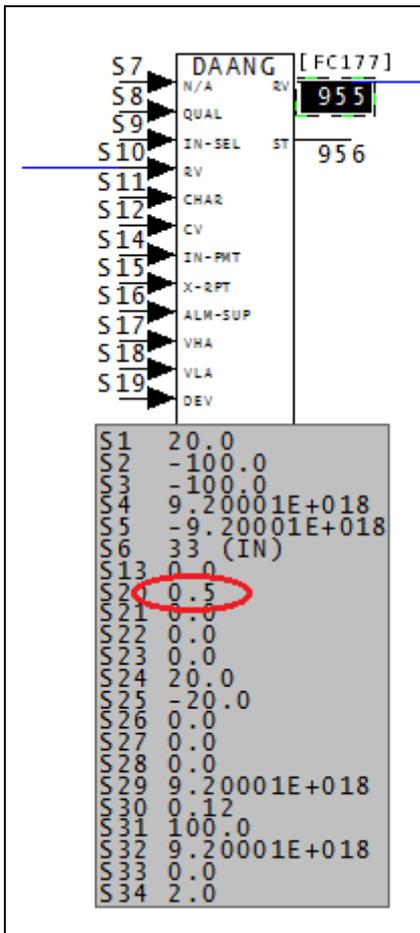
This message means that S20 on the DAANG block has a real value where an integer is expected. Alarming may not be working correctly.

If the value of S20 is something other than one of the values associated with a bit, or a sum of several bits, the alarm will not work

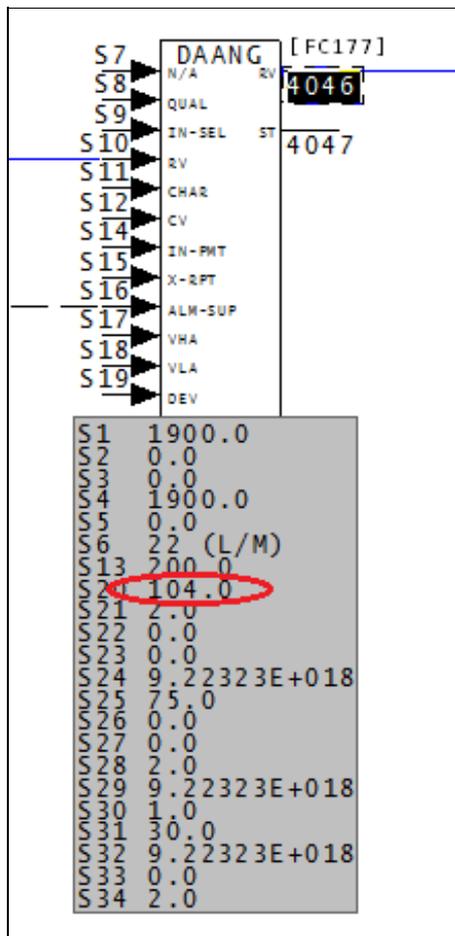
When the value of S20 is a sum of both 32 and 64, (among other things), then both bit 5 and bit 6 are active. Bit 5, de-alarm enabled, and bit 6, return alarm enabled, cannot co-exist. Therefore, when both 32 and 64 are in the S20 value, bit 6 overrides bit 5.

In this case, the value of S20 is 104.0, the sum of 64, 32, and 8, (bits, 6, 5, and 3).

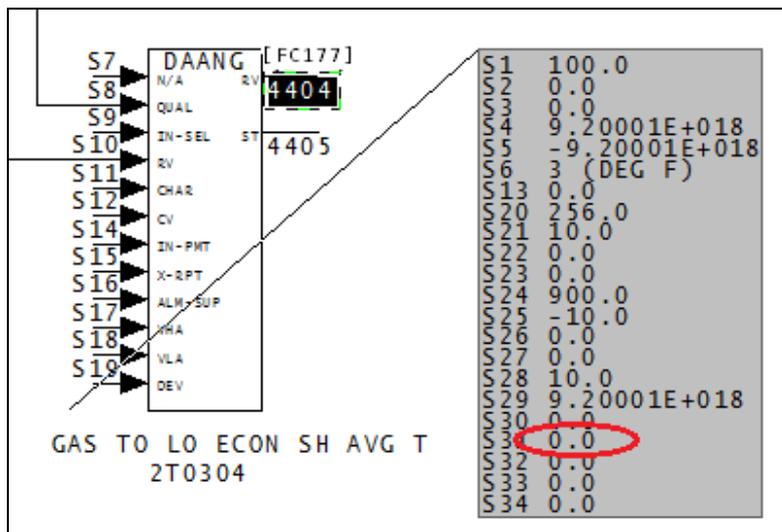
DAANG block Module 11,03,04 Block 427 S31 value suspicious (please verify period for time-based alarms)

This message means that time based alarming may not be configured correctly.

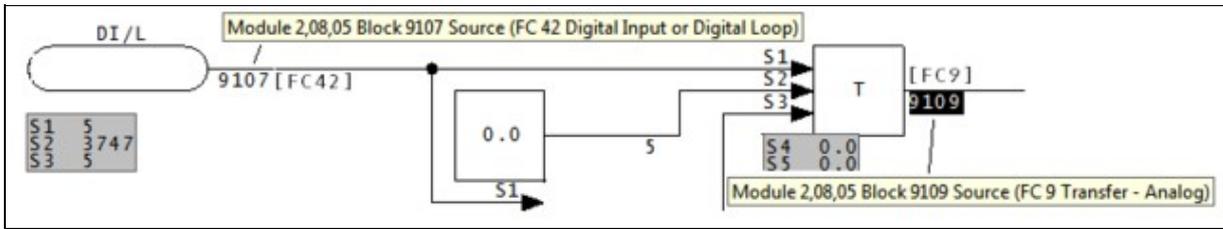
This message says that we found a block where the source and import block types do not match. These might not work and could identify an error.

Data type mismatch: Module 2,08,05 Block 9109 (FC 9) S1 expects type Real but is wired from Module 2,08,05 Block 9107 type Digital

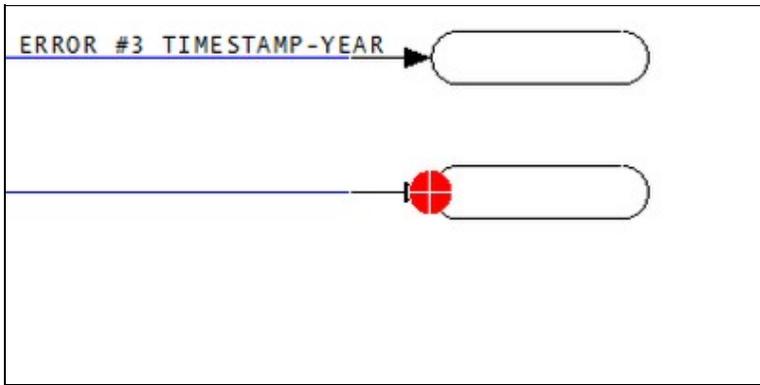
```
Input reference descriptor empty at 1760,1845
Output reference descriptor empty at 1760,2025
```

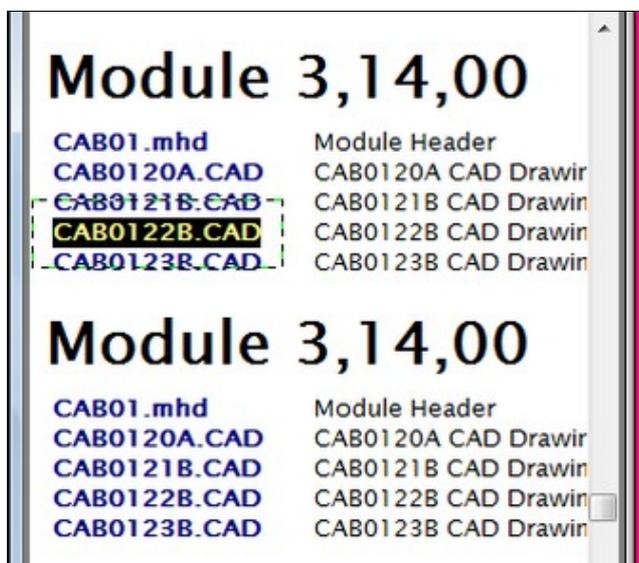
```
--Parsing configuration file C:\DBDOC_BUILDS\SITE MAIN G-P\LMS\LMS.cfg
Document CAB01.mhd already defined in chapter Module 3,14,00.
Document CAB0120A.CAD already defined in chapter Module 3,14,00.
Document CAB0121B.CAD already defined in chapter Module 3,14,00.
Document CAB0122B.CAD already defined in chapter Module 3,14,00.
Document CAB0123B.CAD already defined in chapter Module 3,14,00.
```

We can see in this example that Module 3,14,00 was added twice.

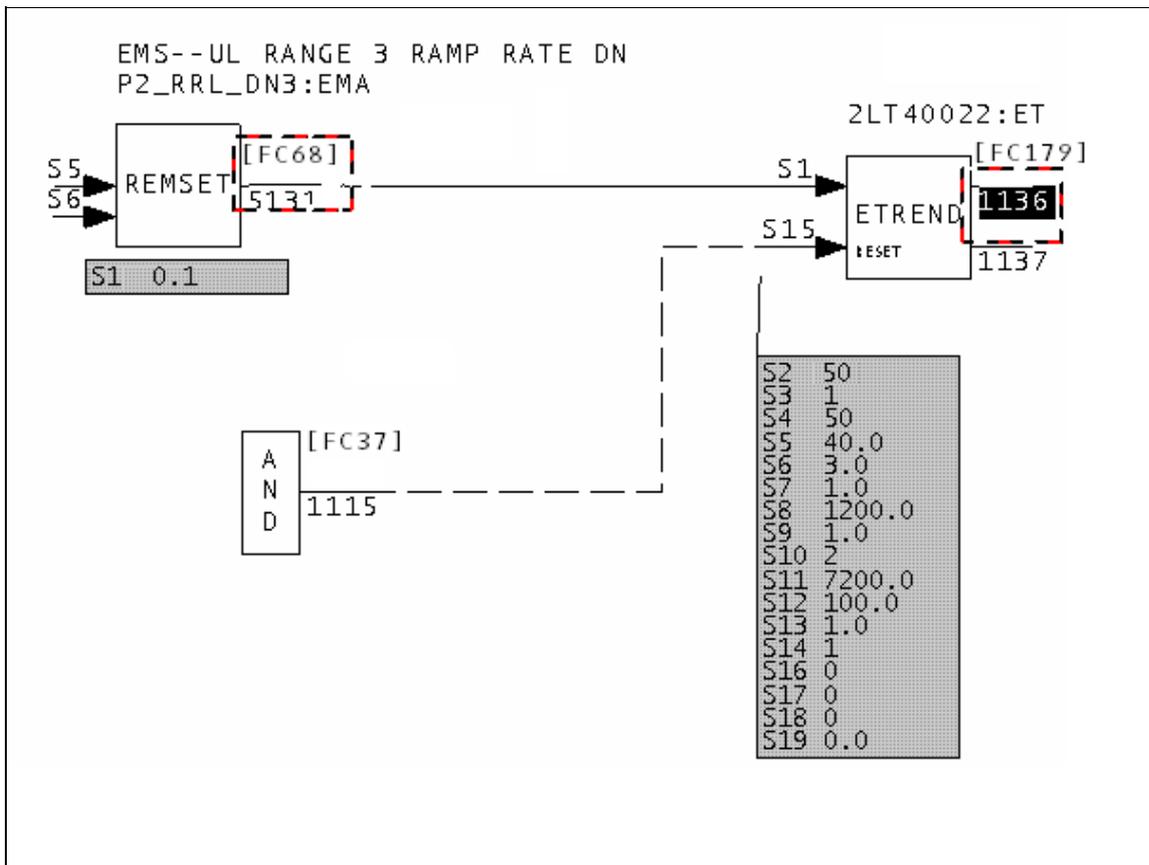
Enhanced Trend: Module 1,01,02 Block 1136 has illegal S2 value 50

- 0 = function code 30, analog exception report
- 1 = function code 45, digital exception report
- 2 = function code 62, remote control memory
- 3 = function code 68, remote manual set constant
- 4 = function code 80, control station
- 5 = function code 123, device driver
- 6 = function code 129, multi state device driver
- 7 = function code 136, remote motor control
- 8 = function code 177, data acquisition analog
- 9 = function code 211, data acquisition digital

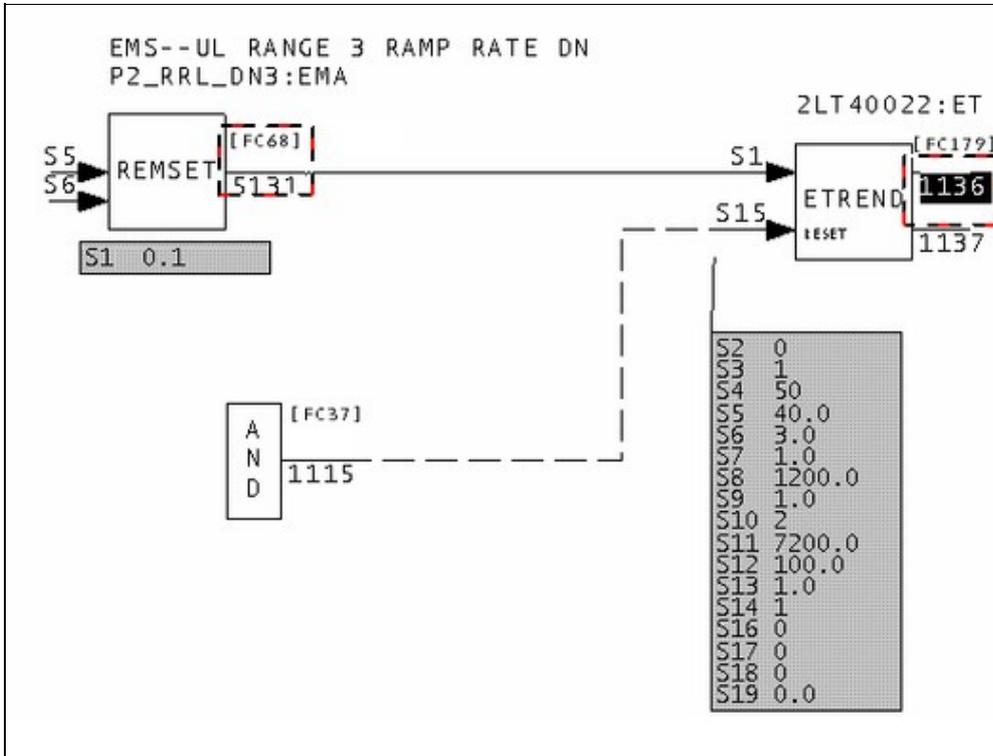
The block addressed in S1 must match the input block type in S2 or a configuration error will result.

Enhanced Trend: Module 1,01,02 Block 1136 S1 is wired from FC 68 Module 1,01,02 Block 5131 but S2 0 specifies FC 30

In this case, S1 is coming from the wrong type of block or S2 should be 3.

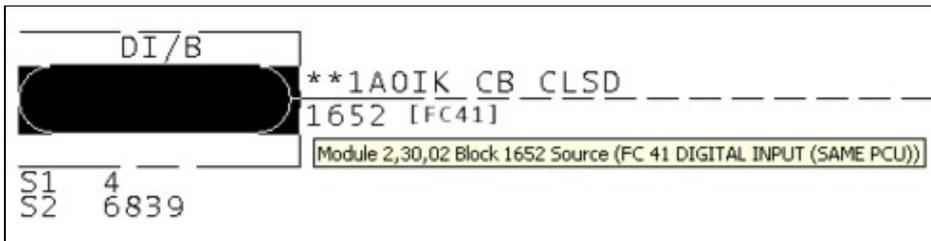
This message tells you that an IREF (Input Reference) exists in the Composer project. However, the function block cannot import it, because it is outside the scope of what it can import.

```
--Parsing file H:\...\EBY45EB.CLD... CAD Names: 2300251A.CAD
External output reference is unreachable for IREF **1AOIK CB CLSD on Module 2,30,02 Block 1652:
cannot import from Loop 2 PCU 20.
```

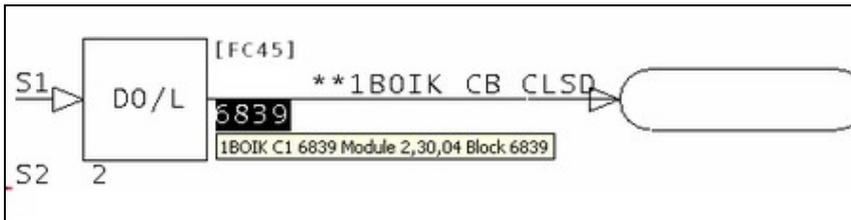
Here is the actual source, as determined by the specifications.
