5 Build Reports and Analysis

5.1 Overview of the DBDOC build reports

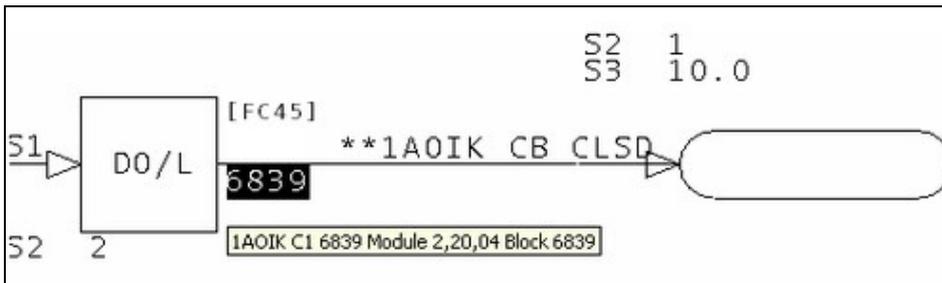
Here is the source that the input reference indicates.

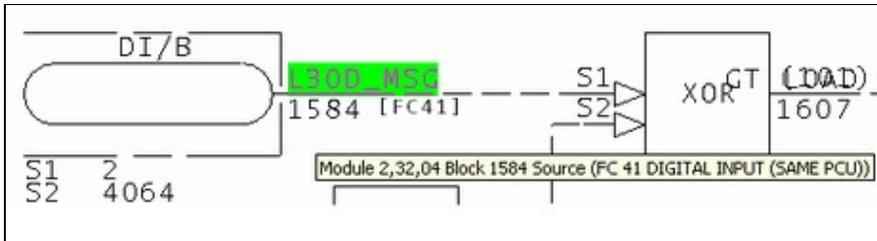
--Parsing file H:\...\EBY3DAC.CLD... CAD Names: 2320454A.CAD
 External output reference is unreachable for IREF L30D_MSG on Module

2,32,04 Block 1584: cannot import from Loop 2 PCU 22."

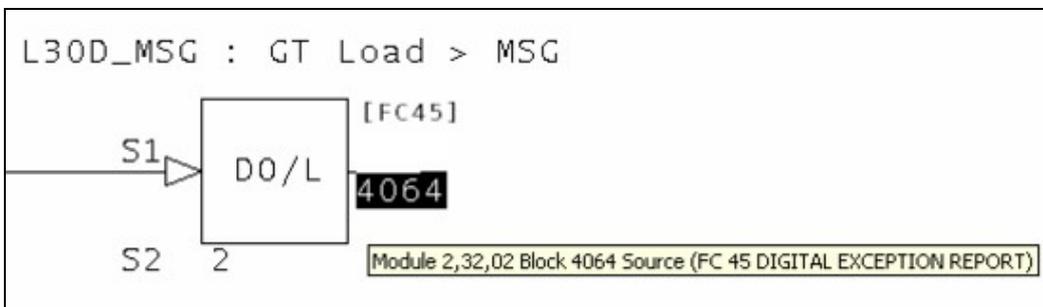
Here is the block that is being imported.

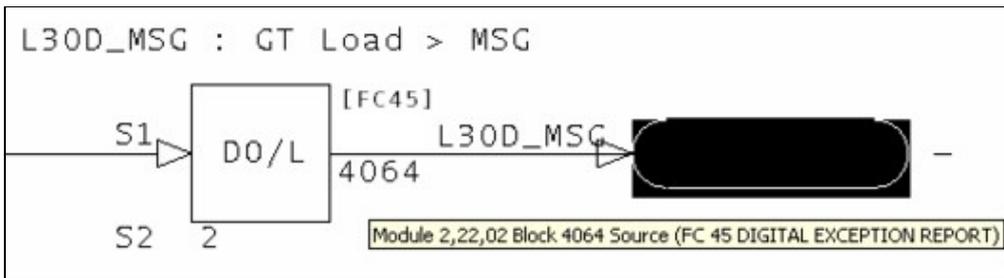
Here is the source indicated by the input reference L30D_MSG.

It is possible to see how Composer, in being robust enough to import files from WinCAD, also allows errors to persist in the input references.

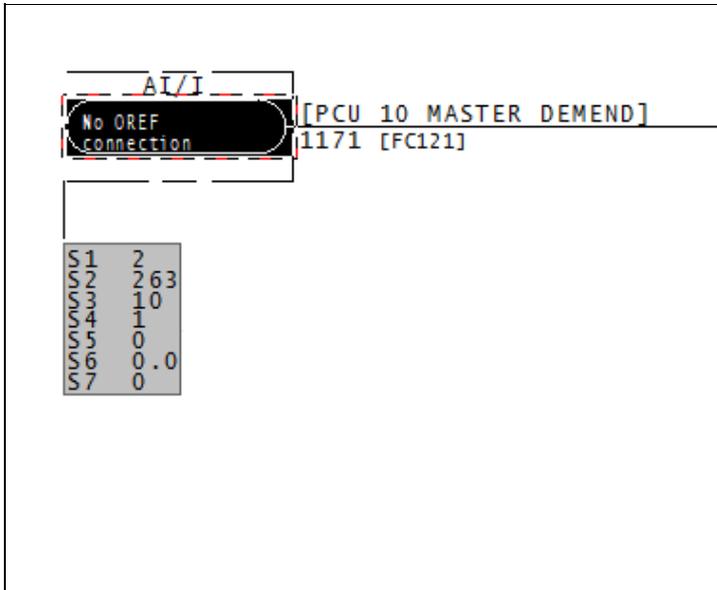
An IREF is used in the project that had no matching External OREF. This can arise in a conversion from WinCAD, for example, when the input reference text on an AI/I reference is the same as that on OREF that distributes its value through the module.

The significance is that only the specifications on the block are being used to make the connection.

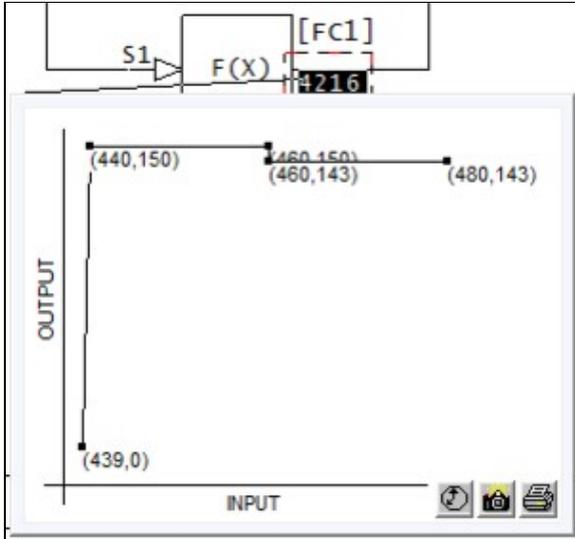
```
F(x) discontinuity (step) in Module 1,16,06 Block 4216 at S8 X value of 460.000.
( S2, S3)          439.0          0.0
( S4, S5)          440.0          150.0
( S6, S7)          460.0          150.0
( S8, S9)          460.0          143.0
(S10,S11)          480.0          143.0
(S12,S13)          480.0          143.0
```

The F(x) graph looks like this:

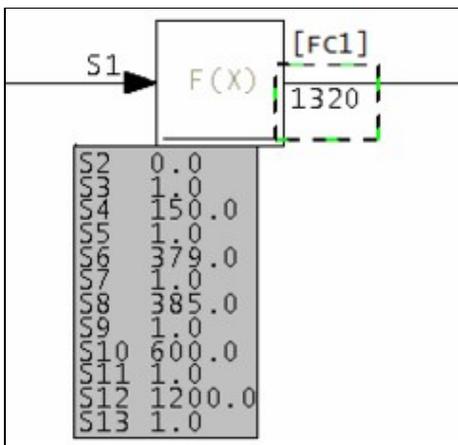
```
--Post Processing drawing 11002B9A.CAD
F(x) Module 1,01,02 Block 1320 graph is flat - value 1.00.
```

Notice that the Y value is 1.0 for all values of the input X value – that is, a constant.

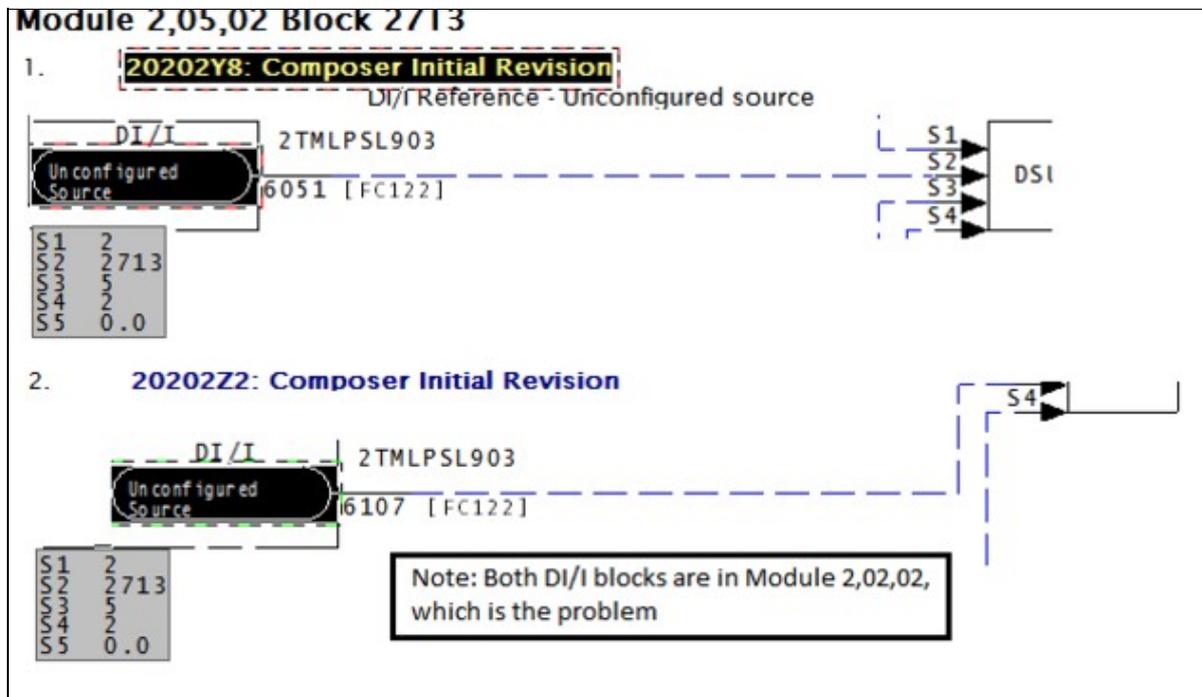
Example 1 (both import blocks used): DBDOC identifies these situations, since one of the import blocks is always frozen.

Duplicate off-module reference (DI/I, DI/I) to Module 2,05,02 Block 2713:
20202Y8: Composer Initial Revision and 20202Z2: Composer Initial Revision

In the case of analog blocks, the value will 'flat-line'. In the case of digital inputs, the imported value will simply fail to respond to a change in the source. This can be catastrophic.

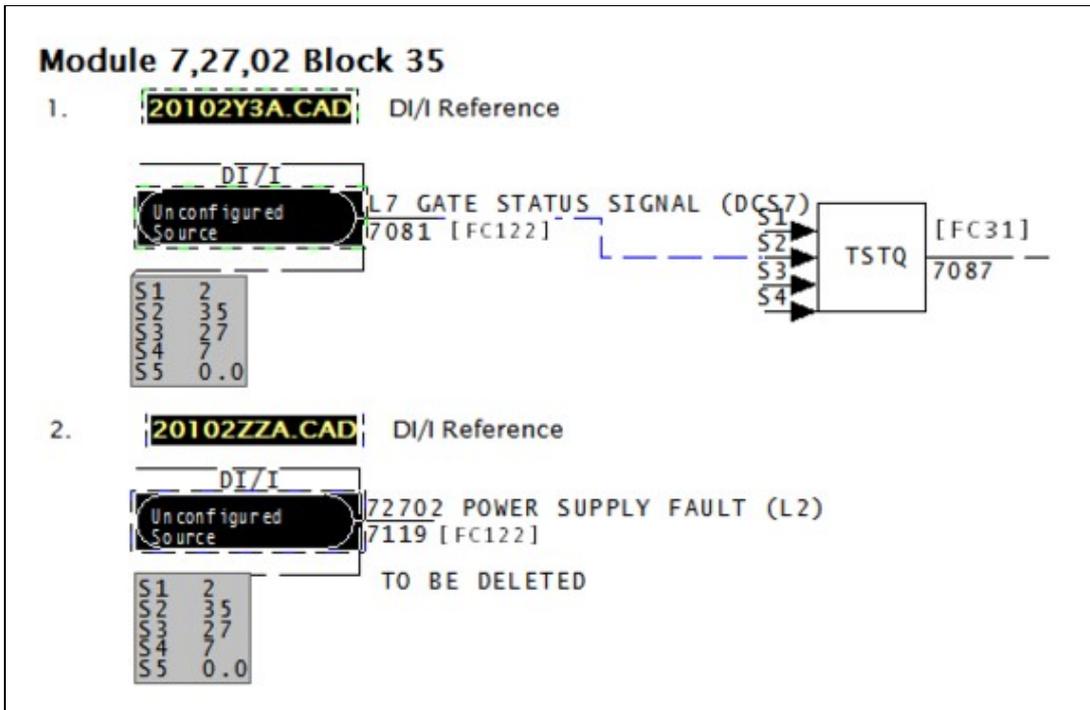
Example 2 (one import block used, one not used): DBDOC identifies these situation, since there is a 50-50 chance that the unwired block will have live data and the wired one will be frozen.

Duplicate off-module reference (DI/I, DI/I) to Module 7,27,02 Block 35: 20102Y3A.CAD and 20102ZZA.CAD

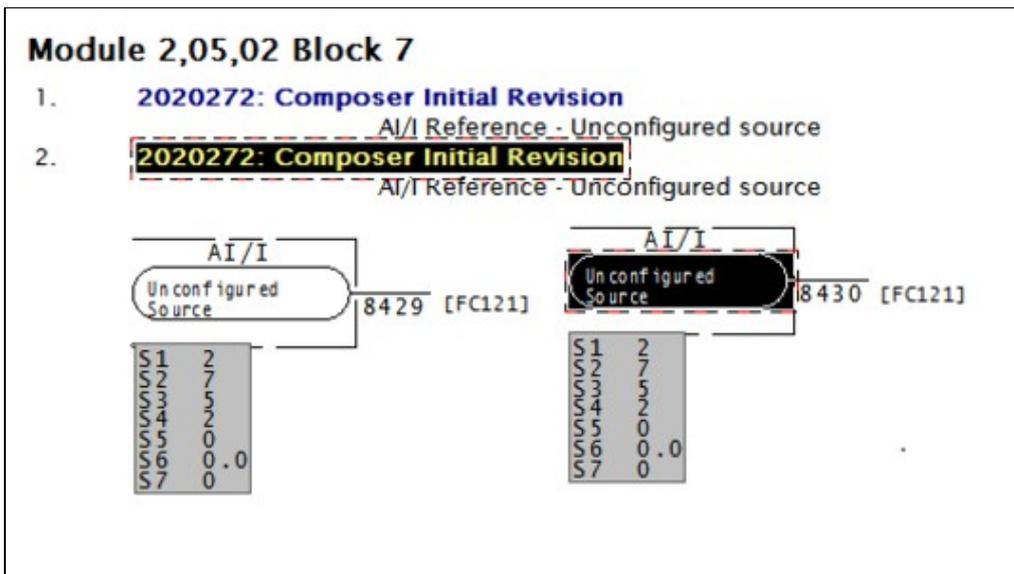
Example 3 (both import blocks not used): There is no DBDOC error message for this situation, because there is no harm possible.

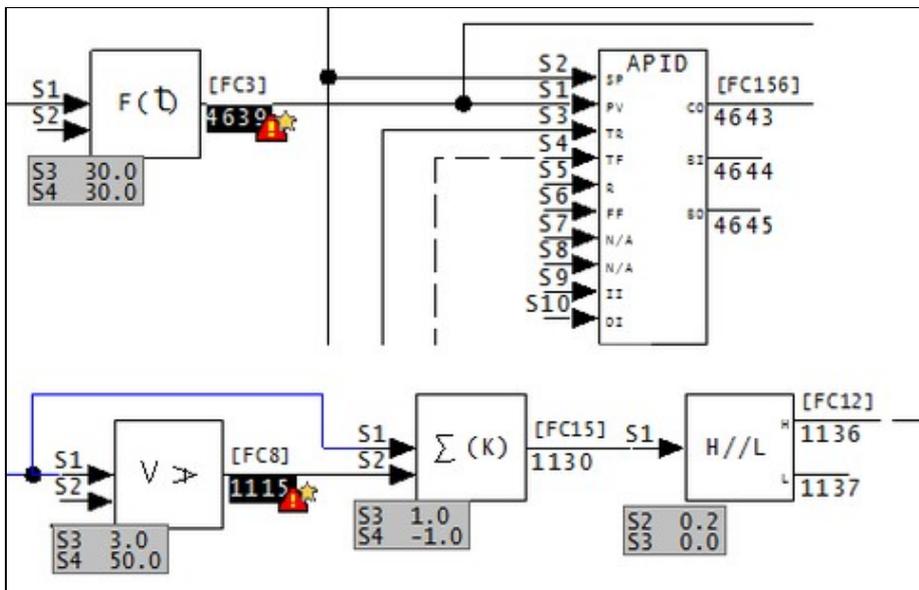
since both blocks feed the input to the output and do nothing if the above conditions are met.

If the block output can be found to be unused, the message is suppressed.

- The first example shows a lead/lag block in a control circuit that is intended to soften the dynamics of process variable changes. This fails to work because the block action is disabled by default.
- The second similarly shows that the amount of rate limiting is intended to be monitored, but this monitoring fails for the same reason.

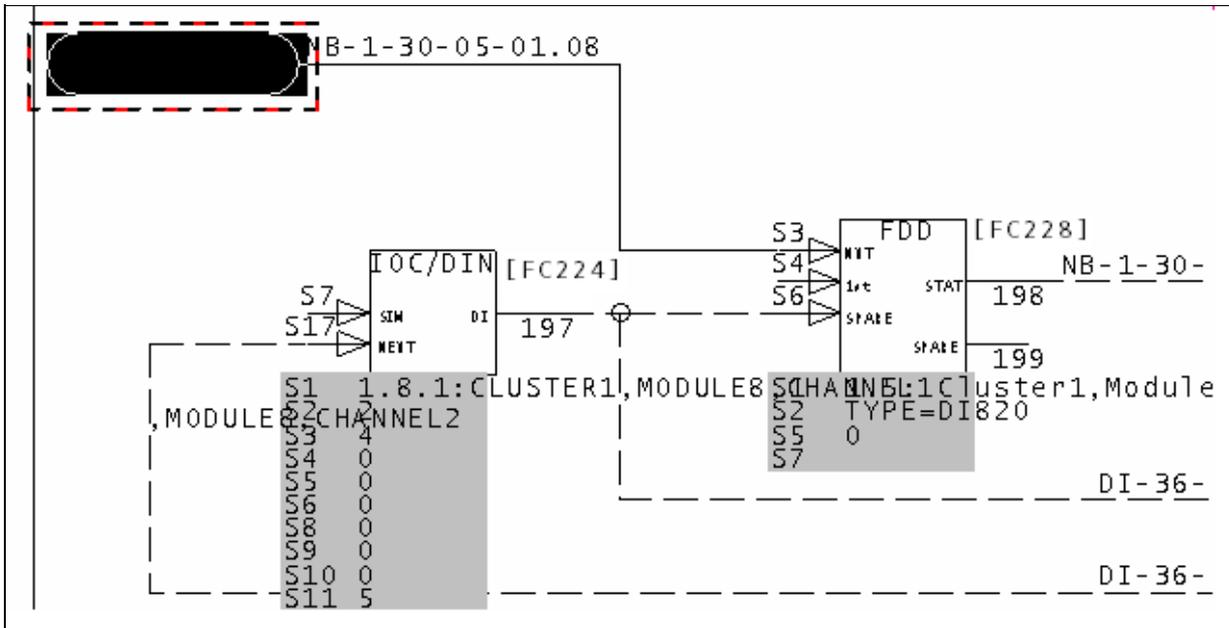
This undocumented issue was found by Ready Engineering when they inadvertently configured some Harmony I/O with empty input references.

Module 1,30,05 Block 198 FC 228 S3 wired from IREF (NB-1-30-05-01.08)with no source: module will compile but not run.

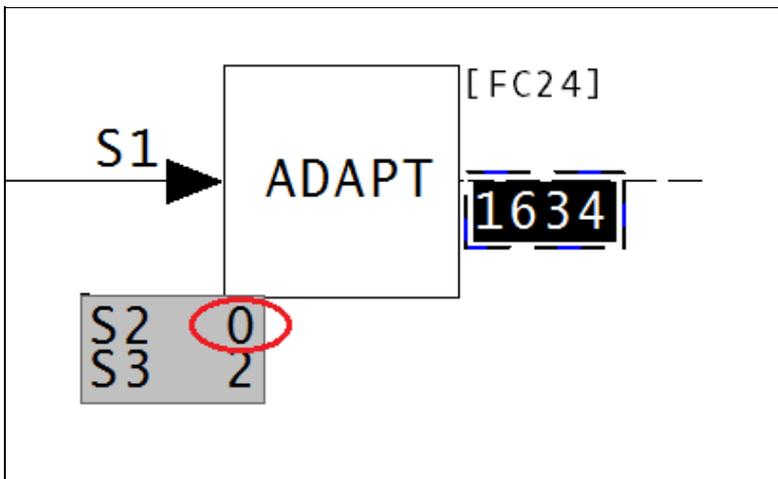
This message means that an adapt block is adapting a Block 0 block. DBDOC ignores Block 0 configuration.

On-site testing has confirmed that an adapt block continues to adapt its target block / spec, even if it has no input. Since block types cannot be changed, the unintentionally adapted spec is legal, but not likely correct.

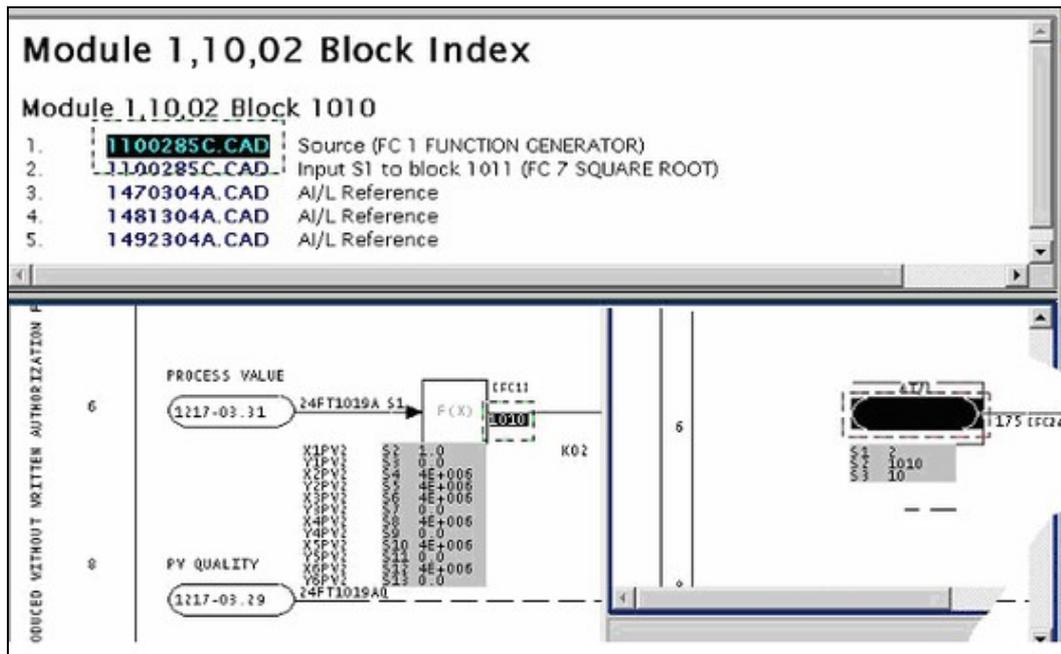
This example shows the attempt to use an AI/L block to import the output of a F(x) FC 1 block, which is not an exception report.

Often, this error leads to uncovering unused or reused logic. Blocks are sometimes used without the knowledge that their values are being imported in another module, PCU or loop. You get a check for this situation on every DBDOC build.

This message says that we found a block that is being imported illegally. If a block that is not an exception report is being imported from the loop, it will not work.

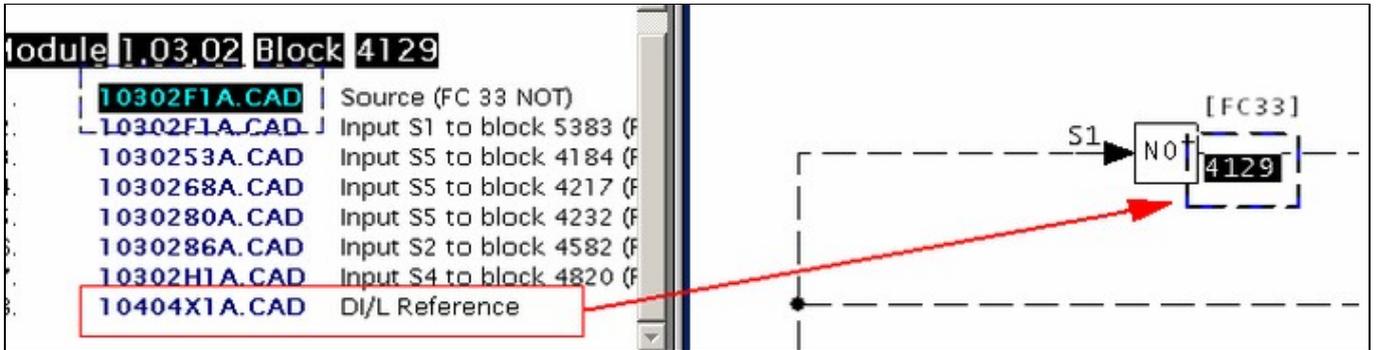
Illegal import: DI/L Reference on sheet 10404X1A.CAD imports Module 1,03,02 Block 4129 (not exception-reported).

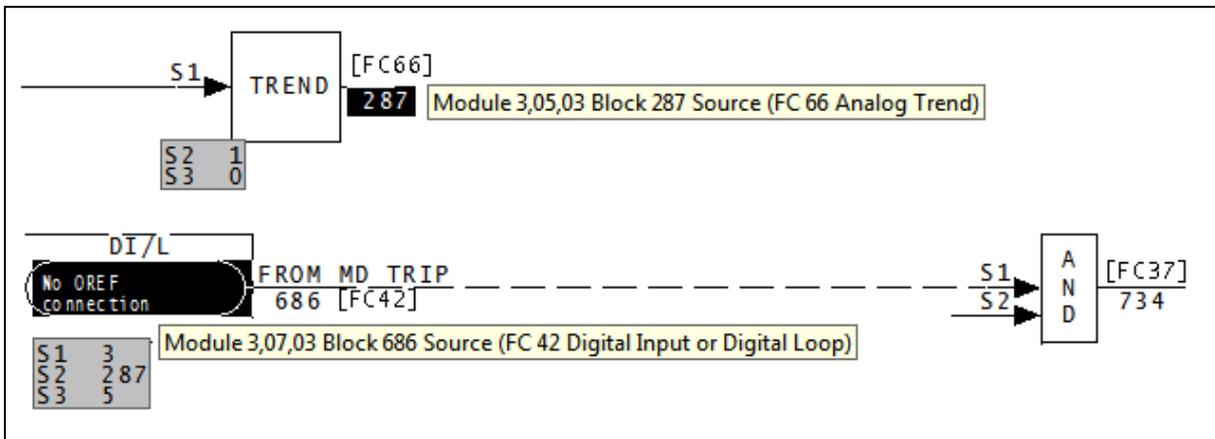
This message says that we found a block that is being imported illegally. Source and import block types do not match. These imports might not work. They often show a configuration error.

Data type mismatch: DI/L Reference on drawing 3070341 attempts to import analog value from Module 3,05,03 Block 287

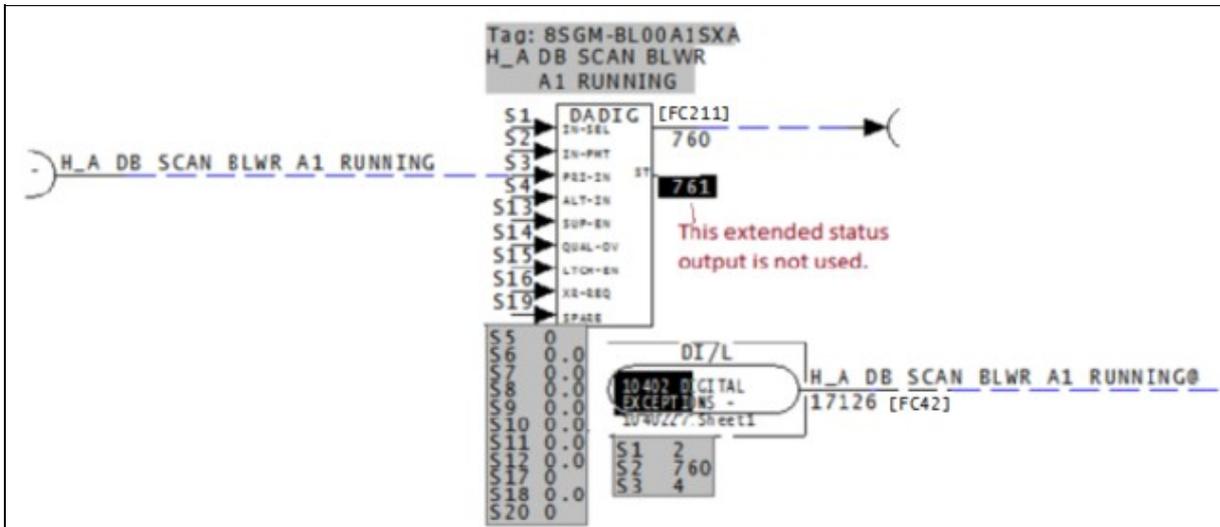
```
Extended status not imported: DI/L Reference on drawing 10104 BUS/LOOP INPUTS - LOOP DIGITAL02
imports DADIG from Module 1,04,02 Block 760
```

This message shows a potential error in the system configuration, although most such errors prove to be harmless. It should be reviewed and hidden, unless it shows an issue that should be addressed.

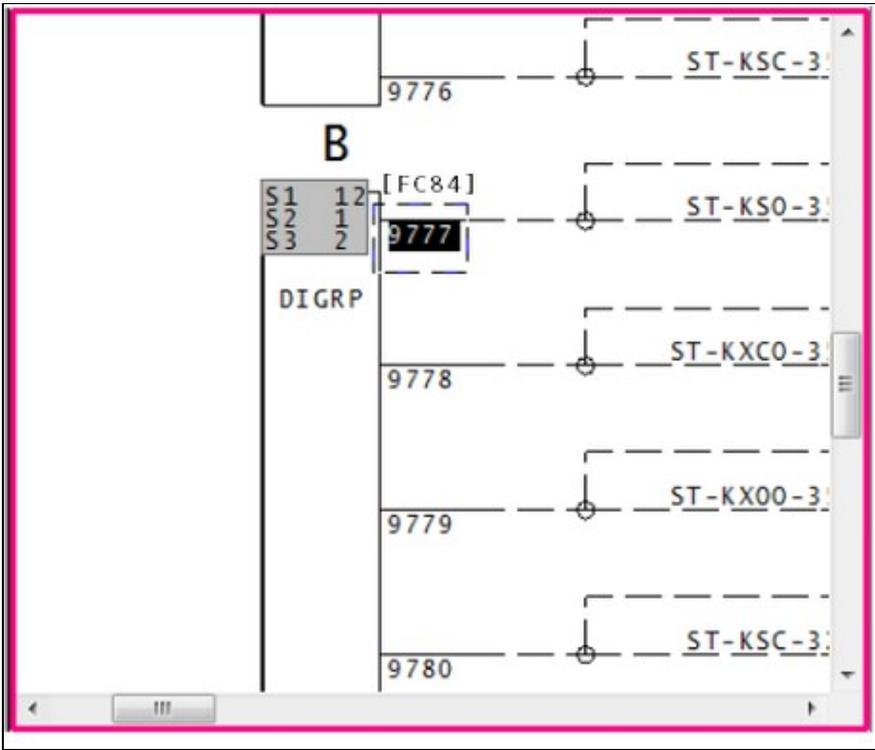
Illegal spec value for Module 1,01,02 Block 1001 (FC 79): trip spec S4 has value 3, should be 0 or 1

The specification shown is not legal, according to the documentation. We cannot tell you if the module will trip on failure or not.

The value S3 in DIGRP: Digital Input Group [FC84] should be either 0 or 1. The action on value 2 is not documented. The value of S3 should be set to the correct value for failing the module or switching to the redundant controller on a failure. What it does right now is not clear.

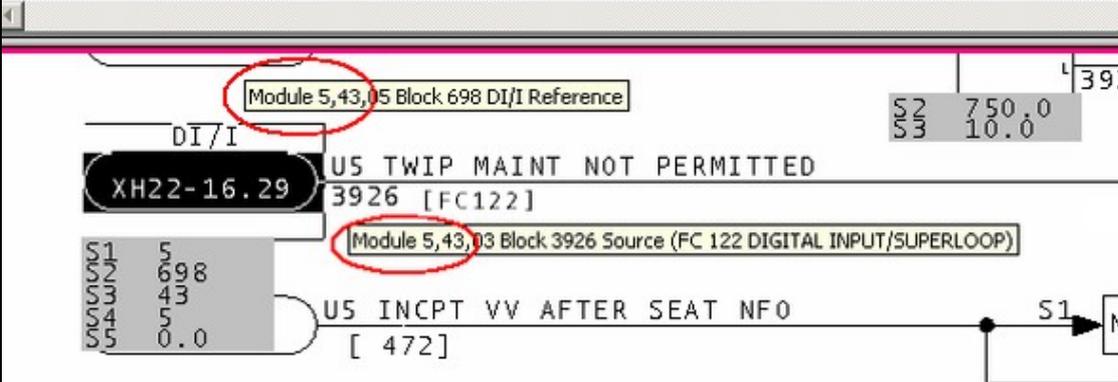
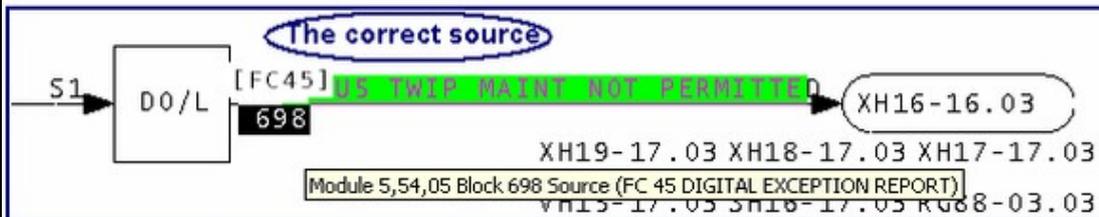
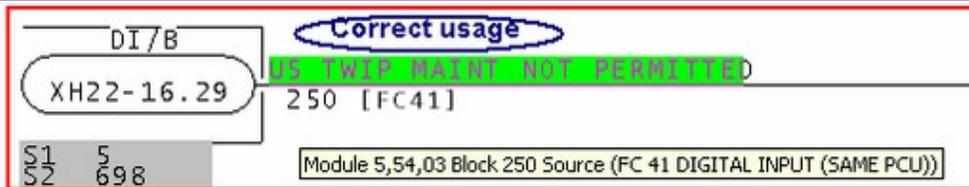
Module 5,43,05 Block 698

1. **54303888.CAD** DI/I Reference

In this case, the error actually points to incorrect parameters that had not been detected.

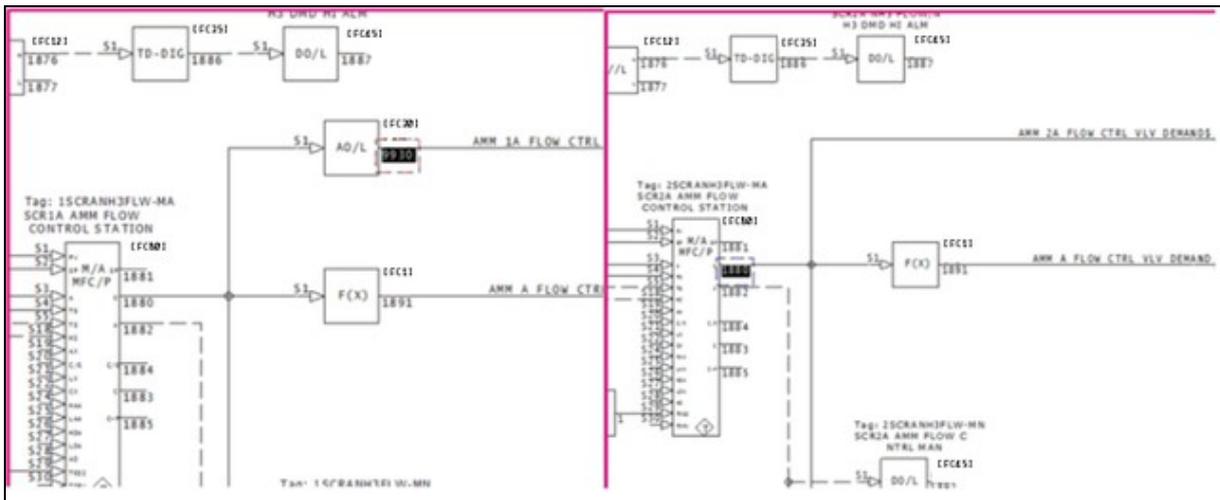
Importing the output of a Station (FC 80) gives the Process Value (PV) instead of the Output (OP). This can be misleading. We have found instances where the designer clearly intended to be importing the Output Value. You should verify any imports like this to make sure the PV is what is intended.

The example tells a story because the error was corrected in one unit but not in its clone. Here we see the two units side by side. On the left is unit 1, where the error was corrected by adding block 9930. On the right is unit 2, which was cloned from unit 1 but the error was never corrected.

Here we see the AI/I references for units 1 and 2. Unit 1 on the left is importing from block 9930. Unit 2 on the right is still importing from S1 of block 1880.

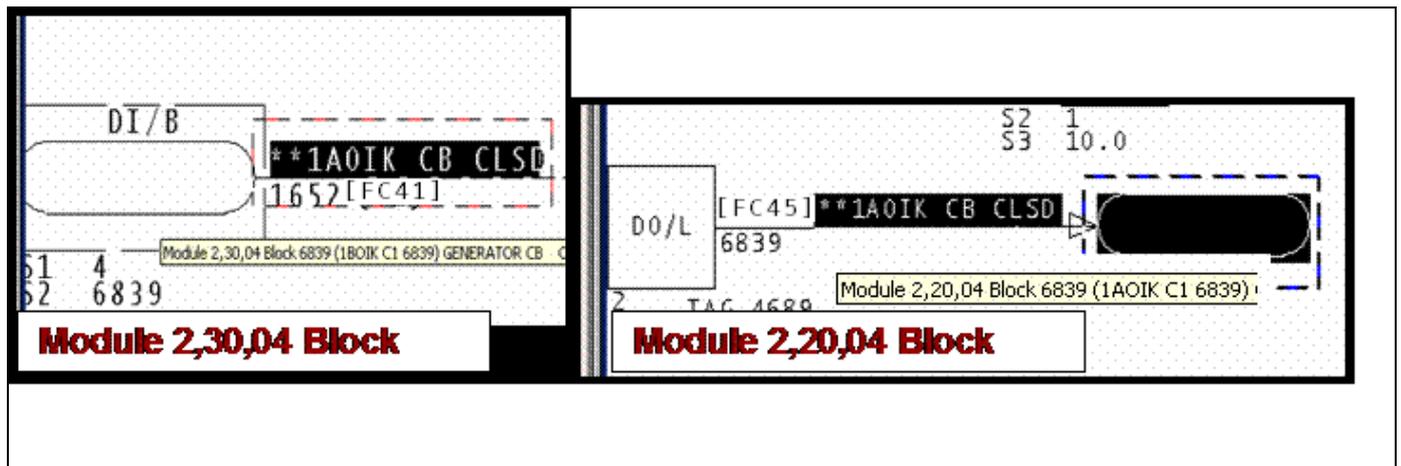
```
--Parsing file E:\EBY45EB.CLD...  
No legal LPM match found for IREF **1A0IK CB CLSD on output 1.
```

In the example, it is possible that the real problem is that the DI/B import block, which is restricted to Loop 2 PCU 30, should actually be replaced with a DI/L block that can import by exception report from Module 2,20,04 Block 6839. Examination of the logic is required to find out how to resolve the problem.

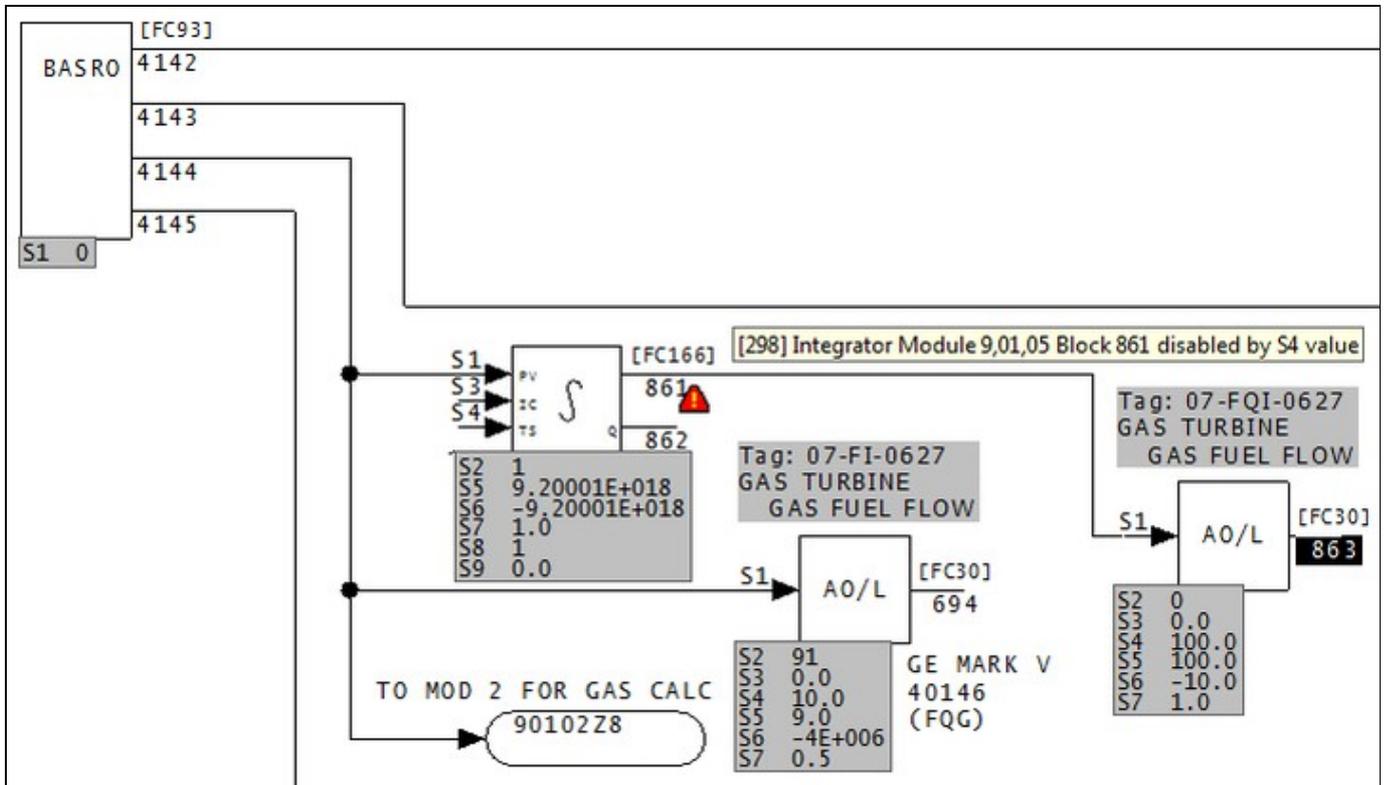
This INTEG: Integrator [FC166] block has a value of zero for S4, so it will never output anything but the preprogrammed initial value on S3.

An integrator block with S4 unwired gets the default value 0 applied to that specification. This means that the output is the value of what is wired to S3, and it does not integrate. If the integrator is intended to function, a constant [1] (or a Boolean signal) must be wired to S4.

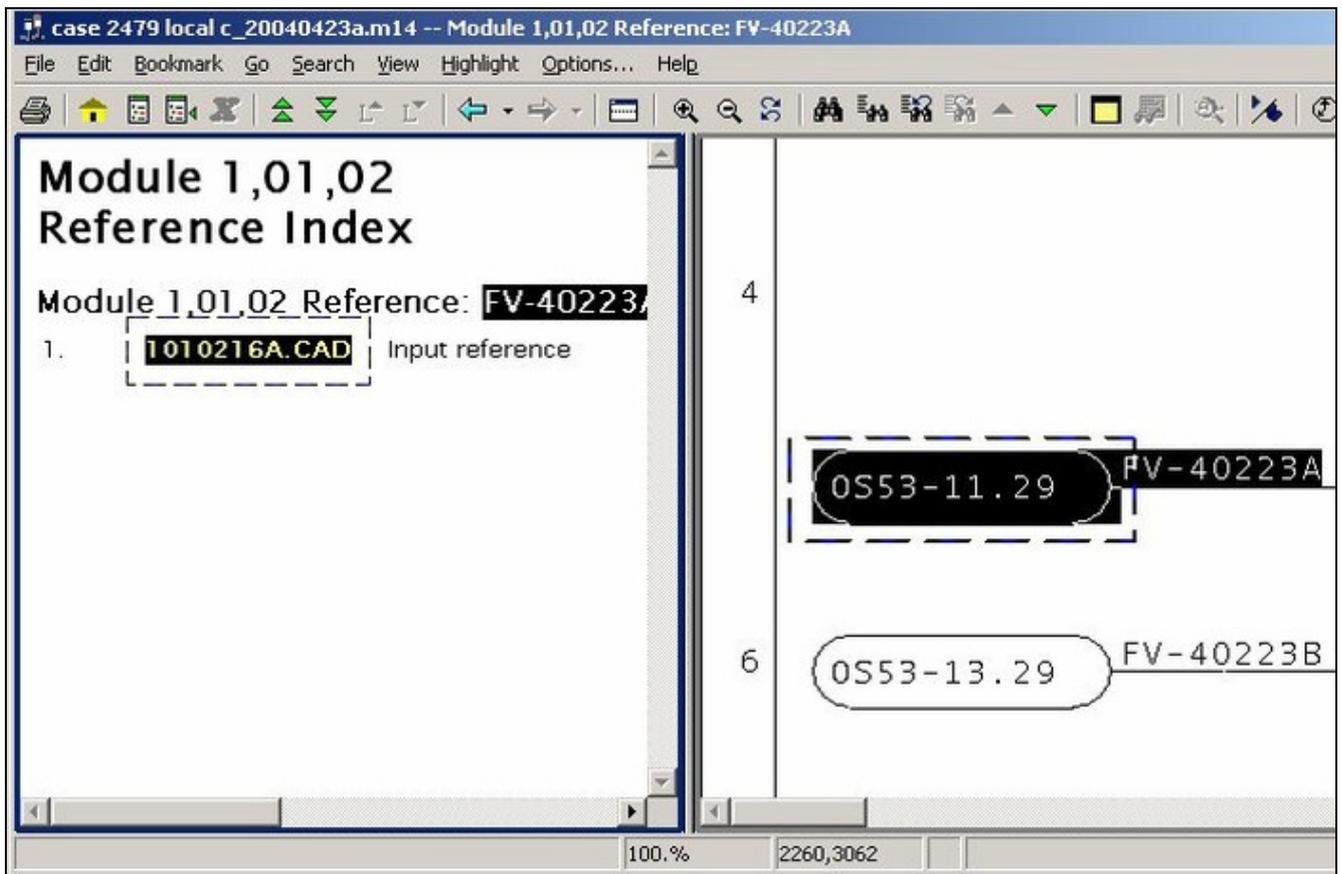
IREF FV-40223A does not have an input.

In the example, see that OREF "PV-40223A" must have existed at one time to make the cross-reference work, but it no longer can be found.

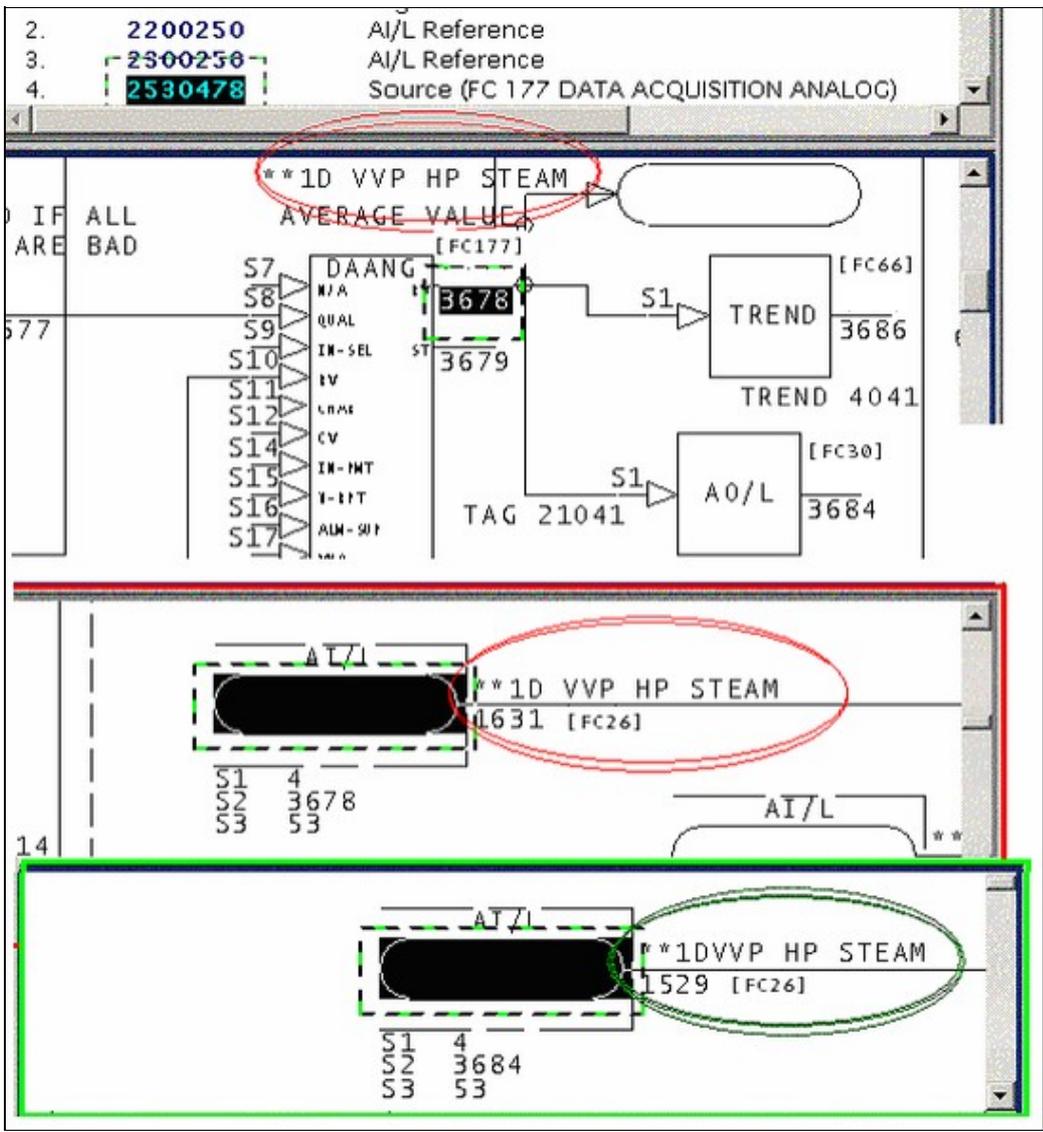
```
Parsing file H:\CLIENT~1\BAR\ACTIVE~1\EBY3FF5.CLD...
IREF **1D VVP HP STEAM makes Module 2,20,02 Block 1631 FC 26 import Module 2,53,04 Block 3678
instead of Module 2,53,04 Block 3684.
```

This Composer diagnostic tells you that the input reference on an import block overrides the specifications in the block that used to be there. As shown here, it can indicate an error. The output reference is wrong.

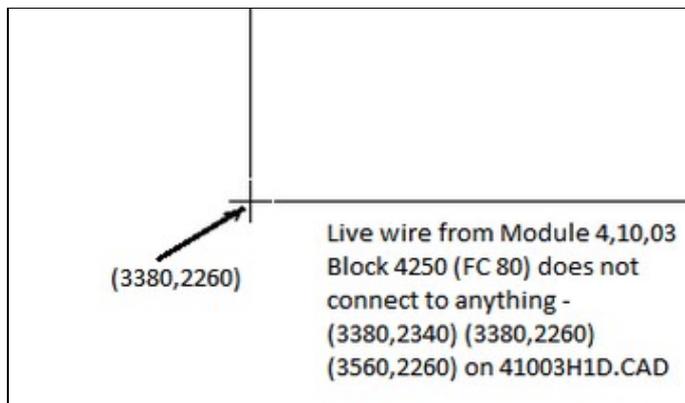
In this example, the wire from (3380,2340) to (3380,2260) does not connect with the wire from (3380,2260) to (3560,2260):

1. A common cause is that an IREF is used to bring a visual line from an external diagram to what looks like an input on an AI: Analog Input [FC27] or DI: TCS Digital Input [FC43] block. There is actually no input for these blocks, so the message may be ignored in these cases.
2. Sometimes, a line is left attached to a source that is no longer used. Deleting the line will eliminate the message.
3. They may tell you that a signal is brought out from the named IREFs but not used. This shows up if people delete logic without deleting the IREFs that feed it.

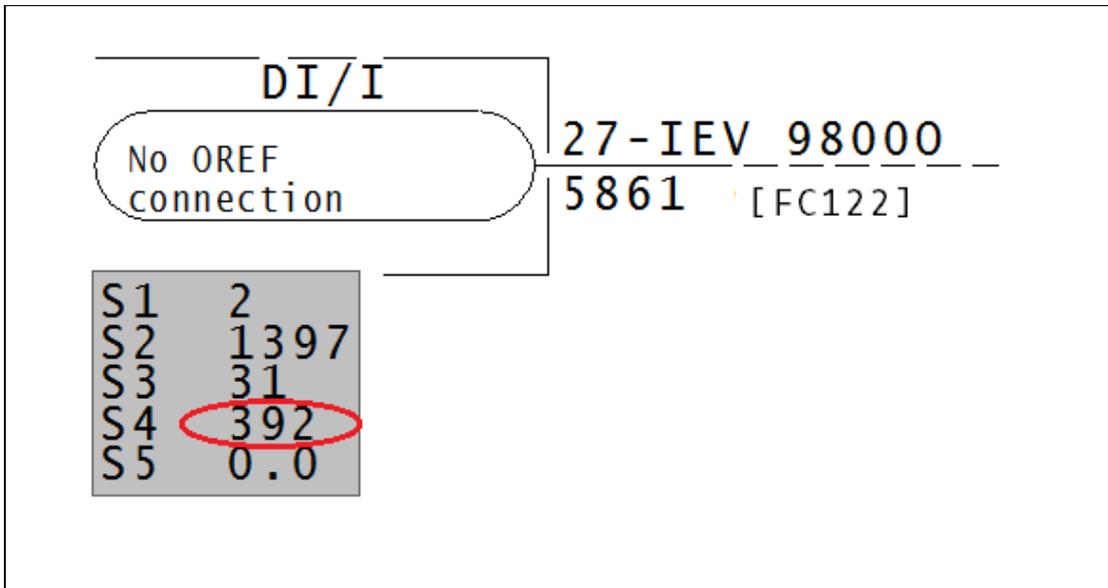
This message means that the value of the loop is smaller or larger than the allowed value range.

It is possible that a spec has been entered incorrectly.

Loop must be between 0-250.

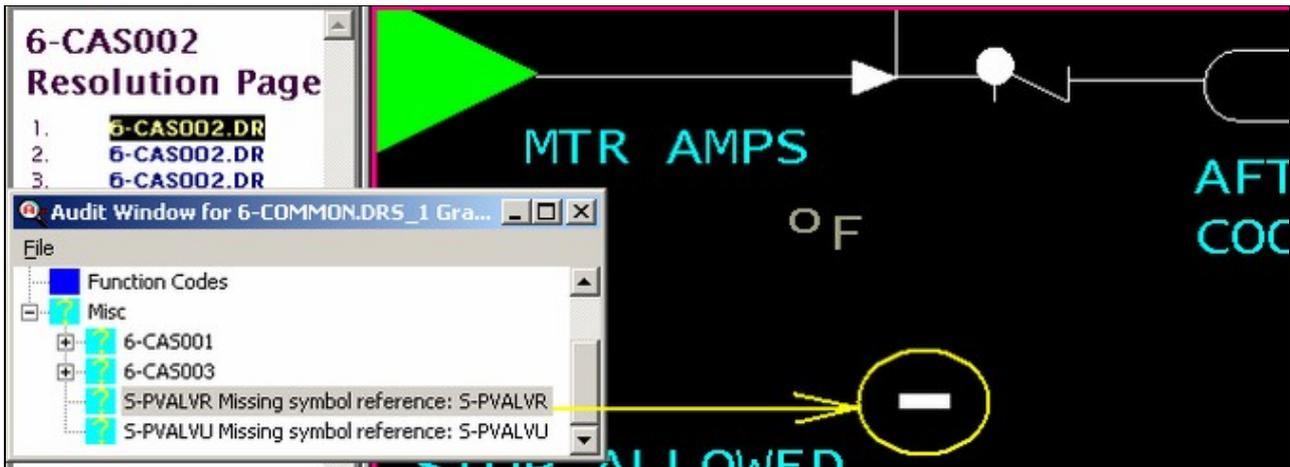
```
--Scanning graphic 6-CAS002.DR
Missing symbol or sub-model S-PVALVR.
Missing symbol or sub-model S-PVALVU.
```

DBDOC makes links to these missing symbols for you. For the example above, you can see this here.

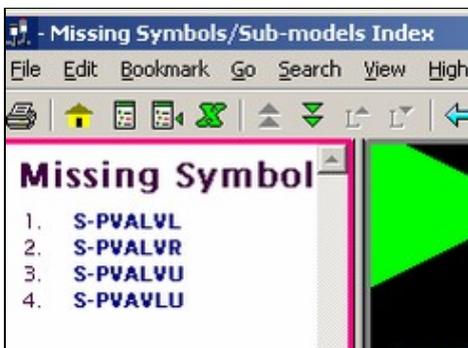
The Missing Symbols Index lists all missing symbols, and each symbol has a list and link to the graphics it is supposed to be found on. DBDOC thus makes it easy to find where these symbols are on the graphic so you can solve the problem that the missing symbol represents.

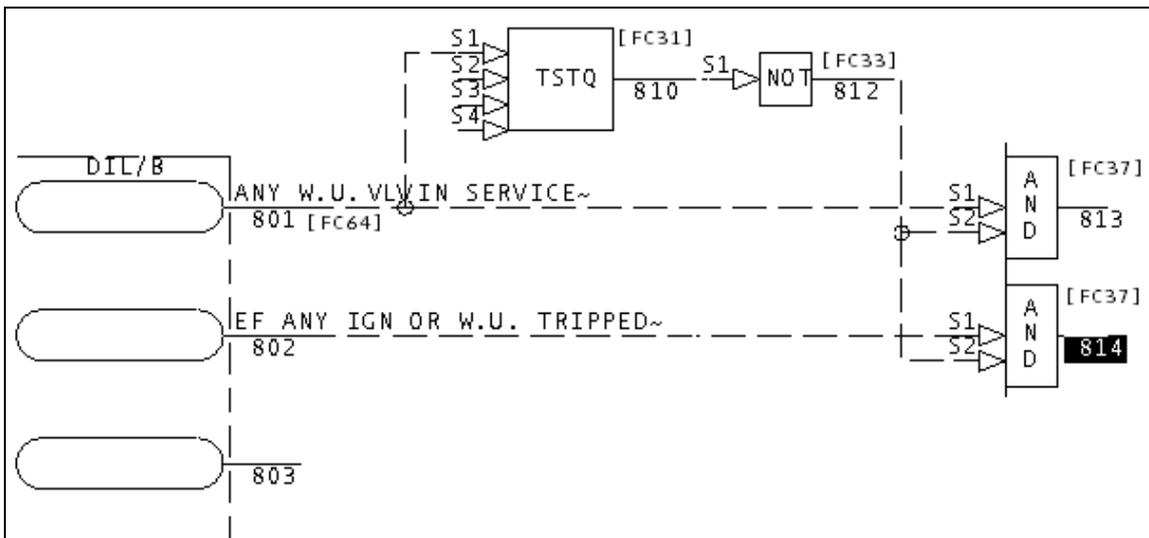
```
--Parsing file E:\...\RI_UNI~4\EBY1E5C.CLD...
Module 8 for IREF MILL GROUP F IN SERVICE~ (S3) does not match module 0 (S2) in file -- skipping.
Module 4 for IREF ANY W.U. VLV IN SERVICE~ (S3) does not match module 2 (S2) in file -- skipping.
Module 4 for IREF EF ANY IGN OR W.U. TRIPPED~ (S4) does not match module 2 (S2) in file -- skipping.
```

Looking at the logic, you can see that what has happened is that an unused DI/L block has been put on a boneyard sheet. The natural outputs, blocks 813 and 814, are not used anywhere else.

This message means that the input reference refers to a module that is not the one indicated by the module specification (S1) in an AIL/B or DIL/B function.

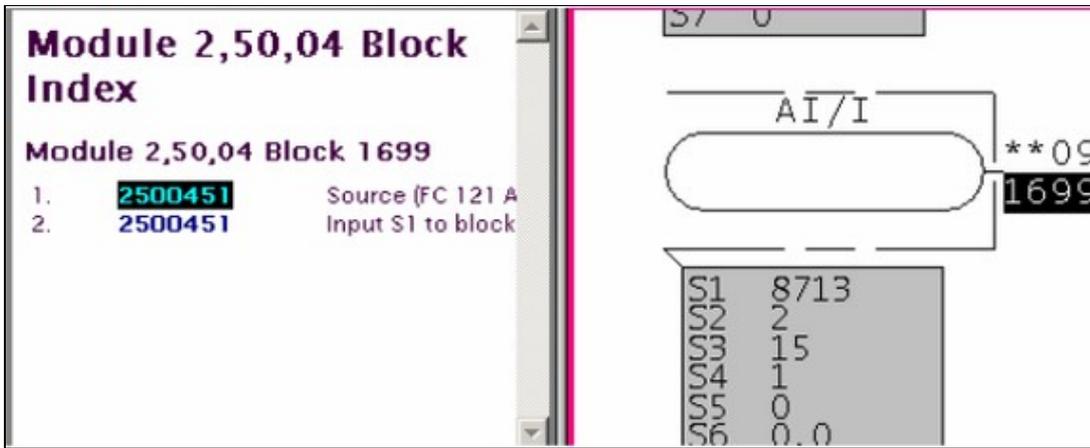
```
Module 8713 out of range for Module 2,50,04 Block 1699 (FC 121).  
Module 8605 out of range for Module 2,50,04 Block 1698 (FC 121).  
Internal error in LPMTToString: module 713 out of range
```

Note that 713 is the lower part of the specious value of S1=module=8713. Correcting the value of S1 and S2 (swapping them) will fix the Internal error, too.

Module must be between 0-32.

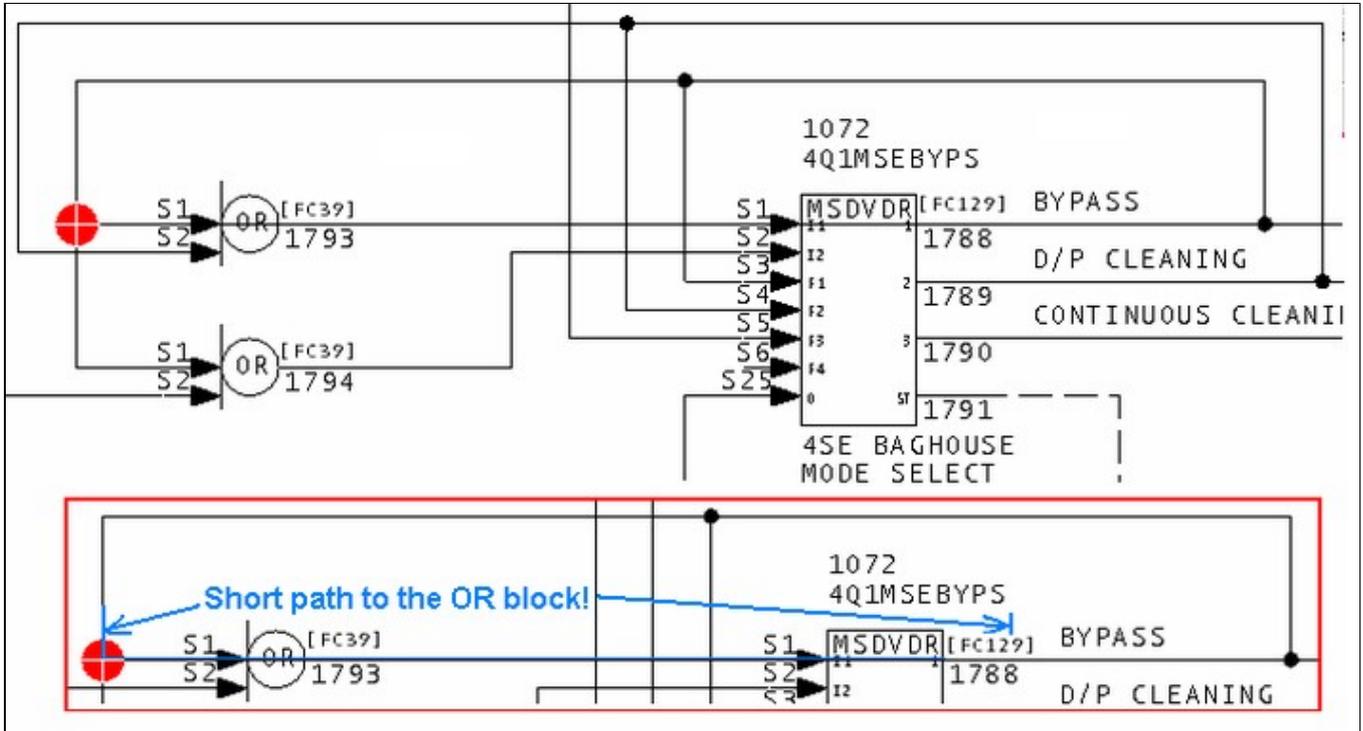
More than one input to connector at 1600,2600: Block 1788 (FC 129) and Block 1788 (FC 129).

You can see that the extraneous line from block 1788 to S1 of block 1793 causes this message.

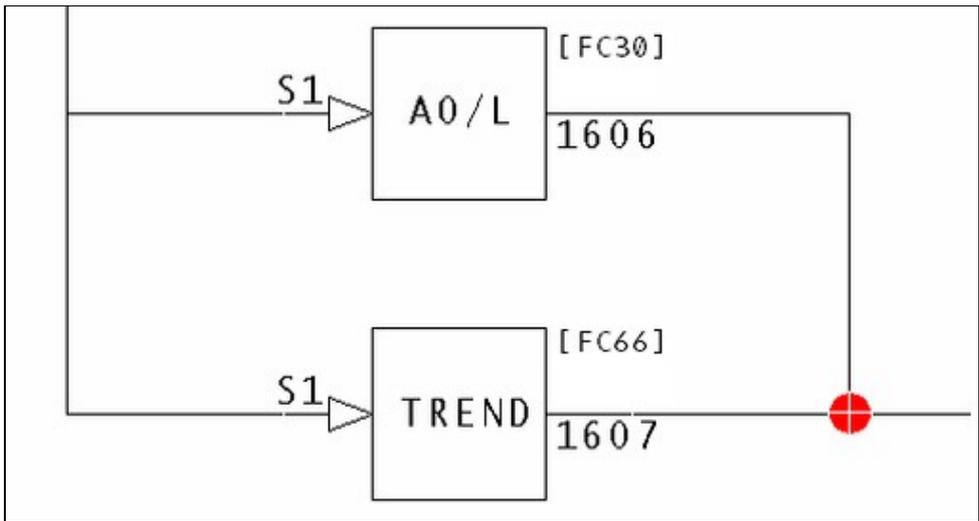
It appears that the signal from the two function codes shown are coming into a connector at the coordinates indicated. More than one input to connector at 6860,5960: Block 1606 (FC 30) and Block 1607 (FC 66).

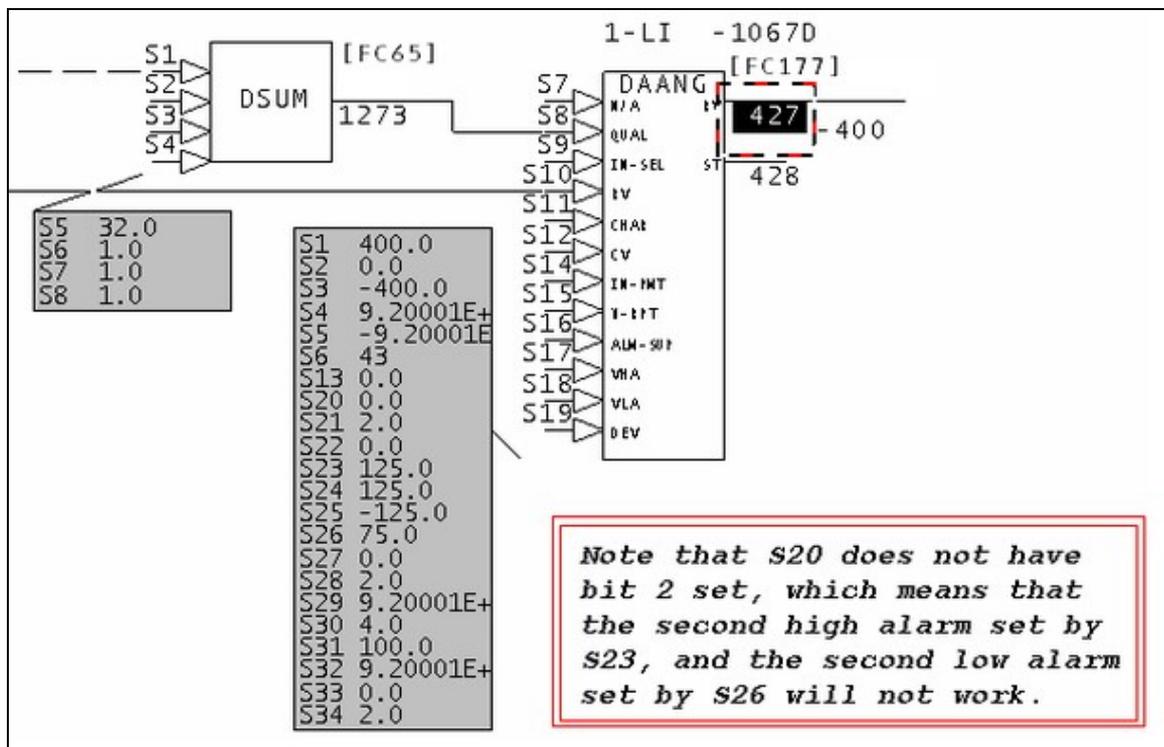
Multilevel alarms configured but disabled for Module 11,01,04 Block 427 FC 177.

We infer that the second and/or third alarm limits are intended to be used by comparing them (if not zero) to the span of the block. If they are less than or equal to the span, we assume that the the extra alarm status checking might be desired.
