5 Build Reports and Analysis

5.1 Overview of the DBDOC build reports

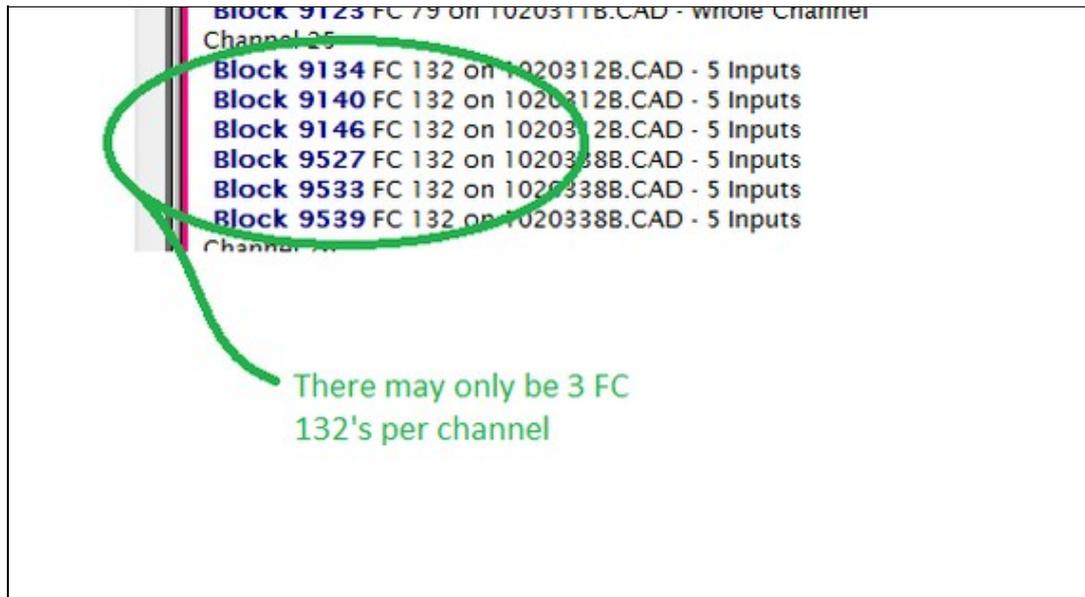
Multiple slave FCs on Module 1,01,02 slave 10: 4 FC 132's, limit is 3 (Module 1,01,02 Header)

DBDOC's analysis of the configuration of your slave specs suggests that there are too many slaves on an AIS/FBS: Analog Input/Slave [FC132] block.

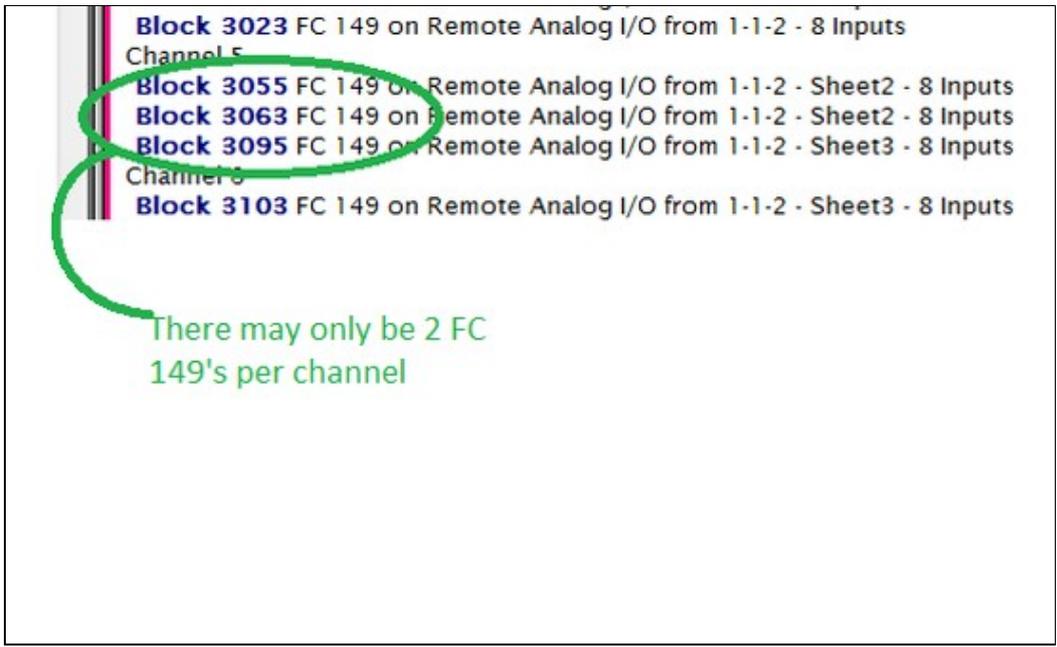
Multiple slave FCs on Module 1,01,02 slave 15: 3 FC 149's, limit is 2 (Module 1,01,02 Header)

DBDOC's analysis of the configuration of your slave specs suggests that there are too many slaves on an ASO: Analog Output/Slave [FC149] block.

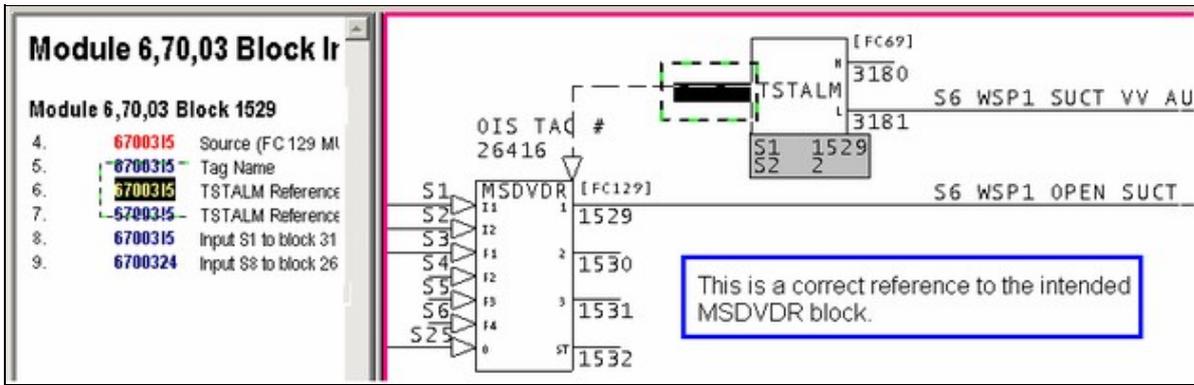
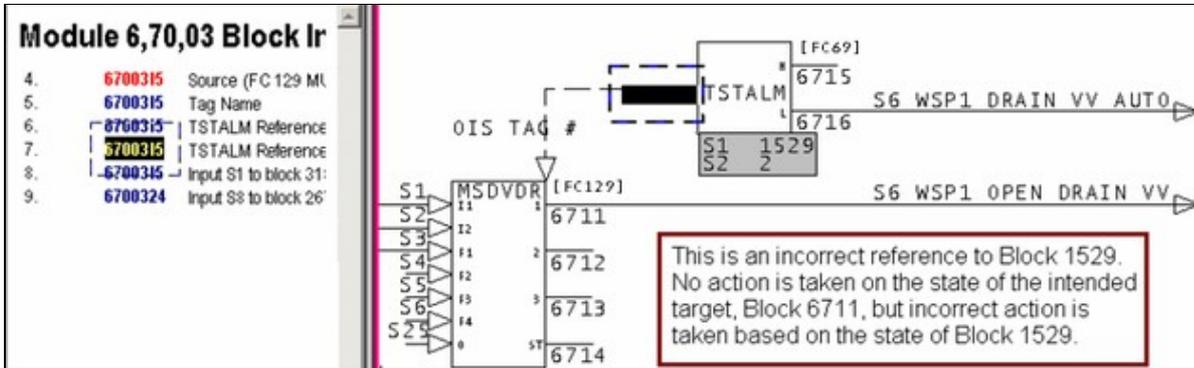
Multiple TSTALM: Module 1,27,02 Block 21160 is tested multiple times (mode 2)
Module 6,70,03 Block 1529 is tested by multiple TSTALM blocks (mode 2).

Specifically, Spec S1 is can be missed when the block numbers are changed in copied logic.

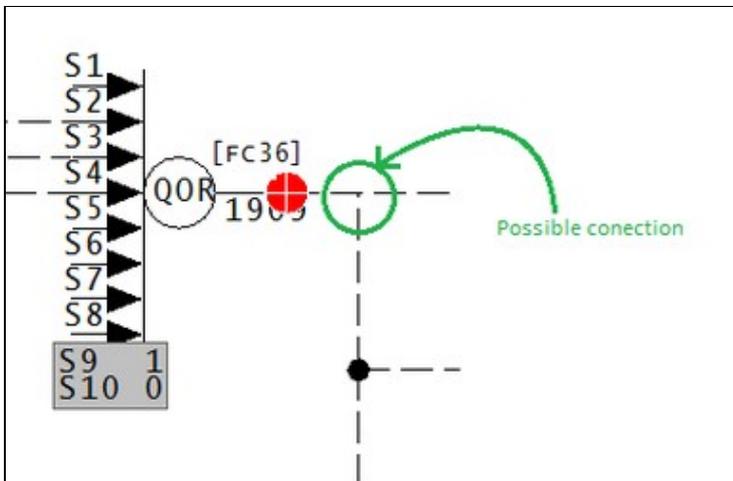
Multiple wires at a source: assuming a connector at 4400,2700

This point has multiple wires in a single location.

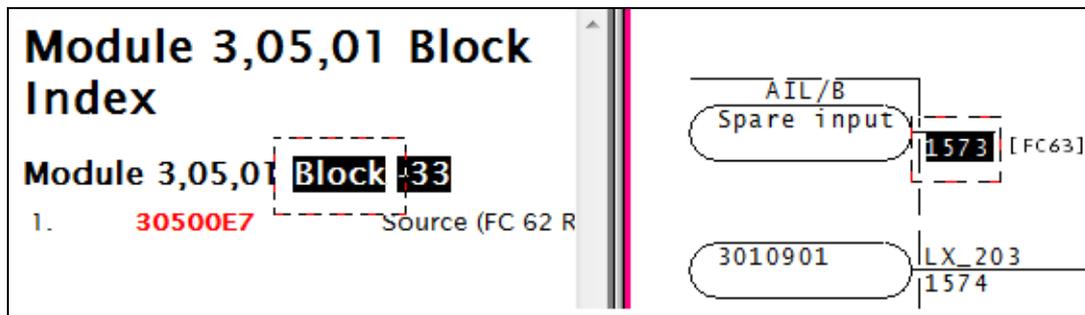
```
--Scanning drawing 30500E7  
Negative block number Module 3,05,01 Block -33 encountered
```

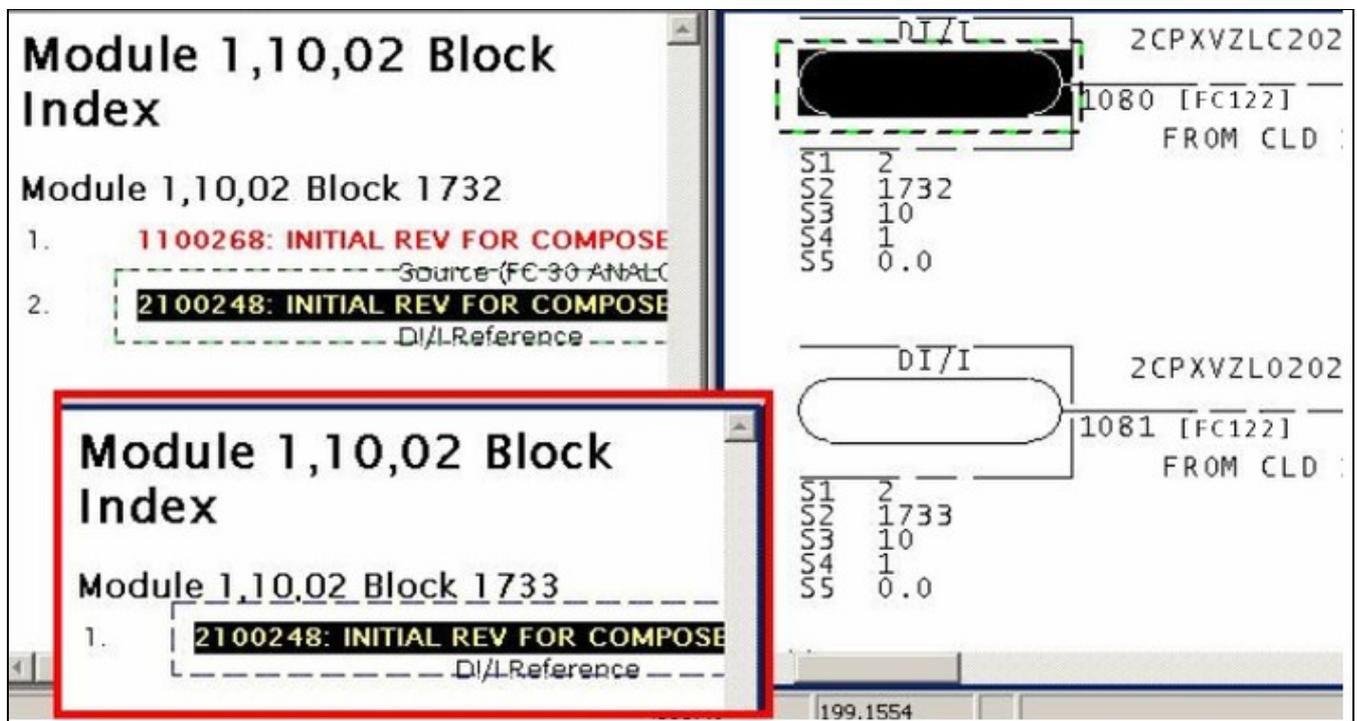
No source: Module 1,10,02 Block 1733 imported - module built

If the blocks actually exist, this message tells you that they are not in the files you built with DBDOC. Sometimes, this means the CAD or CLD files are not up to date.

The other possibility is that the module CAD or CLD files are simply a stub and there are no configuration drawings for the blocks. If the blocks actually exist, you can use **BuildPlus/Tools/Project Options/Define Blocks with External Sources** to define them and eliminate the error message.

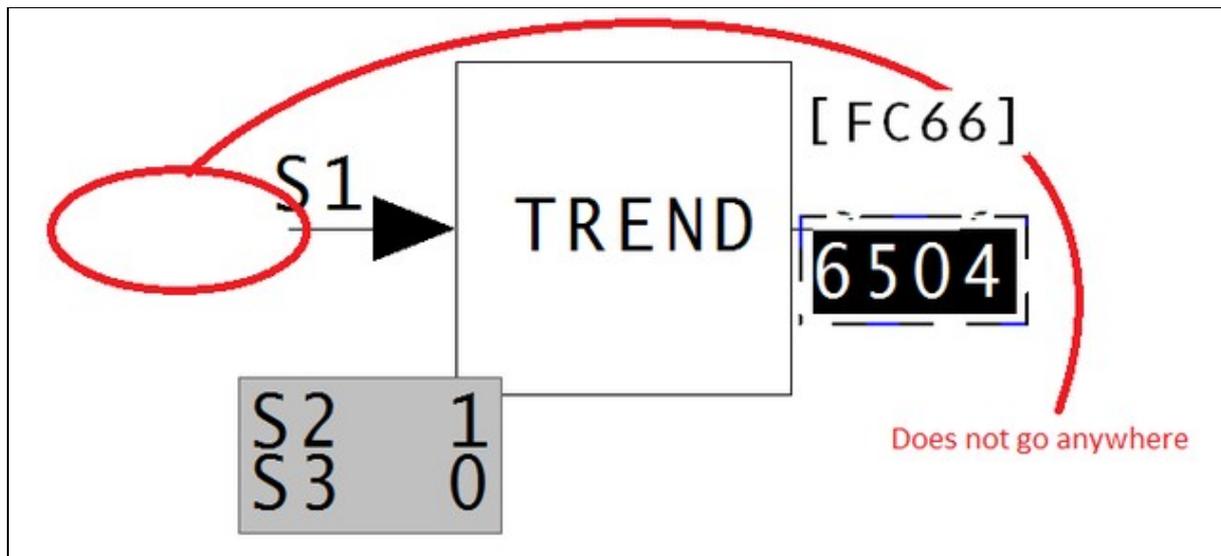
This message means that a block has been found that has no input attached to it. You normally can ignore these messages as a cosmetic issue.

We have seen that this condition can be caused in WinCAD and DOS CADEWS by connecting a source to a F(x) block, then deleting the line. The result is that S1 has a value 0. Composer restores the value to 5.

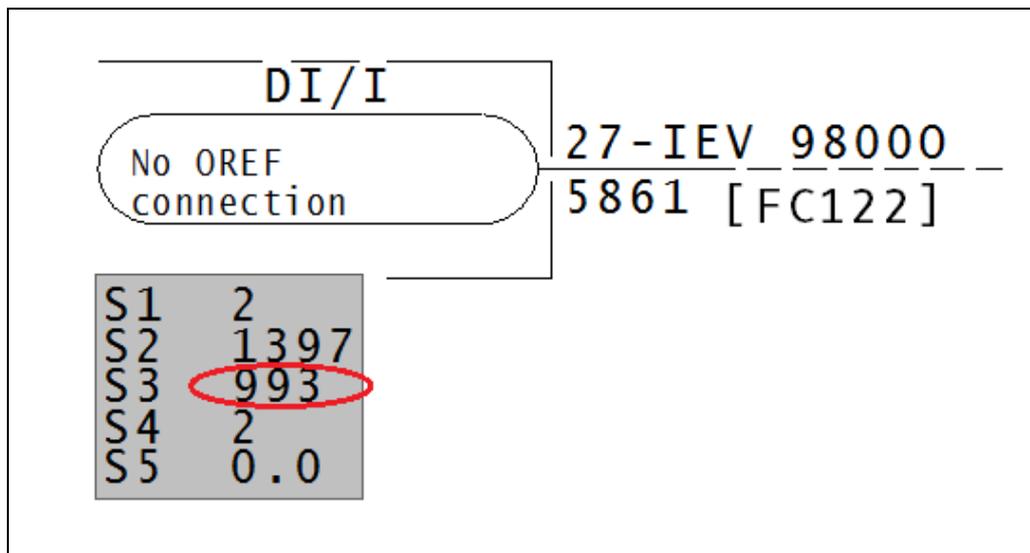
This message means that the value of the node is smaller or larger than the allowed value range.

Node must be between 0-255.

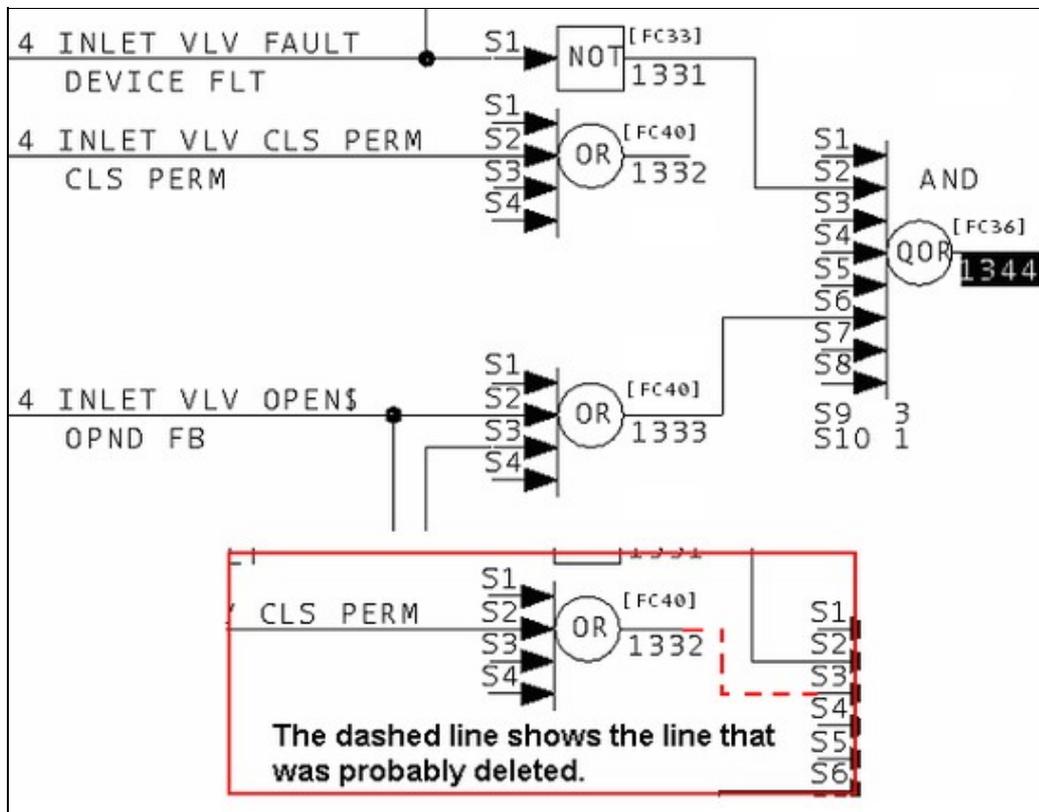
A usual example is of a QOR: Qualified OR (8-Input) [FC36] block used as an AND operator, with S9 greater than the number of inputs.

--Module 4,10,04 QOR Report
 Insufficient number of inputs (2 wired, 3 required) in FC 36 Module 4,10,04 Block 1344.

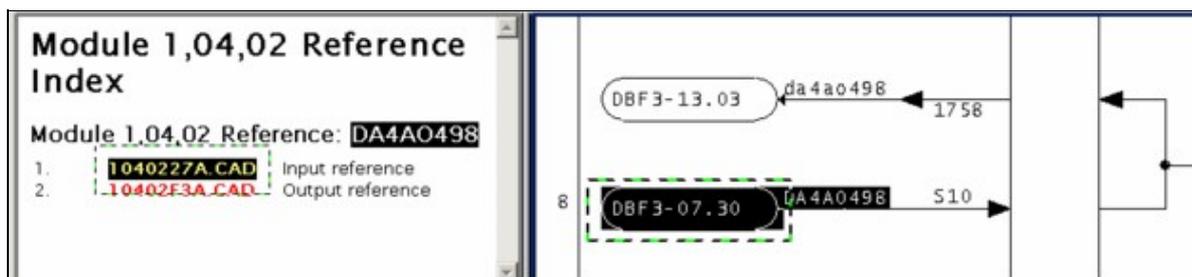
```
--Module 1,04,02 OREF Report
The following OREFs differ in case only: da4ao498,DA4A0498
```

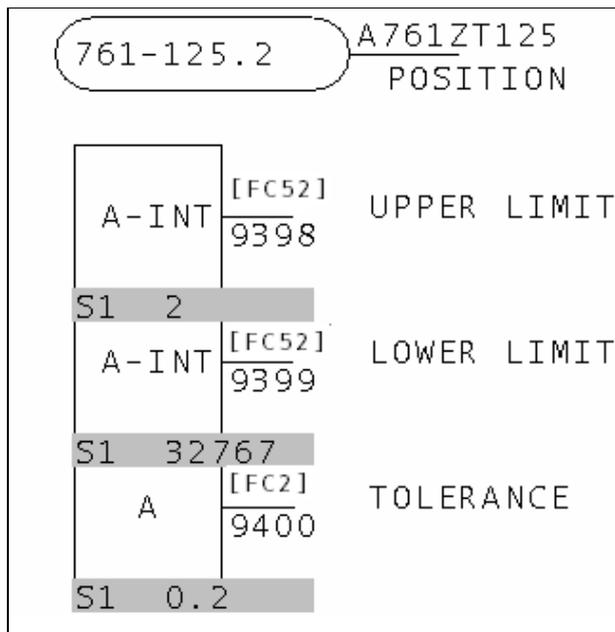
```
--Parsing file E:\PROJECT\ANC_CO~2\EBY0884.CLD...  
Block 9399 S1 integer value 65534 (real value 0.000000) too big for short.
```

From the picture, you can see that somebody must have put 0.0 in S1 of block 9399 (a real number) instead of 0 (an integer). A real number does not have the same structure as an integer, so DBDOC tells you about it. We do not know if it works, but some errors of this type have found actual problems for clients.

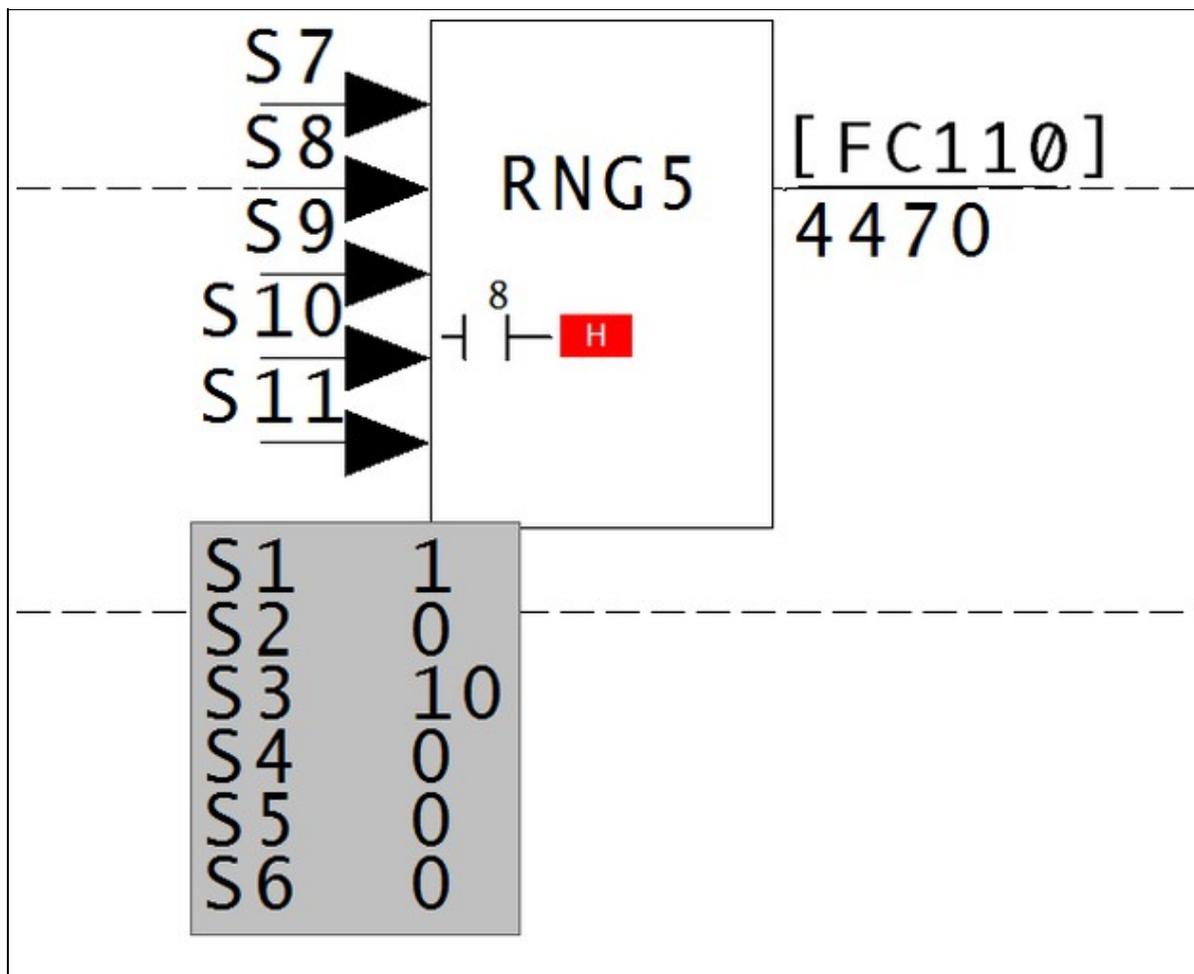
The indicated rung block has its output forced to hold its value. DBDOC indicates this as an H for hold. The logic will not respond to changes in the inputs.

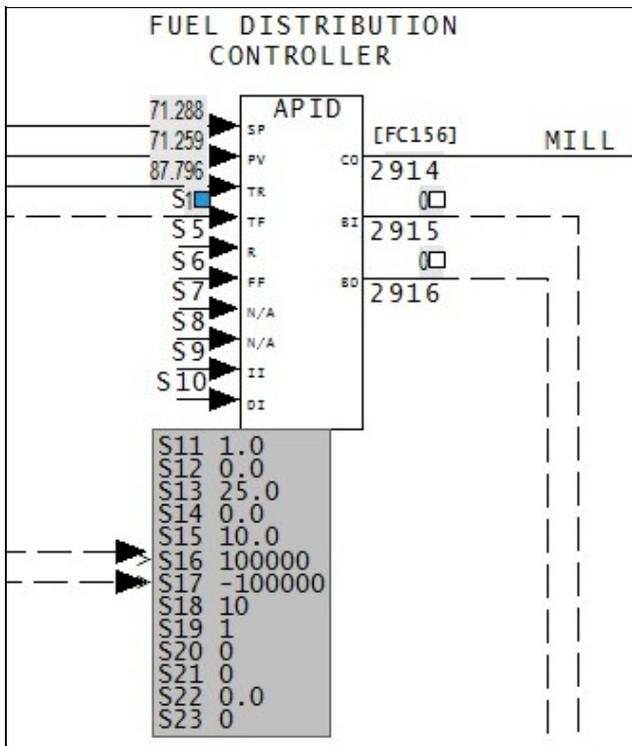
Note that the output is not 0.0 under the following conditions for FC 156 (APID).

- S4 is wired (this is the TR tracking input)
- S5 is wired and has a value 1 (this is the TS track switch input)

The image shows live data when tracking is switched on.

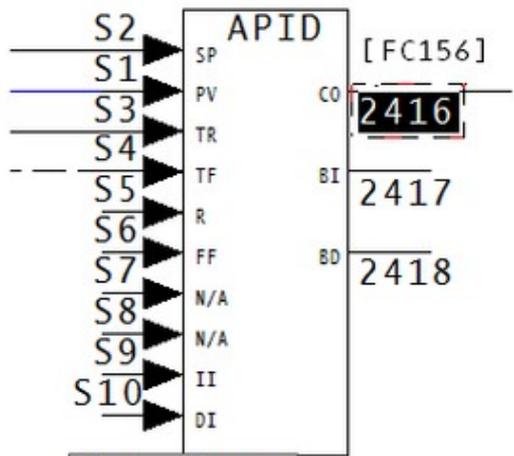
This message means that a PID Controller block has its derivative lag spec S15 set to zero. The derivative term will be applied directly.

If S15 is 0.0, the value 1.0 will be used internally. Also if S14 is 0.0, S15 is ignored.

S11	50.0
S12	1.75
S13	0.25
S14	0.3
S15	0.0
S16	105.0
S17	-5.0
S18	10
S19	0
S20	0
S21	1
S22	0.0
S23	0

With S15 as 0.0, the value of S14 is divided by 1, and the derivative is applied all at once. Therefore There is no lag in effect.

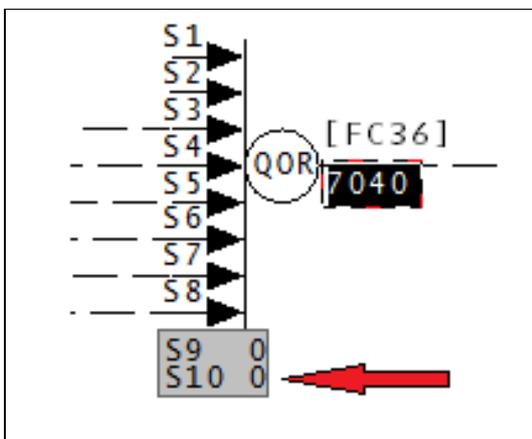
A QOR output has been forced to 1. The message is intended to encourage documentation of forced logic.

A QOR block functions in such a way that if the value of S10 is 0, then the output is 1 if the number of logic 1 inputs is greater than or equal to the value of S9. With the value of S9 at 0 as well, the number of input 1's will always be greater than or equal to 0. therefore the output value of the block will always be 1.

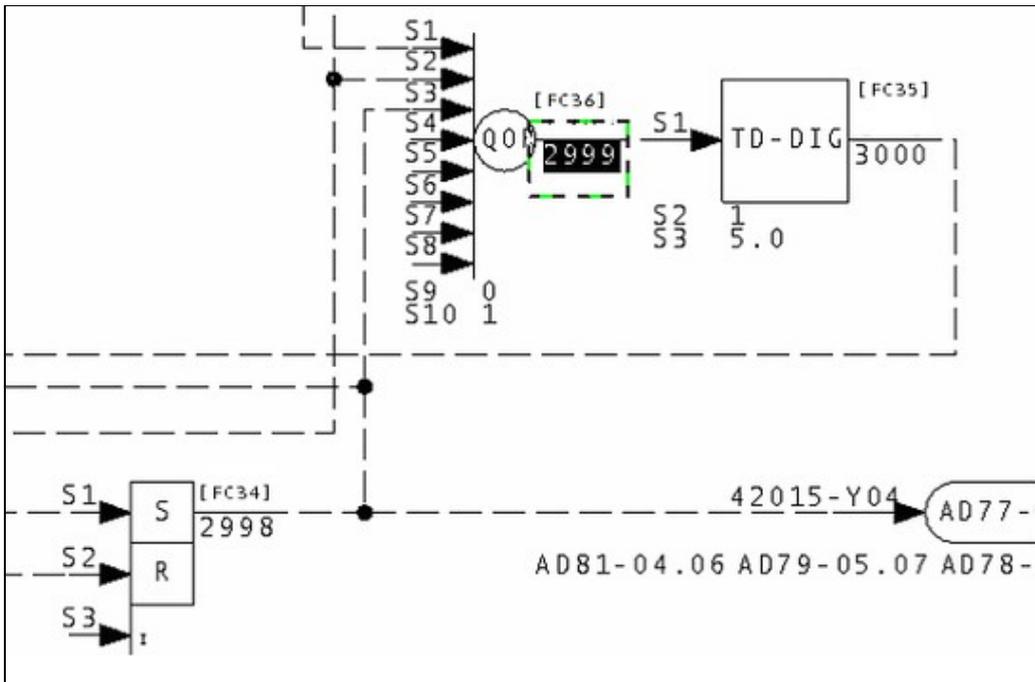
QOR being used as a NOR: possibly unintended in FC 36 Module 1,11,02 Block 2999.

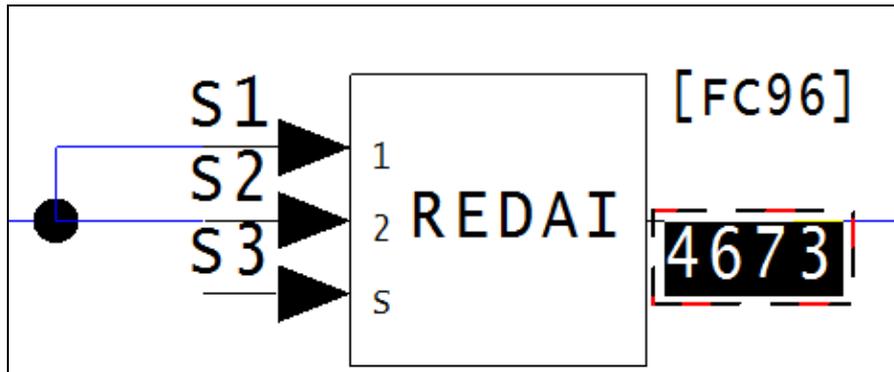
```
REDAI Module 20,03,02 Block 4673 with both inputs from same block Module 20,03,02 Block 452 cannot synthesize quality
```

When a REDAI block has both inputs from same block, the block does nothing because the output tracks the input value and quality. If the input has quality, so will the output. However, if the input does not have quality, the output will never be changed to bad quality, so testing it is misleading. The specifications allow bad quality to be introduced on detection of a rate of change problem. If both S5 and S6 are reasonable, the quality will be set bad if the rate of change (units per second) of the inputs exceeds the sum of S5 and S6 (the deadband parameter). Clearly, the deadband should be less than the rate of change limit. If you see this message with what looks like a valid value of S5, you will find that S6 is not a valid deadband value.

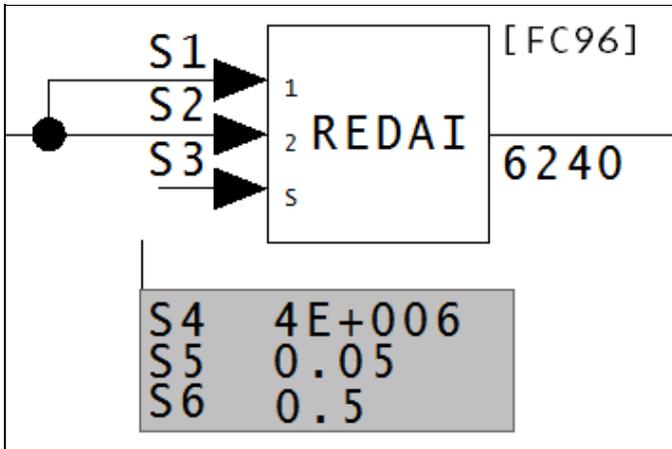
REDAI Module 1,01,02 Block 1000 has deadband S6 larger than rate limit S5

If the deadband exceeds the rate limit, the change to bad quality can not be reversed reasonably.

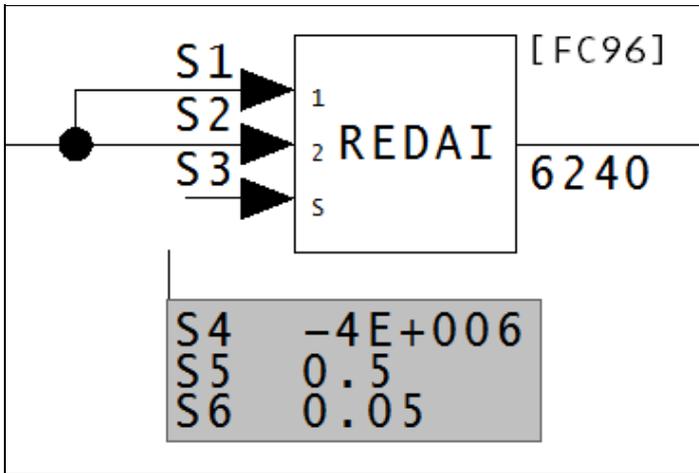
The REDAI deviation limits may not be 0.0 or a negative value.

S4 is the deviation limit, which has the same units as S1 and S2.

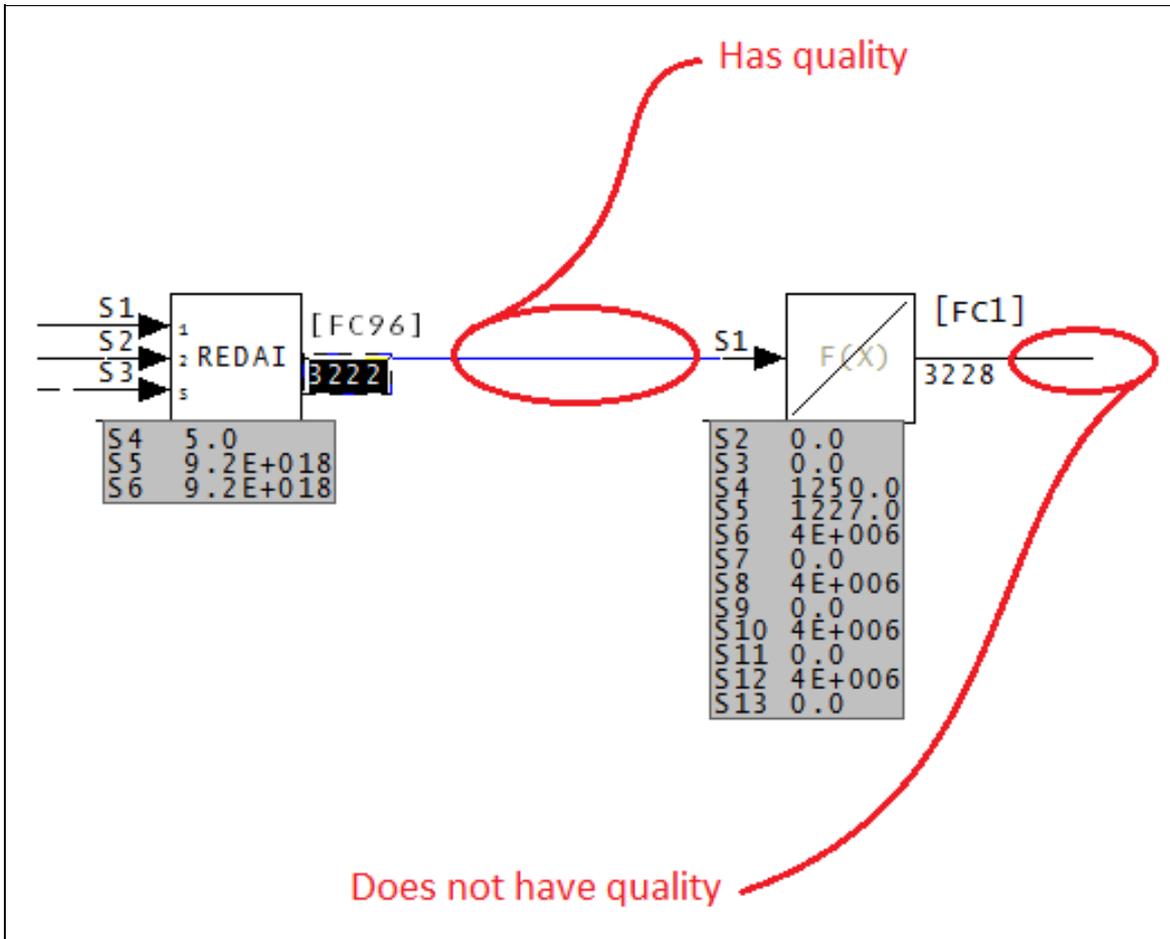
In this case, the REDAI block gives quality to the output value, and as it is entered into the F(X) block, it loses that quality.

This causes the values to be very wrong.

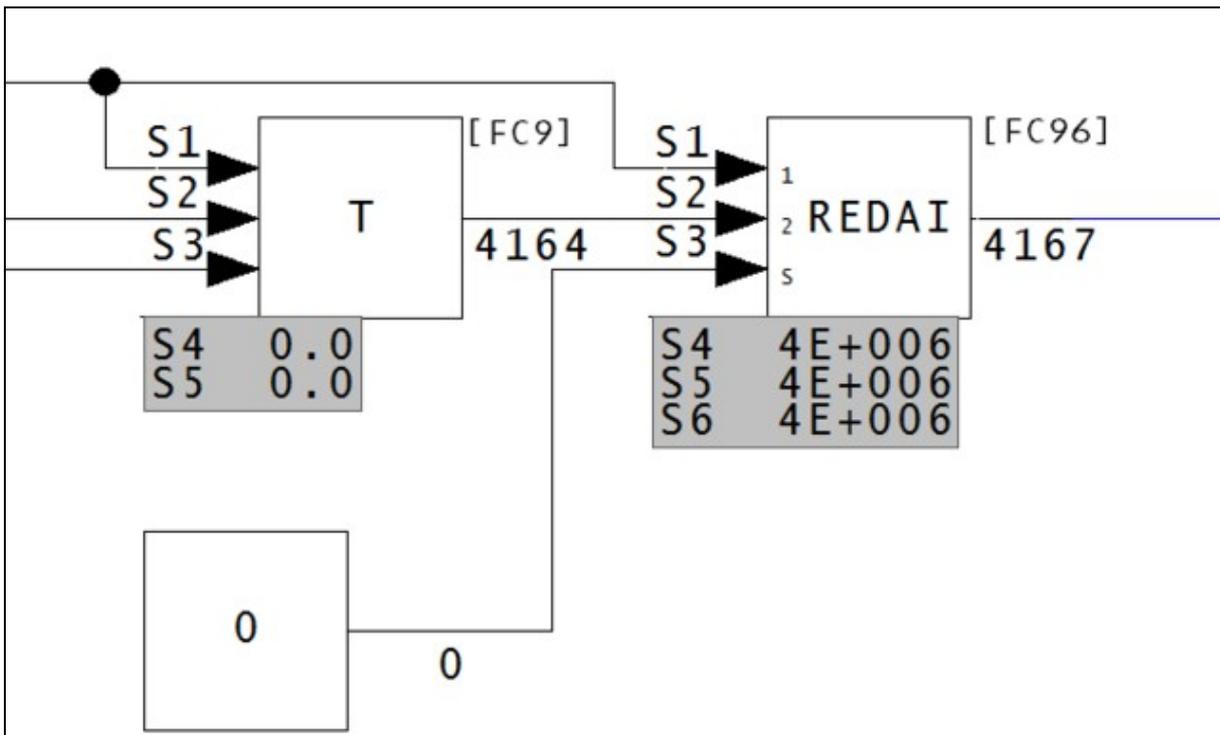
REDAI Module 1,01,02 Block 1000 has select input S3 wired from constant block Module 1,01,02 Block 1001

The select input is designed to switch between two inputs. When it is wired to a constant, no switching is possible. This is why DBDOC draws this to your attention.

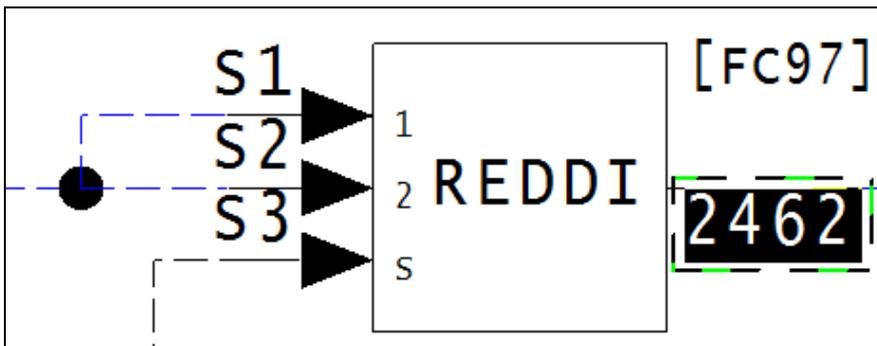
REDDI Module 20,09,02 Block 2462 has both inputs from same block Module 20,09,02 Block 1525

A REDDI block that has both inputs from same block does nothing.

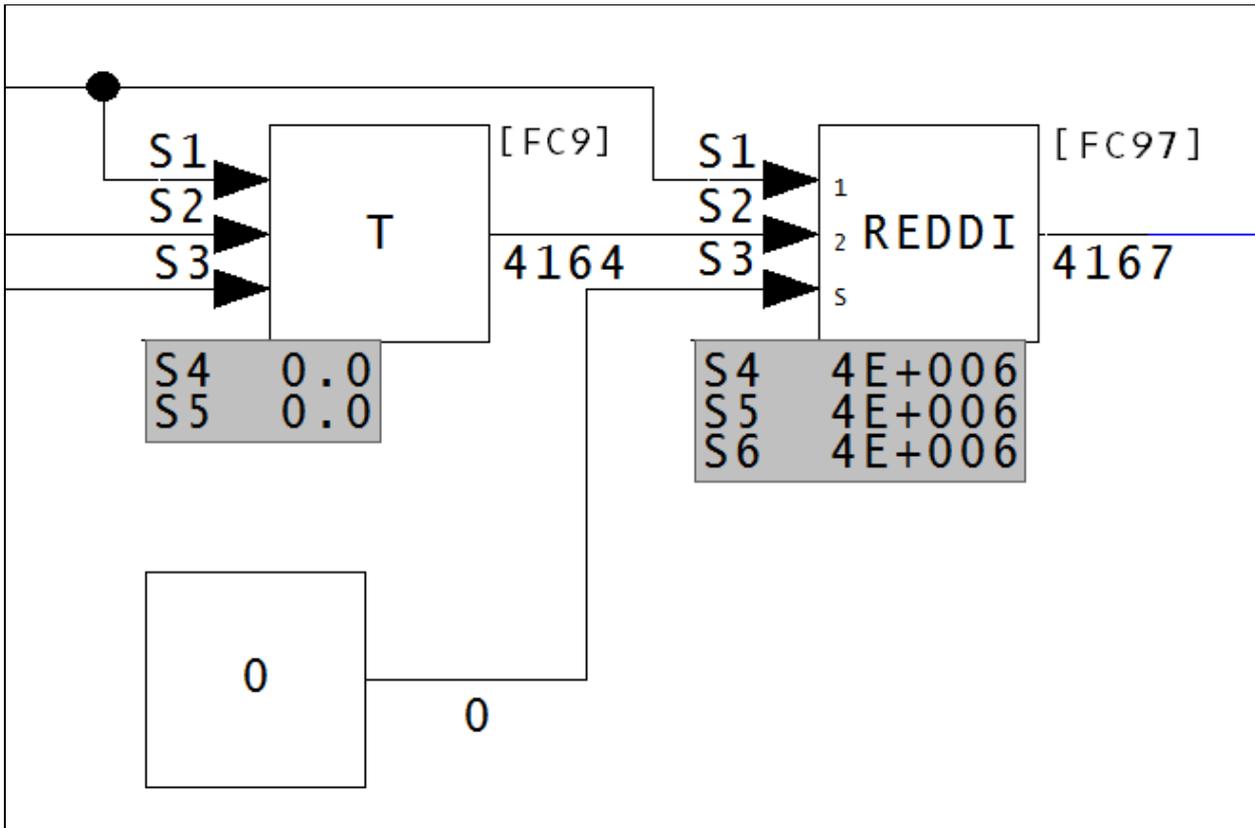
REDDI Module 1,01,02 Block 1000 has select input S3 wired from constant block Module 1,01,02 Block 1001

The select input is designed to switch between two inputs. When it is wired to a constant, no switching is possible. This is why DBDOC draws this to your attention.

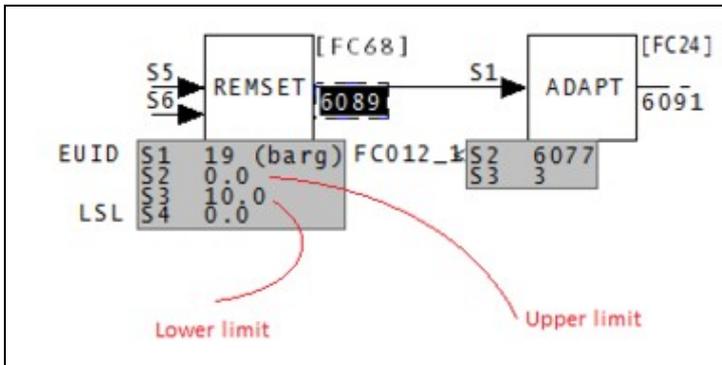
In the image below, the S3 value greater than an S2 value. Because of this, the range of acceptable values does not exist.

This block allows an operator to enter a constant to the control scheme. S2 and S3 are the limits of the range of values the operator can enter.

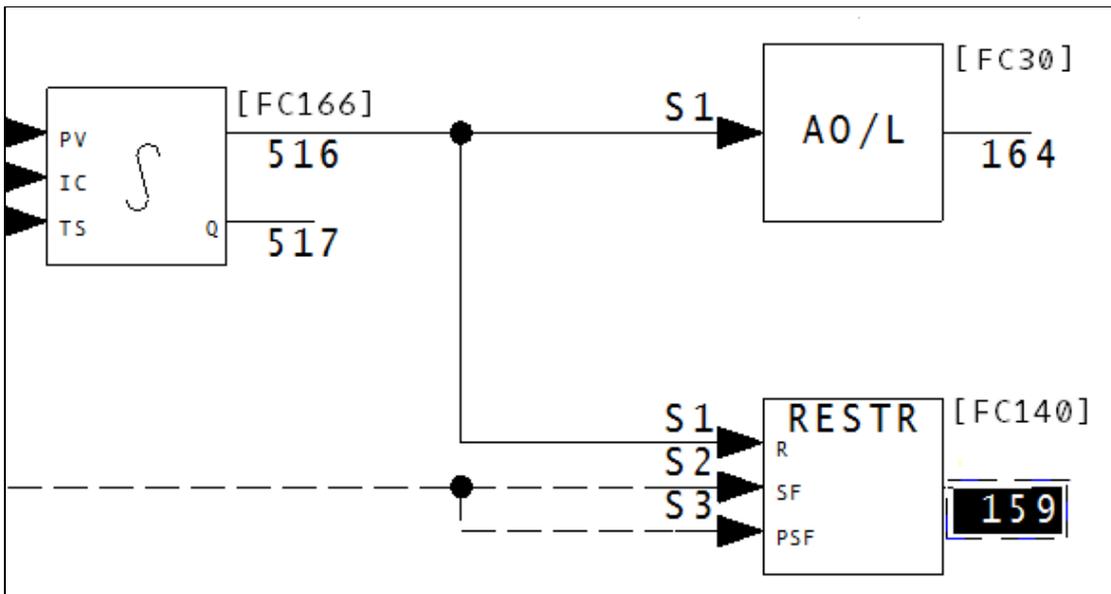
The restore block must be located at a block number greater than the function block being restored (S1).

The restore function code saves and restores values. However, the restore block must come after (be a higher block number) than the block being restored. If it precedes the block it is told to backup, the value restored will be that from the last cycle. This will cause all restored values to be false.

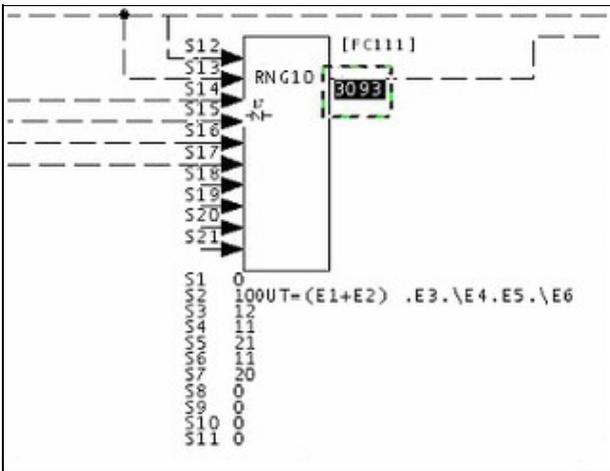
```
--Post Processing drawing 1010274C.CAD  
Rung block Module 1,42,02 Block 3093 did not use all inputs to compute output.
```

This message means that the calculations have not been specified properly. A partial result has been created, but not used.

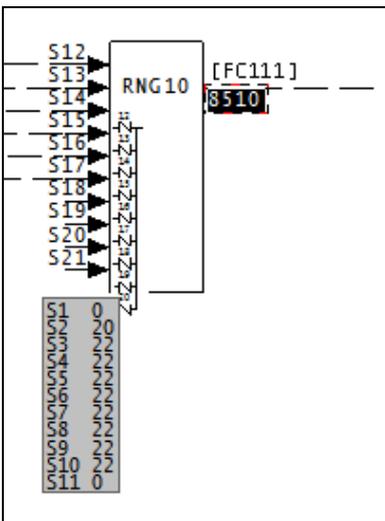
```
--Post Processing drawing 14004Q4
Rung block Module 10,40,04 Block 8510 S18 is unwired but used by S8 value 022
```

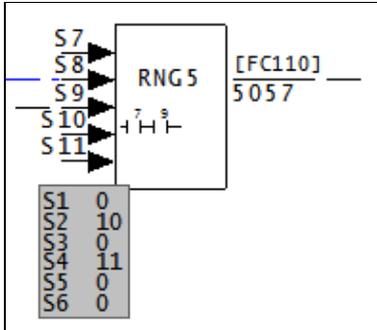
When a block has both this error 125 and "Error 124: Rung block spec is wired but unused", it usually means the source was connected to the wrong input, or the specification values need to be changed:

```
--Post Processing drawing 10902D2
Rung block Module 20,09,02 Block 5057 S7 is unwired but used by S2 value 010
Rung block Module 20,09,02 Block 5057 S8 is wired (block 1055) but unused by S3 value 000
```

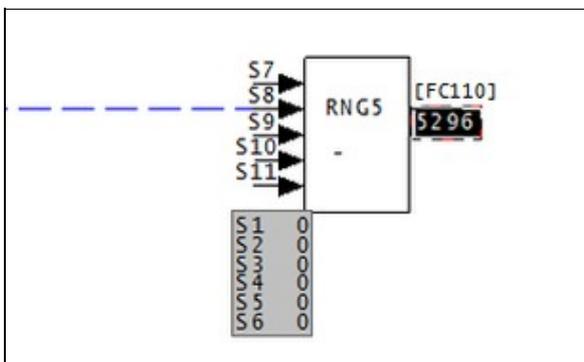
```
Rung block Module 1,01,02 Block 1001 S3 is wired (block 1234) but unused by S8
value 032
```

These are always worth checking, as they mean that the input looks like it is used, but it is not. This may be what is intended, in which case the line should probably be deleted. Otherwise, it could show you a potential problem. In the case of block 0, a logical 0 constant is wired into the rung block but it is not needed because the controlling specification is 0. If you tidy this up, the CLD/CAD sheets will be easier to understand.

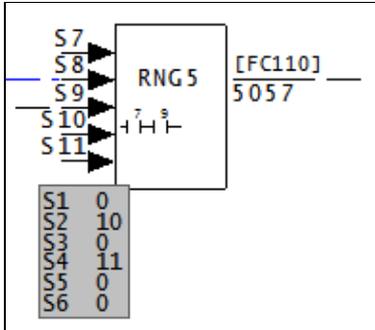
When a block has both this error 125 and "Error 125: Rung block spec is unwired but used", it usually means the source was connected to the wrong input, or the specification values need to be changed:

```
--Post Processing drawing 10902D2
Rung block Module 20,09,02 Block 5057 S7 is unwired but used by S2 value 010
Rung block Module 20,09,02 Block 5057 S8 is wired (block 1055) but unused by S3 value 000
```

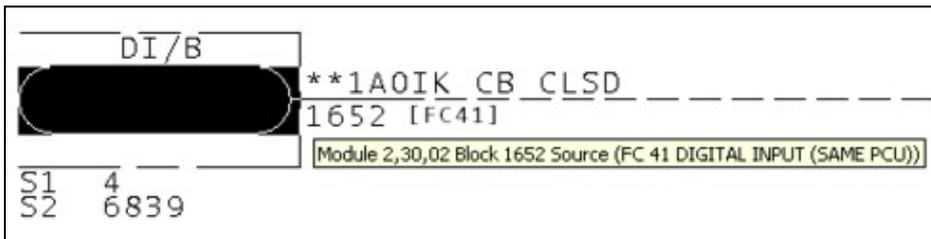
For example, if an AI/L or DI/L import block has an IREF that exists only in another Loop, you will see this message. The reference cannot tell what is being imported, because these functions cannot import from another loop, only the same one.

```
--Parsing file H:\...\EBY45EB.CLD... CAD Names: 2300251A.CAD
External output reference is unreachable for IREF **1A0IK CB CLSD on Module 2,30,02 Block 1652:
cannot import from Loop 2 PCU 20.
```

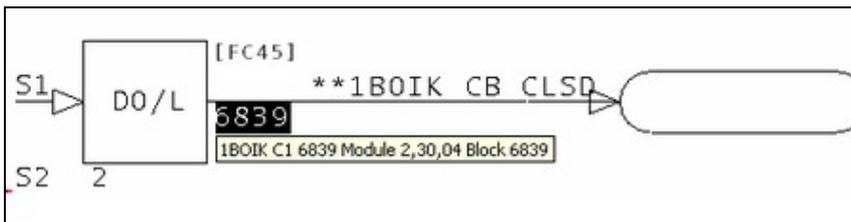
Here is the actual source, as determined by the specifications.

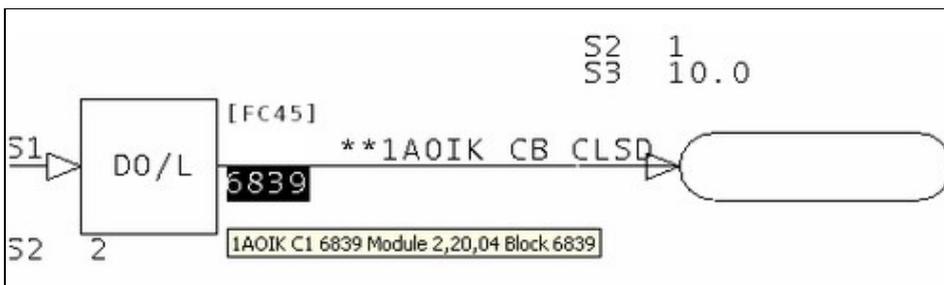
Here is the source that the input reference indicates.

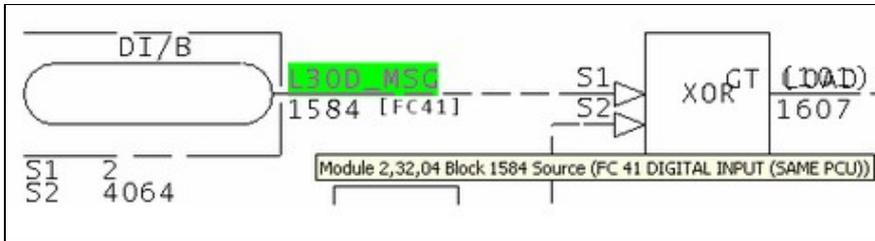
--Parsing file H:\...\EBY3DAC.CLD... CAD Names: 2320454A.CAD
 External output reference is unreachable for IREF L30D_MSG on Module

2,32,04 Block 1584: cannot import from Loop 2 PCU 22."

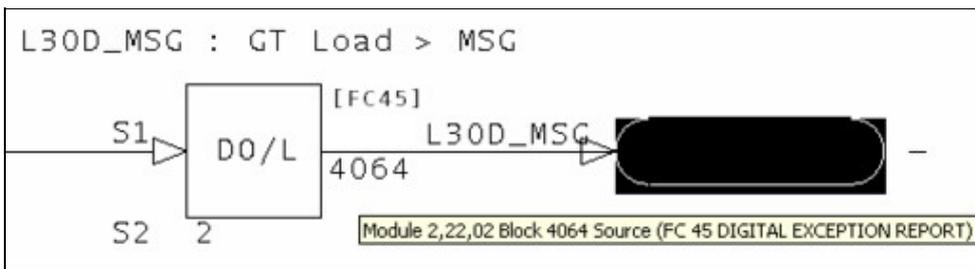
Here is the source indicated by the input reference L30D_MSG.

It is possible to see how Composer, in being robust enough to import files from WinCAD, also allows errors to persist in the input references.

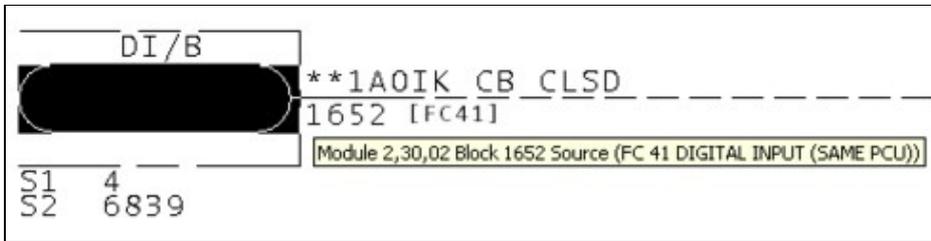
For example, if a Bus Import (AI/B, DI/B, AIL/B or DIL/B function) has a reference in a different PCU, you will see this error. These functions can only import blocks from the same PCU, so the reference text is flawed if it in a different PCU.

```
--Parsing file H:\...\EBY45EB.CLD... CAD Names: 2300251A.CAD
External output reference is unreachable for IREF **1A0IK CB CLSD on Module 2,30,02 Block 1652:
cannot import from Loop 2 PCU 20.
```

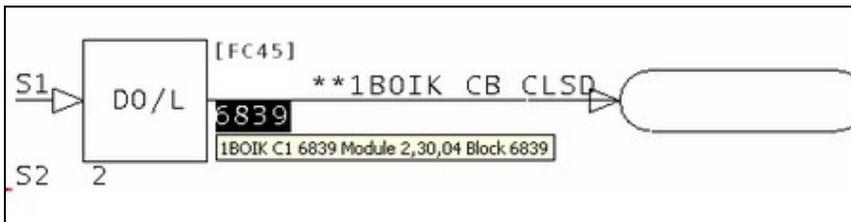
Here is the actual source, as determined by the specifications.

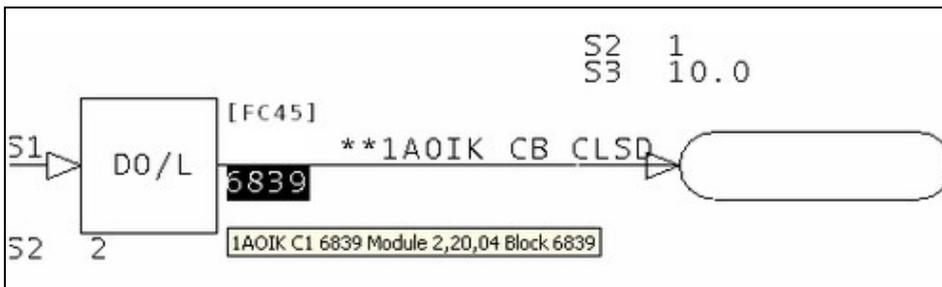
Here is the source that the input reference indicates.

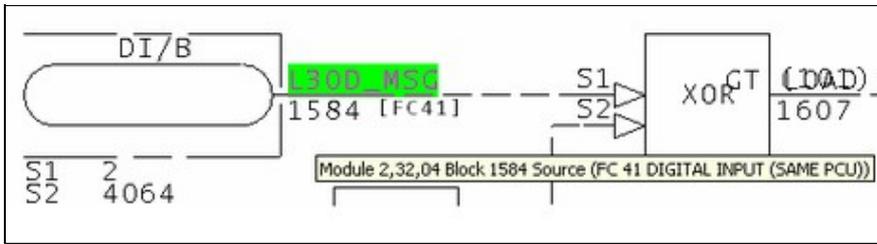
```
--Parsing file H:\...\EBY3DAC.CLD... CAD Names: 2320454A.CAD
External output reference is unreachable for IREF L30D_MSG on Module
```

2,32,04 Block 1584: cannot import from Loop 2 PCU 22."

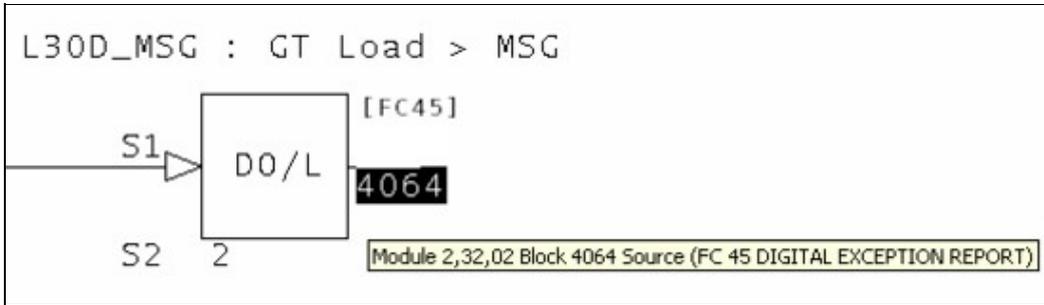
Here is the block that is being imported.

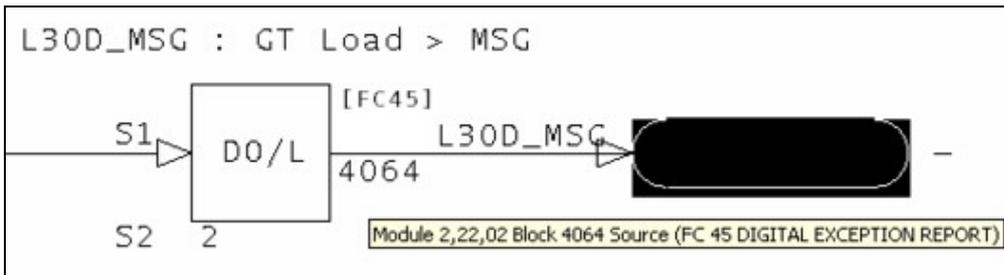
Here is the source indicated by the input reference L30D_MSG.

It is possible to see how Composer, in being robust enough to import files from WinCAD, also allows errors to persist in the input references.

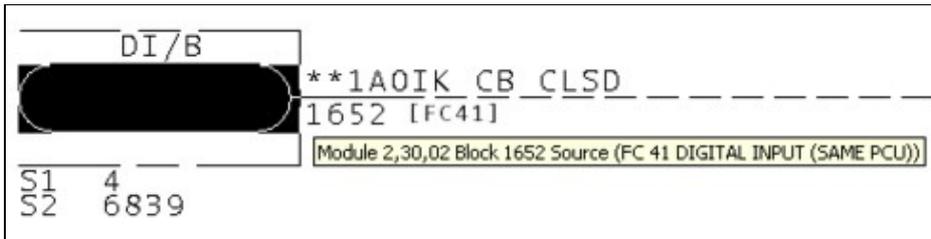
For example, if an AI/L or DI/L import block has an IREF that exists only in another Loop, you will see this message. The reference cannot tell what is being imported, because these functions cannot import from another loop, only the same one.

```
--Parsing file H:\...\EBY45EB.CLD... CAD Names: 2300251A.CAD
External output reference is unreachable for IREF **1A0IK CB CLSD on Module 2,30,02 Block 1652:
cannot import from Loop 2 PCU 20.
```

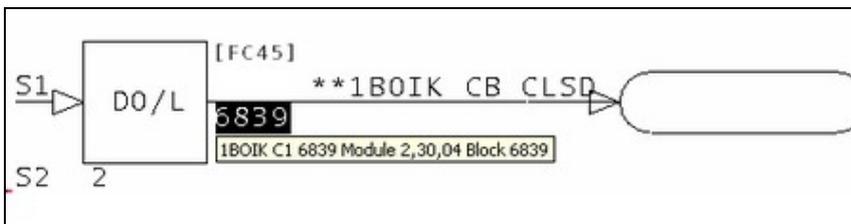
Here is the actual source, as determined by the specifications.

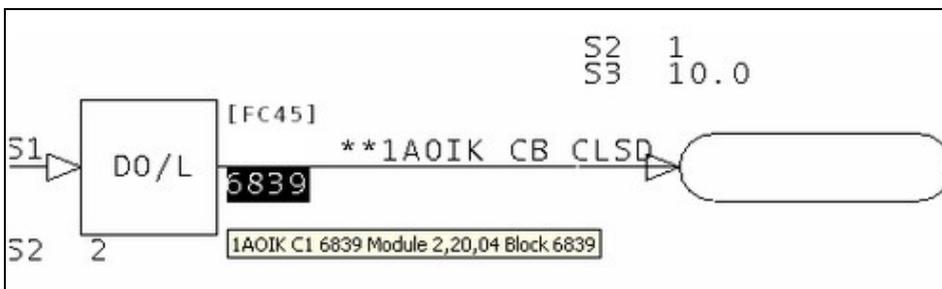
Here is the source that the input reference indicates.

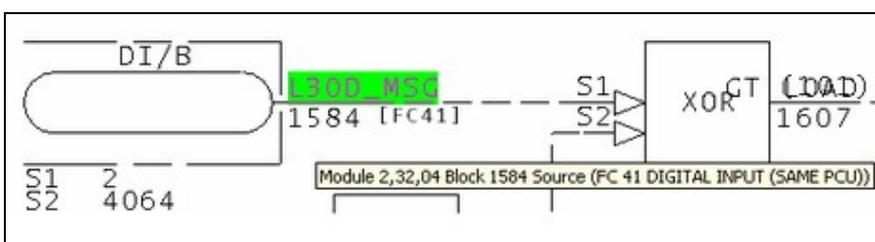
```
--Parsing file H:\...\EBY3DAC.CLD... CAD Names: 2320454A.CAD
External output reference is unreachable for IREF L30D_MSG on Module
```

2,32,04 Block 1584: cannot import from Loop 2 PCU 22."

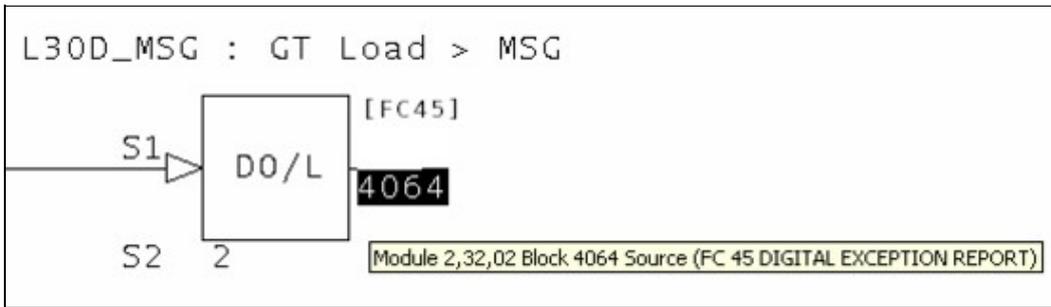
Here is the block that is being imported.

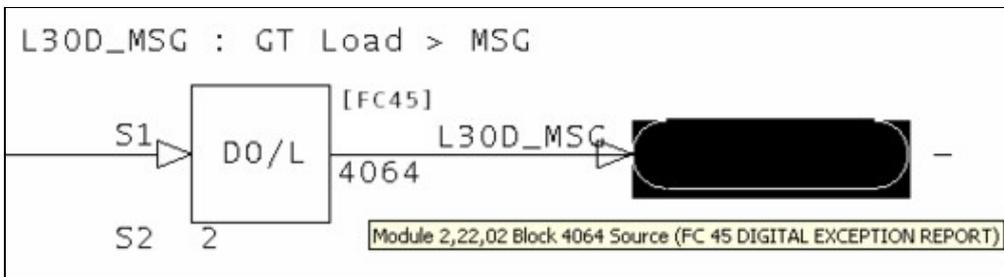
Here is the source indicated by the input reference L30D_MSG.

It is possible to see how Composer, in being robust enough to import files from WinCAD, also allows errors to persist in the input references.
