5 Build Reports and Analysis

5.1 Overview of the DBDOC build reports

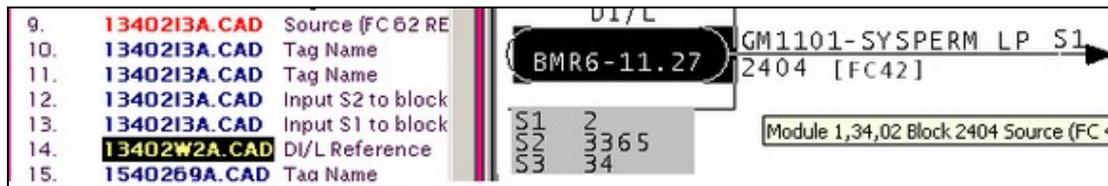
This message means that an exception report input is being attempted from the local module. In INFI 90 Loop, this might cause an "NPMError" when the module is started. Since there was no error in Plant Loop, this has at times been a significant problem.

```
--Generating index: Module 1,34,02 Block Index
Source in same module DI/L Reference MM0310A Module 1,34,02 Block 3365 DOSING EAST MAIN CONTROL
```

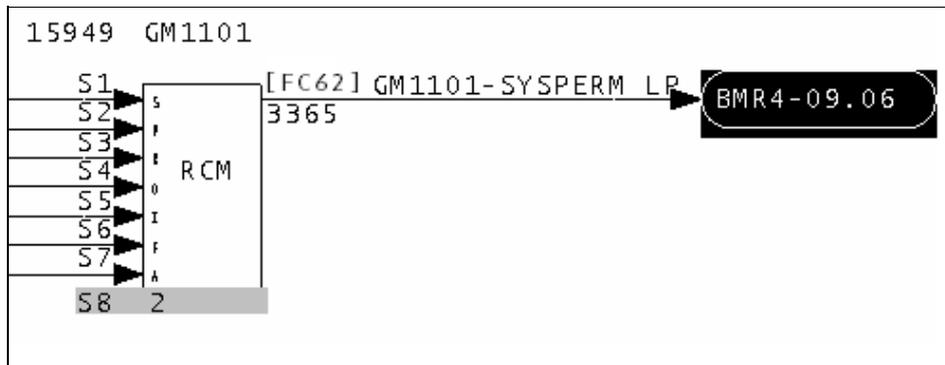
A bit of searching for block 3365 shows that the problem is that S1 should be 4, not 2. Module 1,34,04 Block 3365 is the intended source.

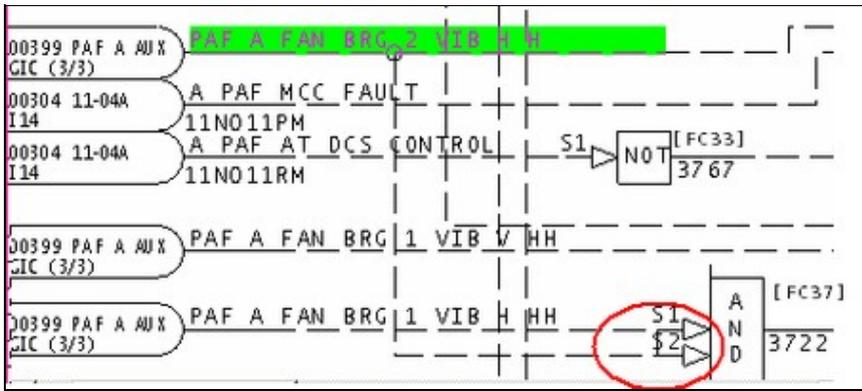
```
--Scanning drawing 3100399 PAF A AUX LOGIC (3/3)
Source may be wired to another source: IREF (PAF A FAN BRG 2 VIB H H).
Source may be wired to another source: IREF (PAF A FAN BRG 1 VIB H HH).
```

The circled area shows an incorrect connection between S1 and S2 of block 3722.

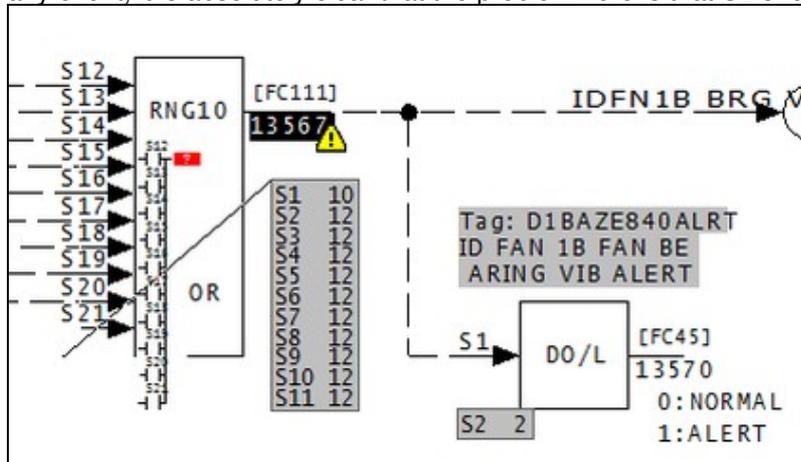
Module 1,01,02 Block 13567 FC111 S1 value 10 is out of the valid range [0,3]

We flag the bad specification as some sort of overridden output, but the new message is simple and direct. In any event, it is absolutely clear that the problem here is that S2 should be 10, and S1 simply 0.

This block does not do what it is supposed to.

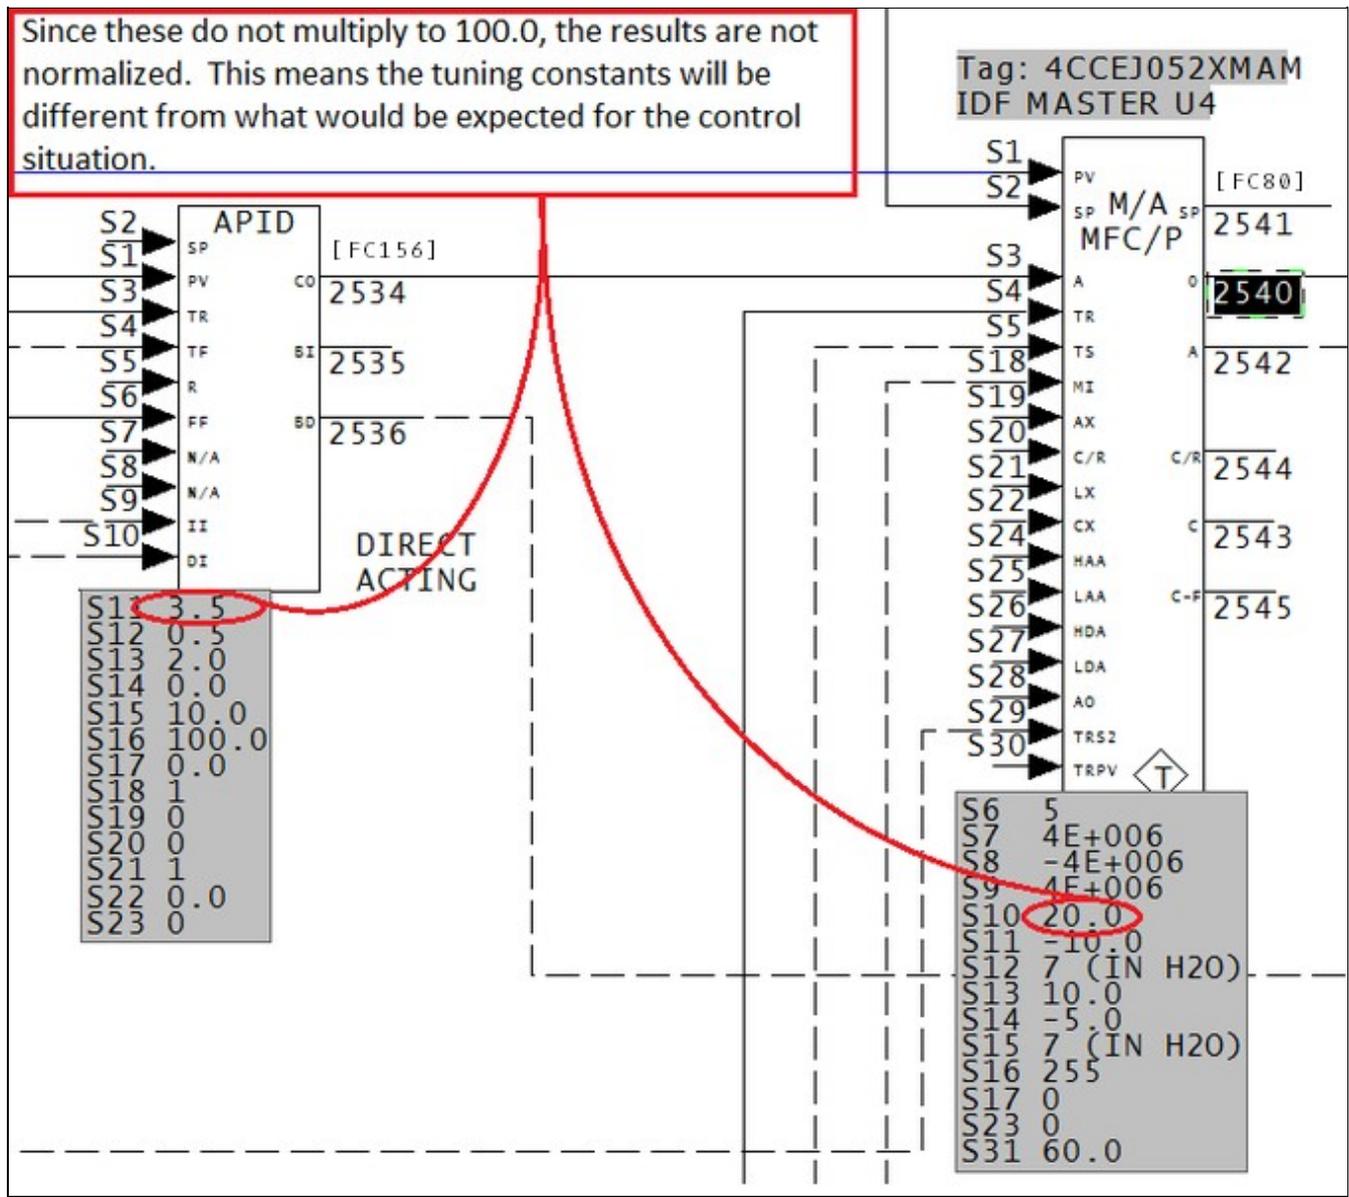
These messages show where that situation does not exist. These blocks can be tuned, but the tuning constants will not be "normalized" and thus will be subject to misinterpretation.

The product of S11 on the APID and the S10 on the M/A MFC/P must fall in the range of 80 to 125. This error occurs when the product is below that range.

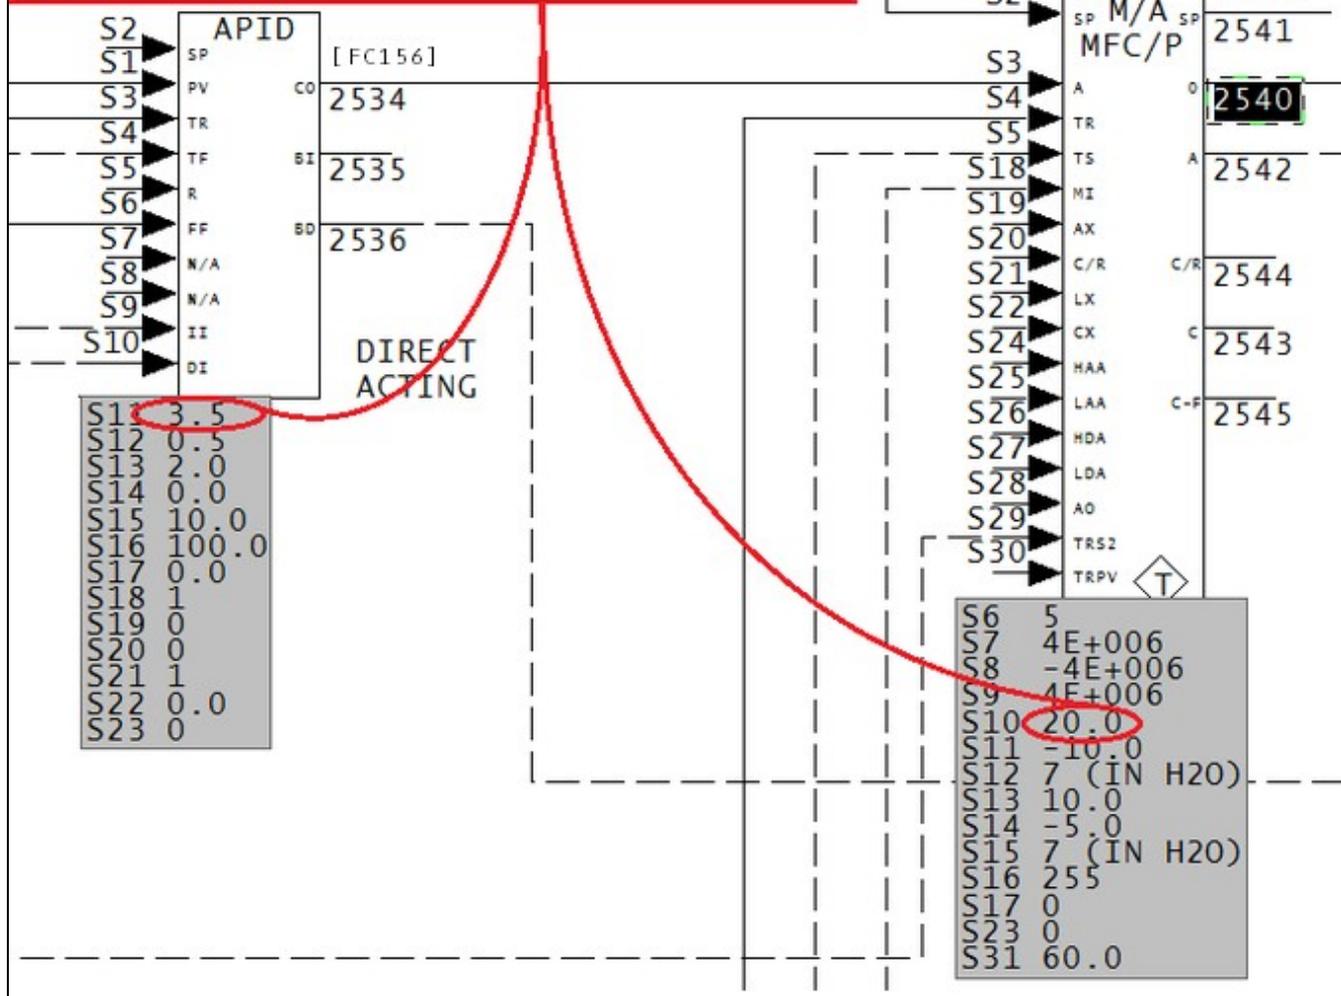
The product of S11 on the APID and the S10 on the M/A MFC/P must fall in the range of 80 to 125. This error occurs when the product is below that range.

Since these do not multiply to 100.0, the results are not normalized. This means the tuning constants will be different from what would be expected for the control situation.

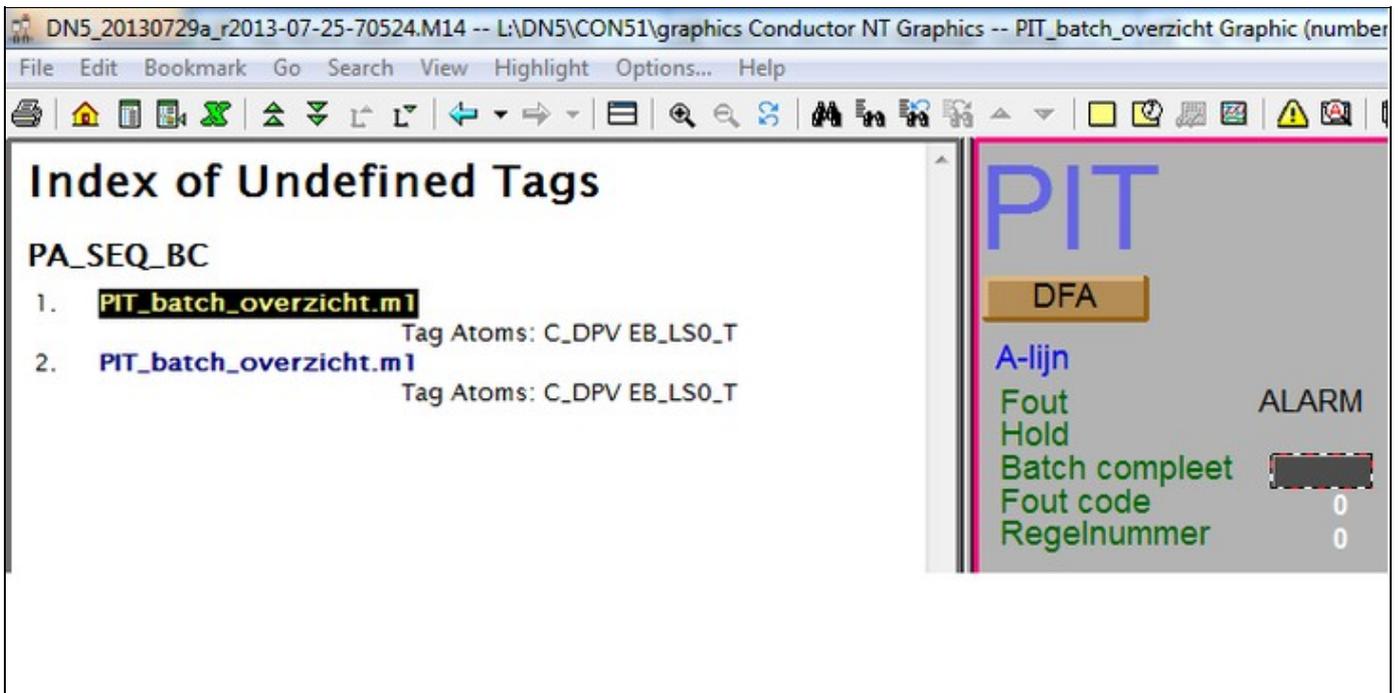
```
Tag atom UndefTag should be upper case
```

The INFI 90 graphics packages are based on Microsoft Access techniques using tagnames as keys, which must be all in uppercase. When they are not all upper case, DBDOC treats them as undefined, and places them in the Index of Undefined Tags. They may not work as expected.

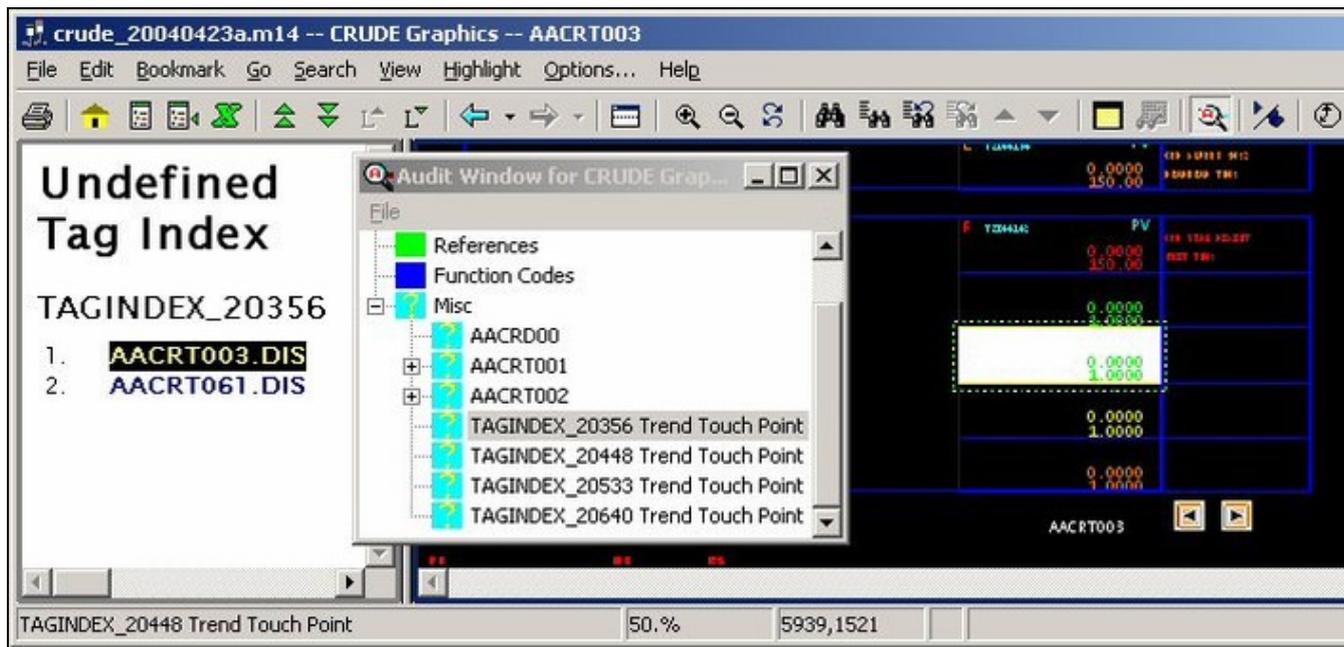
```
--Scanning graphic AACRT003.DIS
```

Tag index not found in AACRT003.DIS: 640

This means that a display element references a blank tagname with tag index 640, but no tag with index 640 was found in the database. That part of the graphic simply does not work. DBDOC cannot tell you what tag index 640 is supposed to be. You have to find that in your archives. The message tells you that the tag index is used in at least one graphic, and it does not exist in the database.

However, searching for places that the undefined tag TAG_00640 is used might be useful. In the image, that is not the case, because you can see that the problem is simply in a trend group. If you find the tag index used on a graphic that gives you some additional clues, it might help resolve it. DBDOC links directly to all of them. In the example, you might find that graphic AACRT061.DIS contains enough information for you to identify the problem and correct it.

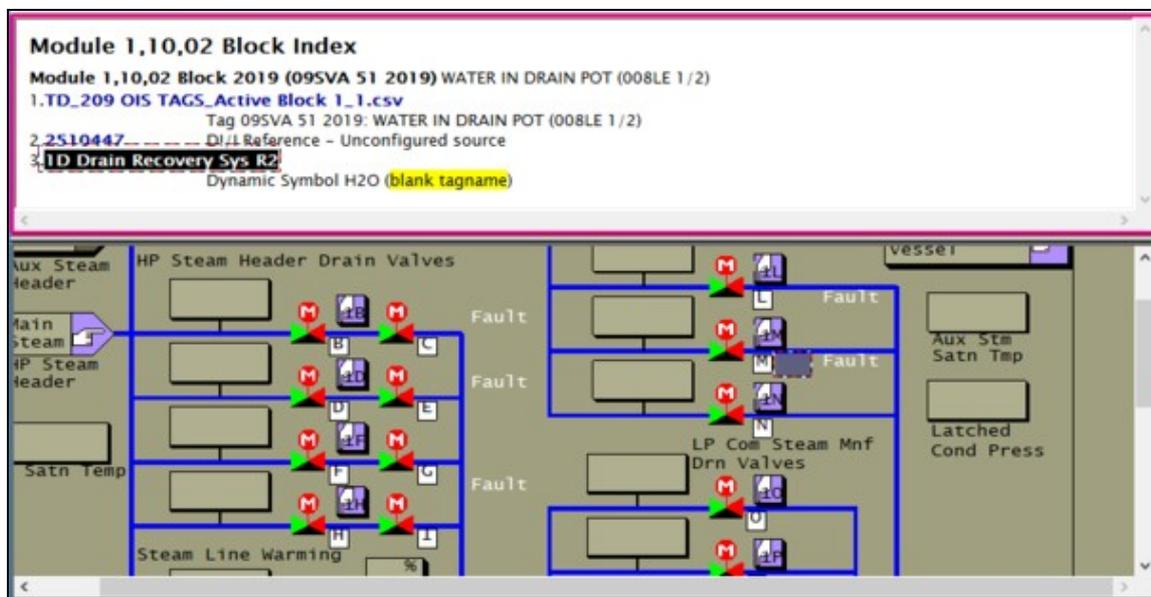
In a SODG graphics system, search for the text "blank tagname" (without the quotes). If you find any, you know that your system has graphics links being made by tag index instead of tag name. This is not stable in the long term.

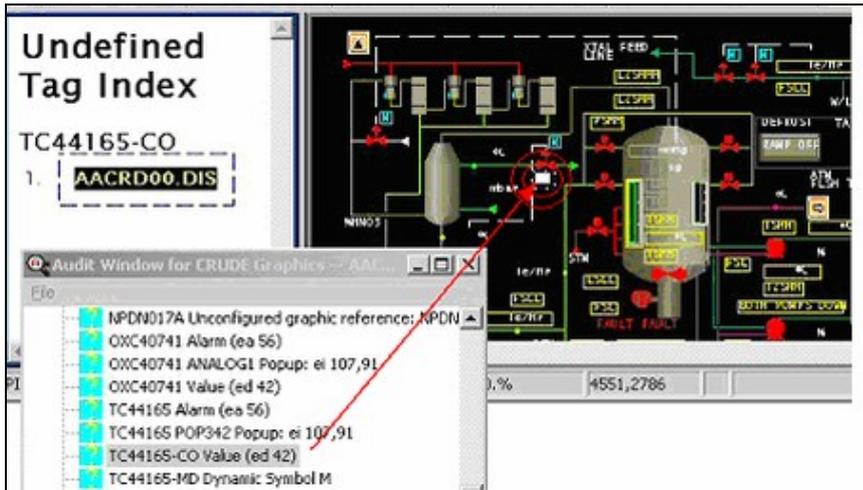
See how the Audit Window actually shows you the type of data being displayed for the undefined tag.

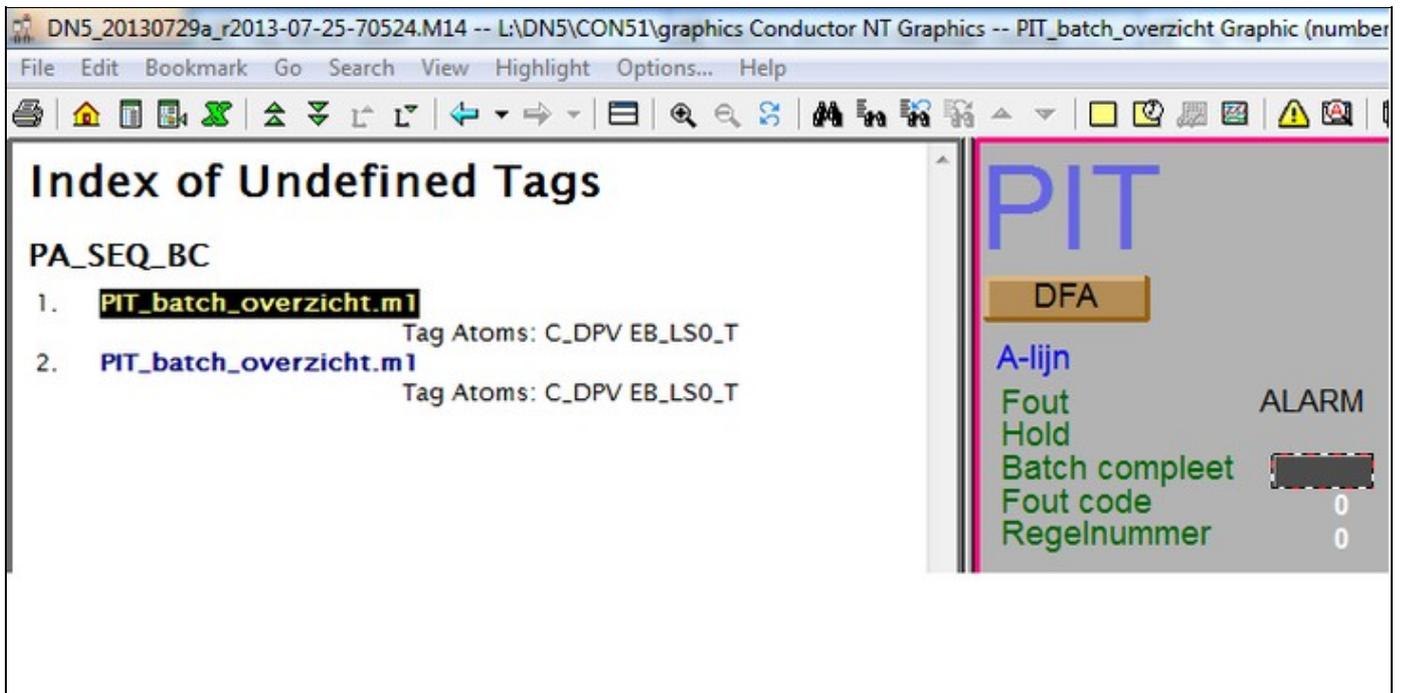
Tag name UndefTag should be upper case

The INFI 90 graphics packages are based on Microsoft Access techniques using tagnames as keys, which must be all in uppercase. When they are not all upper case, DBDOC treats them as undefined, and places them in the Index of Undefined Tags. They may not work as expected.

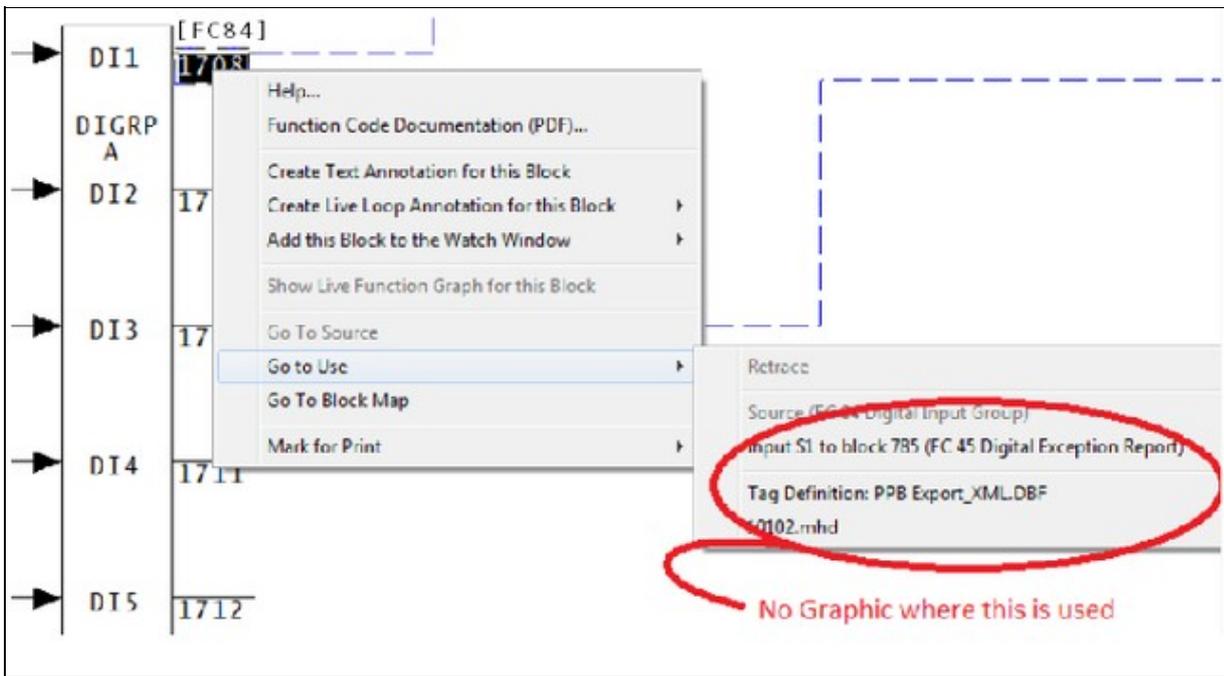
A tag name has been defined for a block output that does not generate an exception report, but the tag is not used on any graphic.

The tag should be corrected, as third-party HMI systems, alarming and history might depend on it. It cannot serve any purpose as it is.

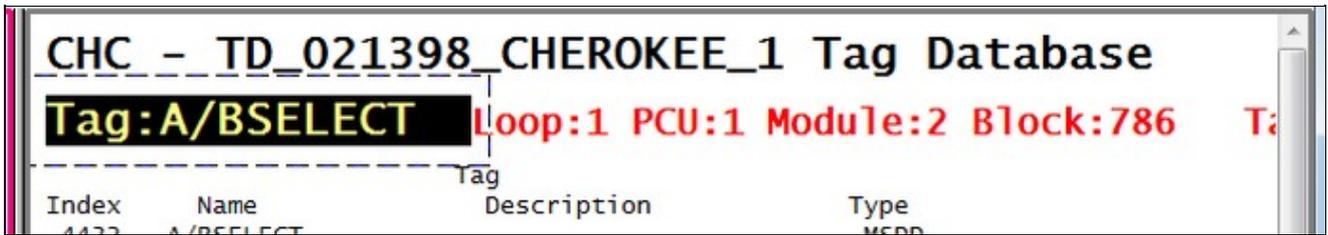
Tagnames with '/' cause problems because '/' is a path delimiting character for QNX. Apparently, WinTools does not notice this and will pass such names into .DR files.

```
--Scanning database file TD_021398_CHEROKEE_1.DBF
Tagname A/BSELECT (Module 1,01,02 Block 786) is illegal in PCView (contains '/').
```

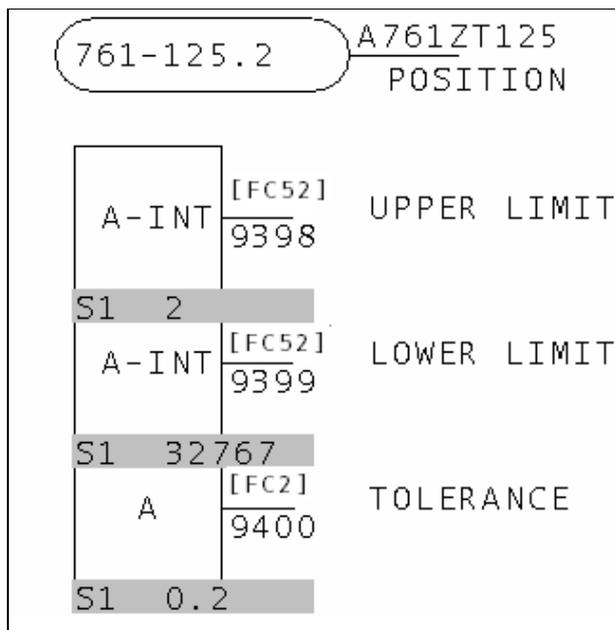
```
--Parsing file E:\PROJECT\ANC_CO~2\EBY0884.CLD...  
Block 9399 S1 integer value 65534 (real value 0.000000) too big for short.
```

From the picture, you can see that somebody must have put 0.0 in S1 of block 9399 (a real number) instead of 0 (an integer). A real number does not have the same structure as an integer, so DBDOC tells you about it. We do not know if it works, but some errors of this type have found actual problems for clients.

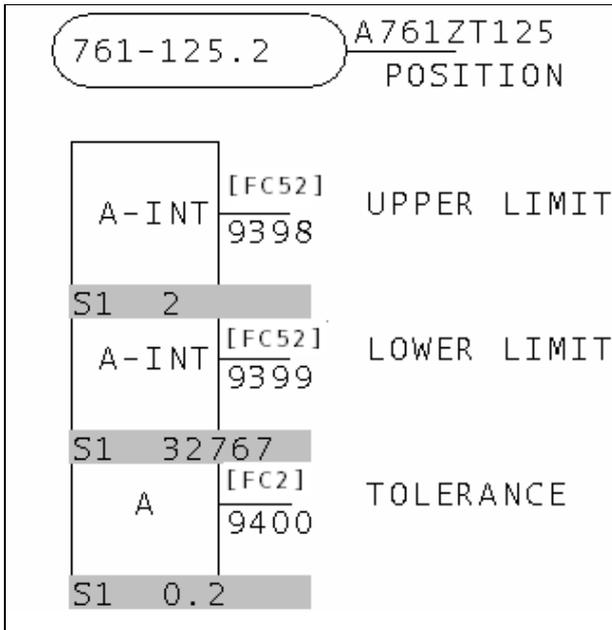
```
--Parsing file E:\PROJECT\ANC_CO~2\EBY0884.CLD...  
Block 9399 S1 integer value 65534 (real value 0.000000) too big for short.
```

From the picture, you can see that somebody must have put 0.0 in S1 of block 9399 (a real number) instead of 0 (an integer). A real number does not have the same structure as an integer, so DBDOC tells you about it. We do not know if it works, but some errors of this type have found actual problems for clients.

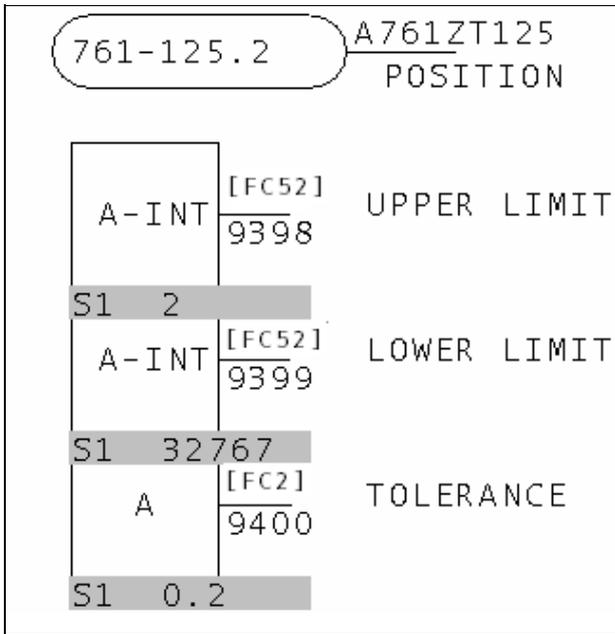
```
--Parsing file E:\PROJECT\ANC_CO~2\EBY0884.CLD...  
Block 9399 S1 integer value 65534 (real value 0.000000) too big for short.
```

From the picture, you can see that somebody must have put 0.0 in S1 of block 9399 (a real number) instead of 0 (an integer). A real number does not have the same structure as an integer, so DBDOC tells you about it. We do not know if it works, but some errors of this type have found actual problems for clients.

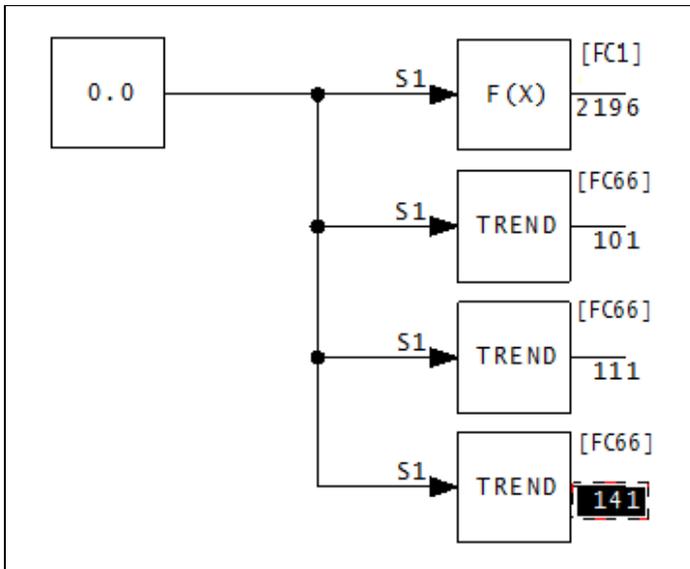
A TREND: Analog Trend [FC66] block records the mean, minimum, maximum, sample, and sum for an input over a given time. This takes processing time, data bandwidth and disk space, to record the trends. When these trend blocks are attached to a constant, all data collected will also be that constant. It is a waste of resources to store this data.

In the above diagram, not only is a trend block wired to a constant (in this case 0.0), but three trend blocks are wired to the same constant.

The trend tag identified is wired from a constant block. It might be using processing time in the controller needlessly, as well as possibly being sent to the history system, using data bandwidth and often disk space.

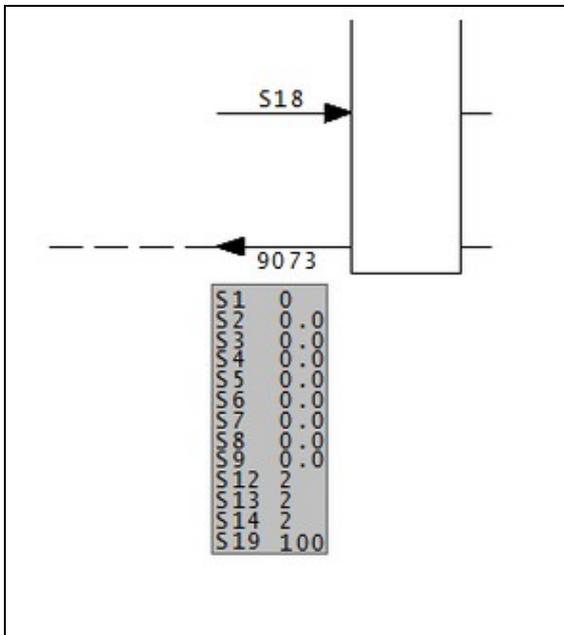
In this case, a CISI/O: Control Interface Slave [FC79] value 100 will cause a trip if any defined I/O point is bad. Value 101 is used to mark the slave as bad if any defined I/O point is bad, but will not trip.

The "trip" specification controls if the module / controller should fail over to the redundant processor if a hardware fault is found. If the trip spec is set to "trip on fault", the module will stop working. If it is set to "continue operation" on fault, the module will smoothly transfer control to the redundant module. This is the normal mode of operation.

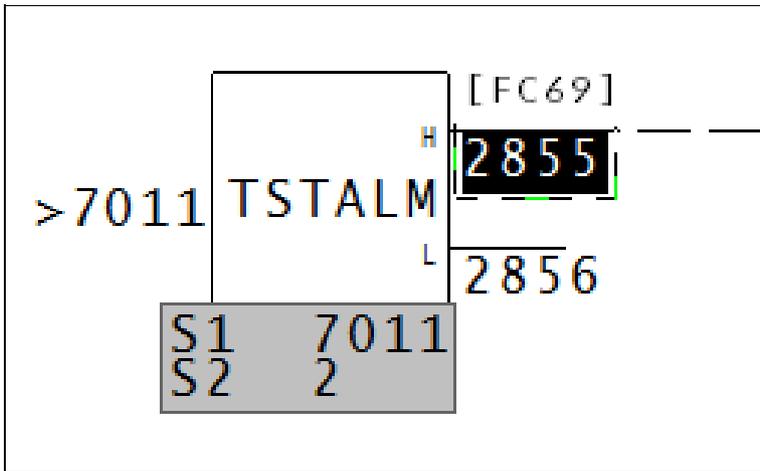
When the TSTALM block has a lower block number than the block it is testing, it executes first in the cycle, therefore it will test the value of the block, taken in the previous cycle.

The test block, (2855), is before the block being tested, (in this case 7011).

These messages exist because in a redundant module switchover, the first scan of the module may have indeterminate or incorrect values for the blocks being tested, as it will not have been executed.

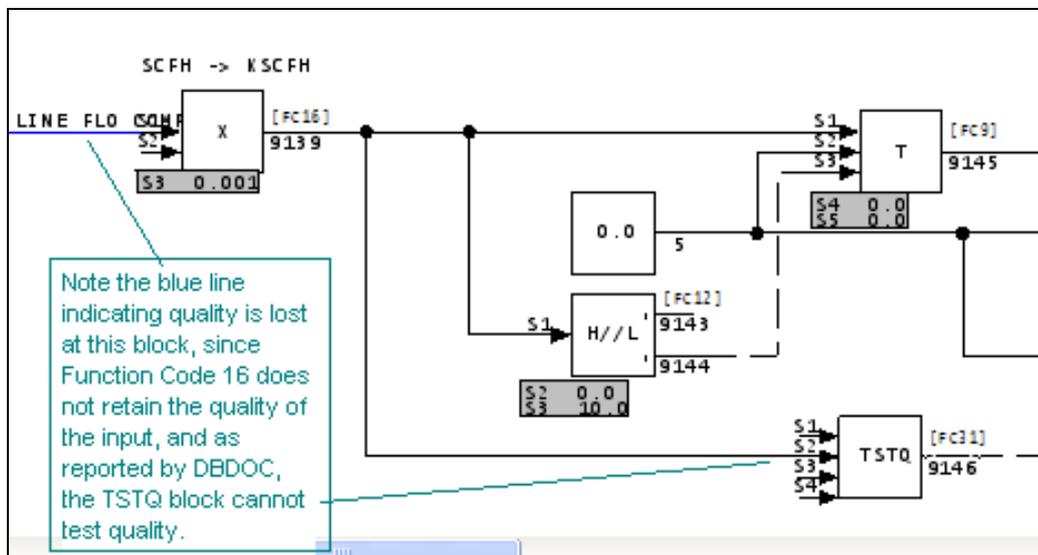
```
--Post Processing drawing T CCW Pumps Auto Trip  
TSTQ Module 1,02,10 Block 6031 tests Module 1,02,10 Block 5663 (FC 38), which does not have quality
```

It is very important to note that this error will only cause a problem when a signal that is counted upon goes bad quality and the logic fails to detect that problem. It was missed in checkout and commissioning, or in subsequent work because it cannot be tested validly.

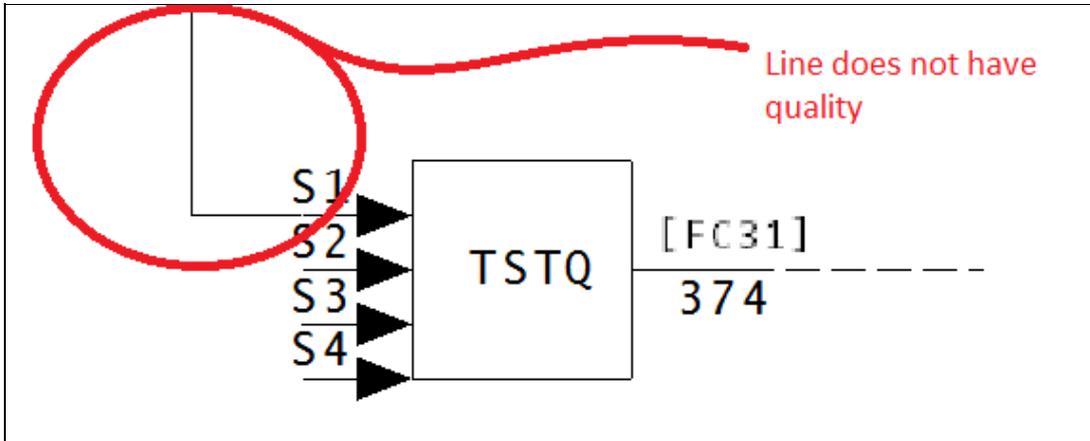
```
TSTQ Module 20,09,31 Block 28552 tests quality on executive block 5,  
which does not have quality [156]  
TSTQ Module 1,06,31 Block 21464 tests quality on Module 1,06,31 Block 21333 (FC 52),  
which does not have quality [156]  
TSTQ Module 1,06,31 Block 21464 tests Module 1,06,31 Block 21333 (FC 50),  
which does not have quality [156]
```

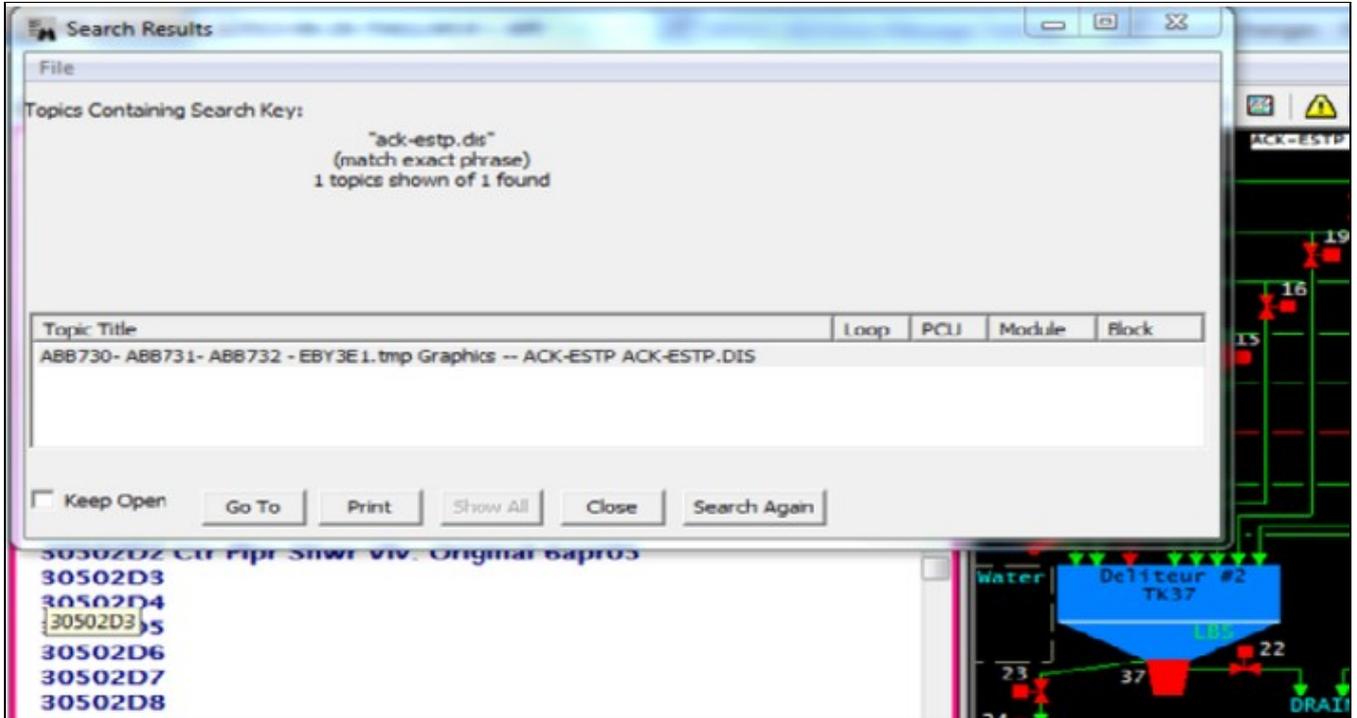
However, when the graphic is searched for, it opens without difficulty.

This shows that the graphic is present, just unconnected to anything.

When a graphic is called upon from the error browser, it fails to open to anything.

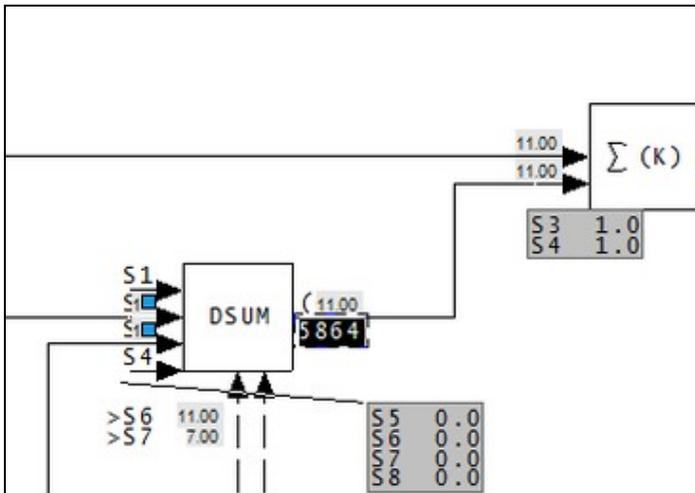
Wired gain spec is adapted: S2 of Module 1,01,02 Block 1001 of 3 FC 1 adapted by Module 1,01,02 Block 1234

This message indicates that a wired gain spec is adapted. Verify that the intent of the logic is to have the gain controlled by an Adapt block.

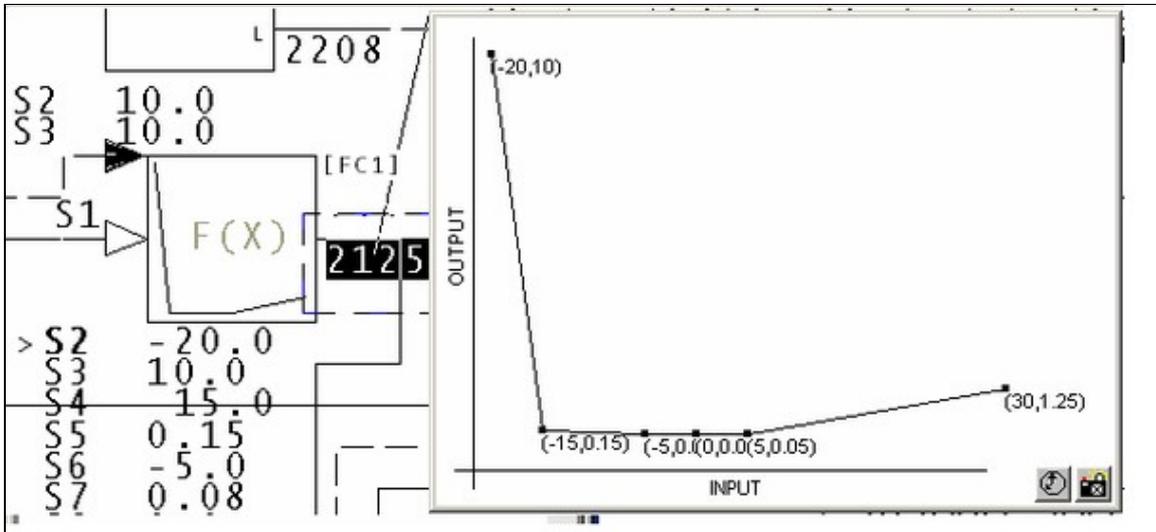
```
--Scanning drawing 24305U8: As Shipped  
X-coordinate adapted - S2 (-20.00) of Module 2,43,05 Block 2125
```

You can see that the default value of S2 will affect the way the function is documented.

We suggest that you should figure out default values for all adapted coordinates. That way, DBDOC can show you what the design function generator shape is supposed to be. Also, live data will then show you deviation from the design shape.

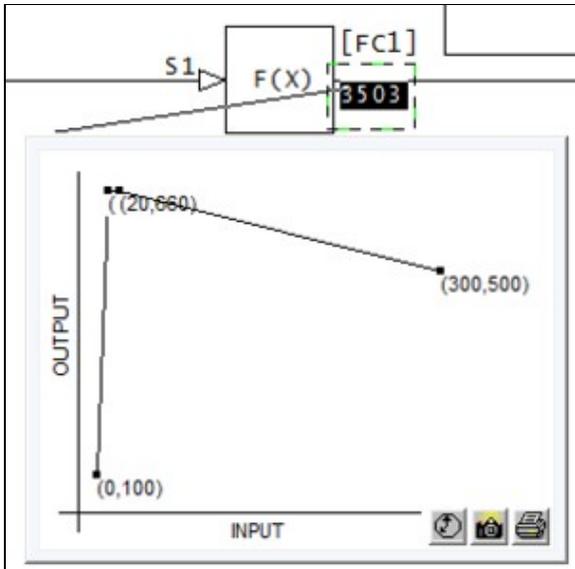
(S2, S3)	0.0	100.0
(S4, S5)	10.0	660.0
(S6, S7)	20.0	660.0
(S8, S9)	300.0	500.0
(S10,S11)	40.0	200.0
(S12,S13)	50.0	100.0

The F(x) looks like this:

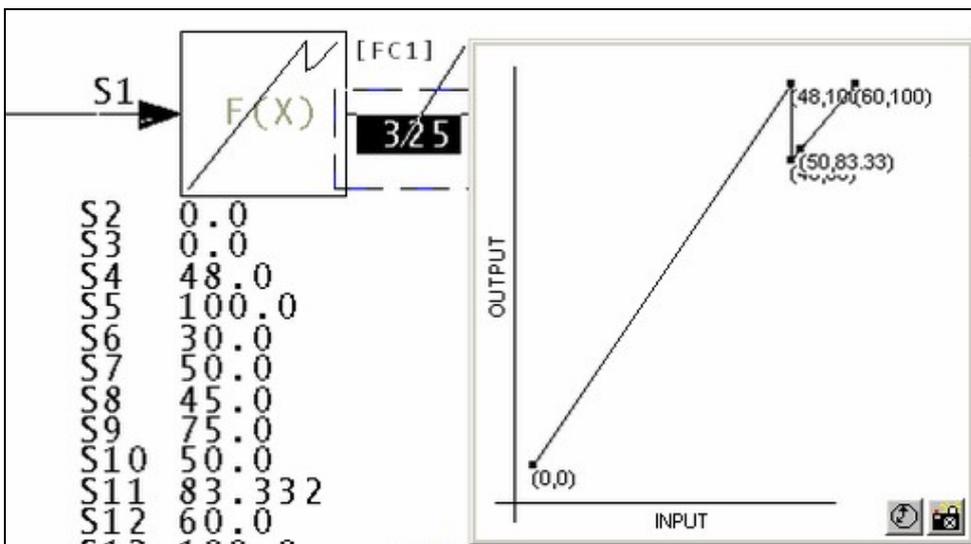
Here's another example:

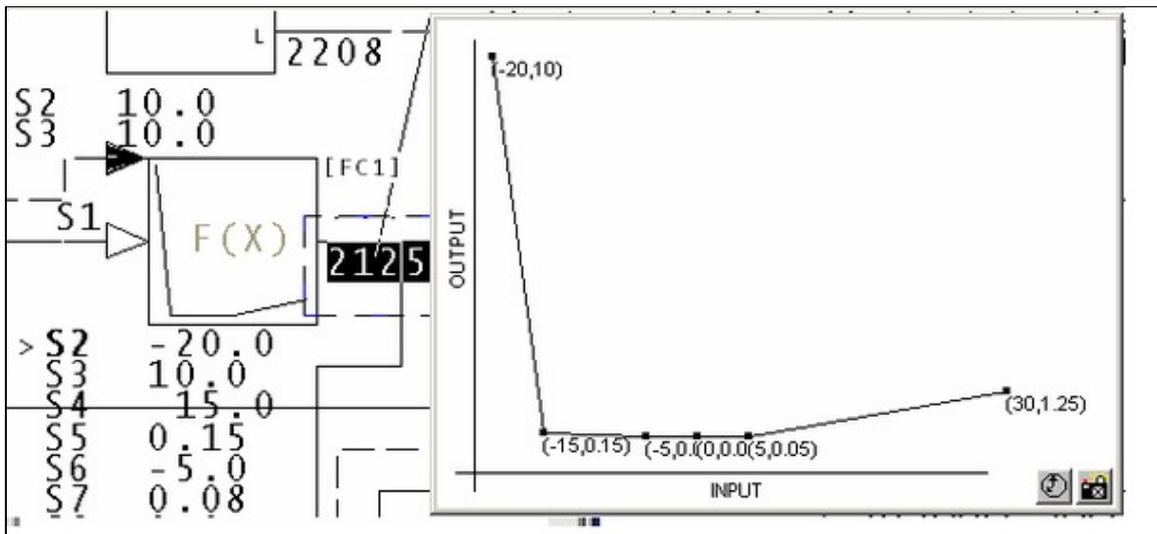
```
--Scanning drawing 24305U8: As Shipped
Y-coordinate adapted - S3 (10.00) of Module 2,43,05 Block 2125
```

You can see that the default value of S3 will affect the way the function is documented.

We suggest that you should figure out default values for all adapted coordinates. That way, DBDOC can show you what the design function generator shape is supposed to be. Also, live data will then show you deviation from the design shape.

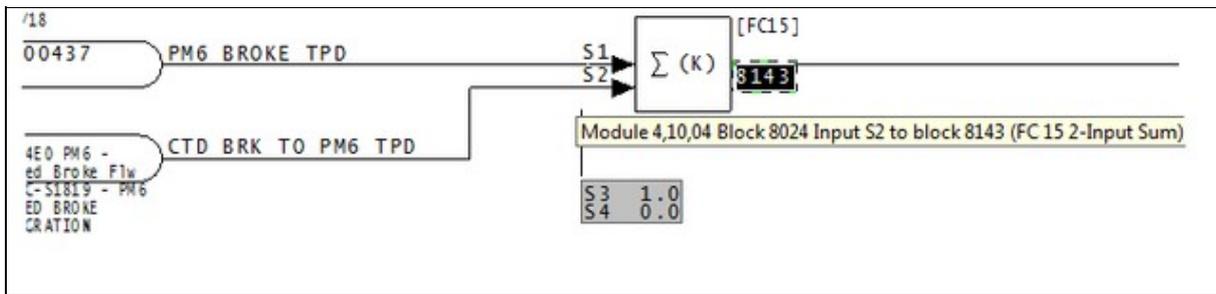
Zero gain value for S4 of Module Block 8143 FC 15 means that Block 8024 is being ignored

The indicated input block is being ignored because the gain applied to it is 0.0. It does not appear as though the block is doing nothing unless specs are viewed as well. This often indicates a value available for tuning that is currently unused, especially if the input block is a constant.

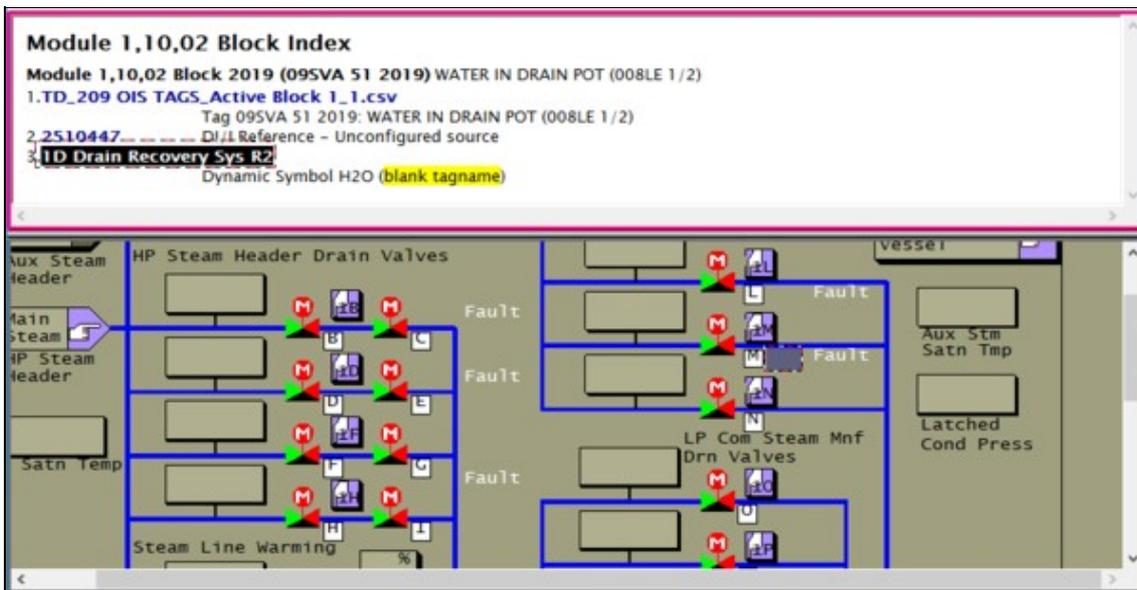
In a SODG graphics system, search for the text "blank tagname" (without the quotes). If you find any, you know that your system has graphics links being made by tag index instead of tag name. This is not stable in the long term.
